**PART 138 ASSESSMENT OF CAUSE AND RISK**

**Case:** Dundee ATIS gave instructions which resulted in the C152 pilot flying into confliction with the PA28.

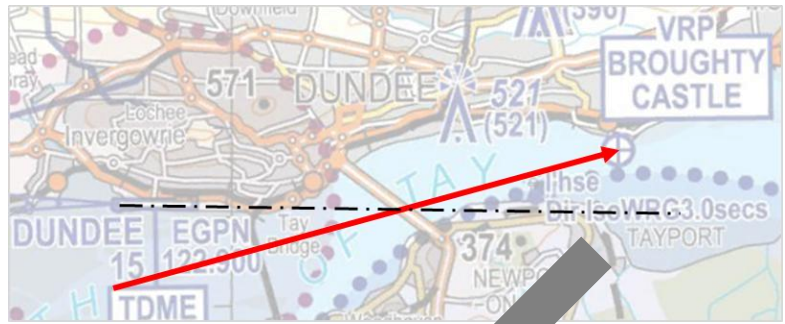
A 3° visual glide slope would place approaching traffic at an altitude of about 700ft at that same position. Departing traffic turning towards the Broughty Castle VRP later in the downwind leg, or on a wider or tighter circuit pattern, would only marginally change the geometry and hence present a similar confliction risk. The Board felt that a more specific departure instruction such as “route to Broughty Castle VRP via the south of the road bridge” might have assisted, or perhaps even an instruction for the C152 pilot to depart to the west and then north in order to avoid routing against the incoming traffic flow at all. The Board agreed therefore to recommend that Dundee review their departure and arrival procedures and phraseology to ensure traffic deconfliction.

The PA28 pilot stated that he had maintained 1500ft until the road bridge, which would have placed him at about 800ft above the glide slope and 700ft clear of the C152 at that point. In the absence of a radar recording it was not possible for members to state the actual course of events but it was agreed most likely that the C152 and PA28 pilots flew into collision somewhere to the west of the road bridge, probably near the ATZ boundary.

**Recommendation:** Dundee review their departure and arrival procedures and phraseology to ensure traffic deconfliction.
