AIRPROX REPORT No 2014235

Date/Time:	28 Dec 2014 0918Z (Sunday)	
<u>Position</u> :	5139N 00022E (Lambourne Hold)	
<u>Airspace</u> :	London TMA	(<u>Class</u> : A)
	<u>Aircraft 1</u>	<u>Aircraft 2</u>
<u>Type</u> :	A320 (A)	A320 (B)
<u>Operator</u> .	CAT	CAT
<u>Alt/FL</u> :	FL116	FL109
Conditions:	VMC	IMC
Visibility:	>10km	
Reported Separation:		
	100ft V/3nm H	100ft V/NK H
Recorded Separation:		
	700ft V/2.9nm H

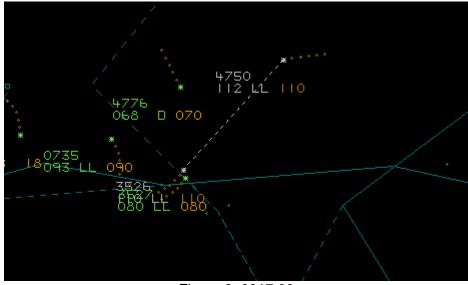
Figure 2: 0917:00

The LL INT controller instructed A320 (A) pilot to turn right immediately heading 330° degrees and to stop descent. At 0917:00 (Figure 2), the A320 (A) pilot was instructed to climb to FL120 and given Traffic Information on traffic in their 10 o'clock same level at 3nm. The controller then reiterated the instruction as avoiding action. A320 (A) pilot read back the instruction to climb and informed the LL INT controller that "we have the traffic".

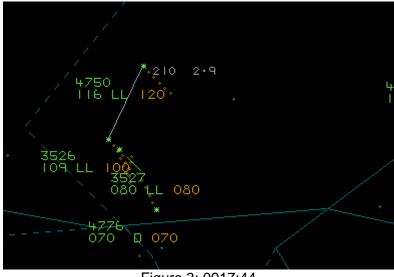
Figure 3: 0917:44

The LL INT controller instructed A320(B) pilot to descend to FL100 and gave Traffic Information on the other A320 as in his 3 o'clock at a range of 2½nm, climbing to FL120. A320 (B) pilot stated that they had A320 (A) on TCAS. CPA occurred at 0917:44, when the two aircraft were 2.9nm/700ft apart; the aircraft subsequently diverged.
