### **AIRPROX REPORT No 2013066**

*Date/Time*: 3 Jul 2013 1556Z

Position: 52 03N 000 01W

*Type*: Lynx Tiger Moth

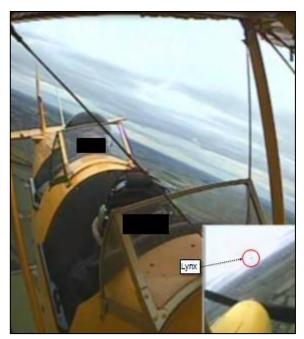
Both pilots reported turning right; the Tiger Moth pilot submitted a cockpit video which clearly shows his turn and its effect but, whilst the Lynx can be seen, the image is not clear enough to assess any manoeuvres it may have made. Figures 1 and 2 are taken from the Tiger Moth's cockpit video and show the aircraft before and after the CPA.

Figure 1. Before CPA

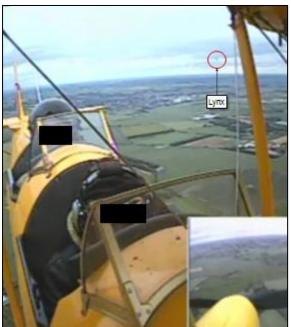
Figure 2. After CPA
