AIRPROX REPORT No 2013176

Date/Time: 1 Dec 2013 1213Z (Sunday)

Position: 5120N 00132W
(Rivar Hill Glider Site)

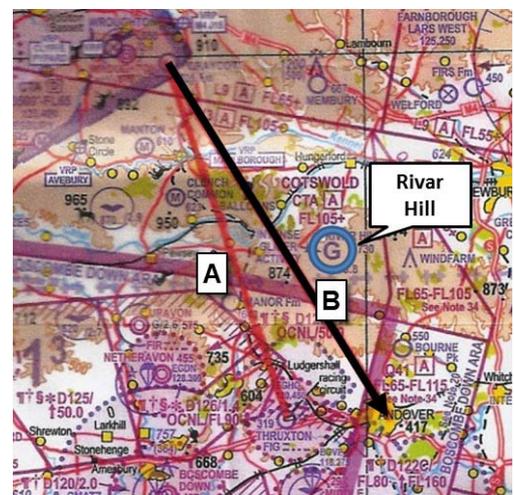
Figure 2

THE CESSNA 175 (C175) PILOT reports flying VMC, 500ft below cloud, heading 150° at 110kt with navigation lights illuminated and transponder Modes A and C selected. Having climbed to 2000ft, his intention was to route to Andover to position for right-base for RW25 at Thruxton because this routing would have kept him away from Danger Area D126 and clear to the west of Rivar Hill glider site (Route B in Figure 2). The pilot was aware of the Gliding Site en-route but the day had started with a low cloud base which had risen significantly during the morning; having been a glider pilot, he was aware that it was not a good 'thermal type of day', so he did not expect to see much gliding activity but was 'aware of the situation'. Around the mid-point of his route, as he had passed over the River Kennet, he saw what he thought to be a single-seat, medium-performance glider, possibly a red, or dark

As for the C175 pilot, the Board greatly appreciated his open and honest report, which included the map of his planned routing. It was clear to the Board that he was aware of the location of Rivar Hill Gliding Site, of glider operations in general, and had planned appropriately. However, it appeared that in execution of his flight he had made a navigation error and had inadvertently over-flown the launch-site.

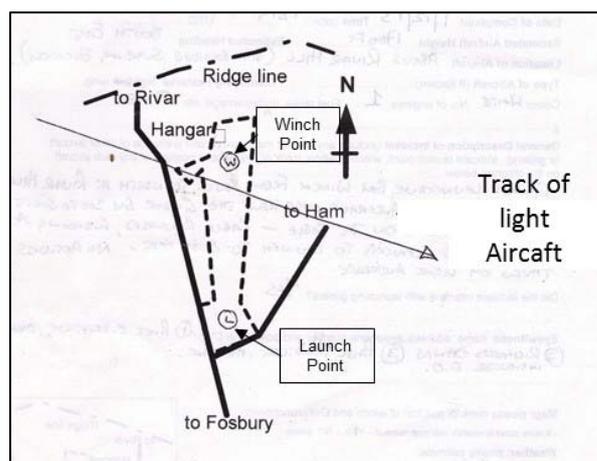
THE SHALBOURNE SOARING SOCIETY reports gliders were being launched by winch from south to north, and that Rivar Hill gliding site is authorised to winch-launch up to 3000ft. The cloud-base was reported as 2500ft agl with a northwesterly wind at 8kt and over 30km visibility. As well as the glider pilot, 2 club members at the launch point observed the C175 overflying the gliding site and agreed with the glider pilot's assessment that it had over-flown the glider by around 2-300ft. Figure 4 shows the estimated track of the C175.

The C175's track is shown squawking Mode 3/A 7000 with no Mode C, on the Heathrow 10 radar recording. It passed overhead Rivar Hill Gliding Site from northwest to southeast at 1213:36. The Puchacz glider is not shown on the radar recording but a group of intermittent Primary Radar returns are shown to the northeast of the aerodrome; these cannot be positively identified as returns from aircraft but they are commensurate with those of manoeuvring gliders.

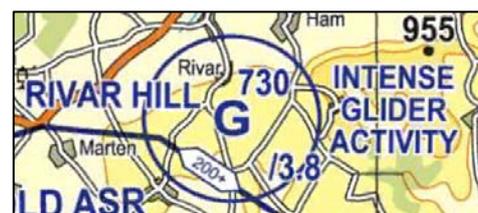
Figure 5

Rivar Hill Glider Site is published in the UK AIP¹ with winch-launches up to 3000ft agl and displayed on the 1:250,000 chart (Figure 5), with winch-launches up to 3,800ft amsl and an aerodrome elevation of 730ft.
