AIRPROX REPORT No 2012108

Date/Time: 24 Jul 2012 1544Z

Position: 5337N 00002W
(4nm NNE Grimsby)

Type: Tucano Spitfire Mk26

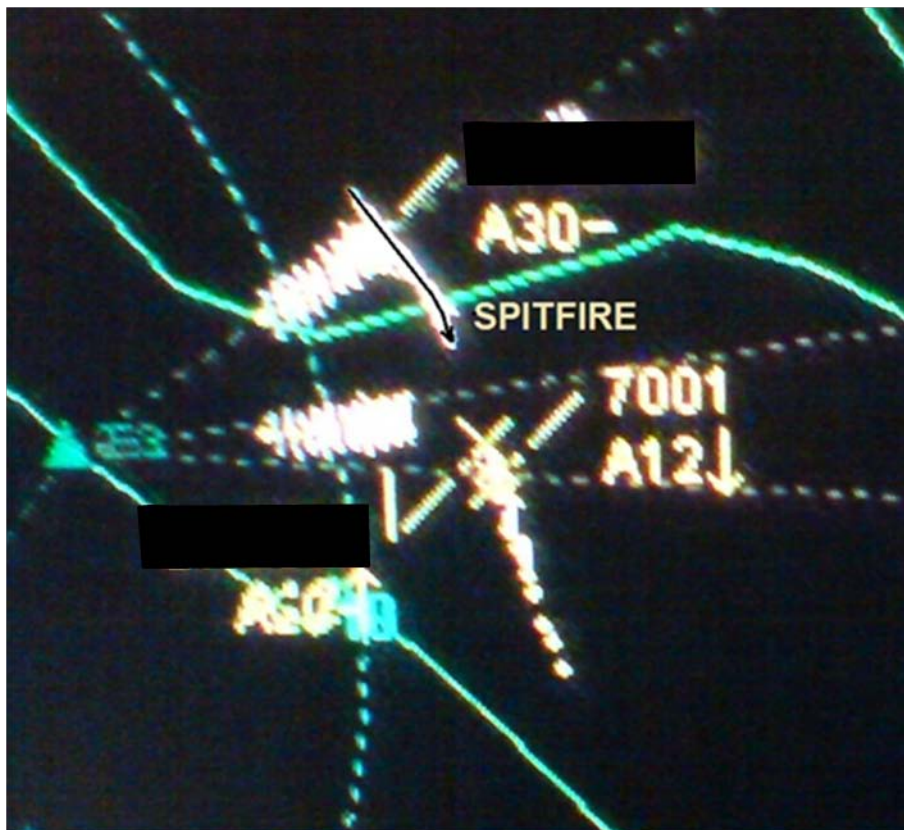
Picture 1: 1543:45 - Humberside radar

At 1543:33, the controller transmitted, “[Formation C/S] *did you copy the traffic on your nose range of a mile and a half opposite direction believed to be about a thousand feet unverified.*” The formation responded, “*and visual with both [Formation C/S]*” and then at 1543:45, “[Formation C/S] *break right.*” As the formation started the R turn, the Humberside radar showed the Spitfire commencing a R turn onto a S’ly heading, as shown in picture 1 below. For clarity, a black line and arrow has been added to highlight the track of the Spitfire. The Tucano formation is shown flying 0.4nm in trail.

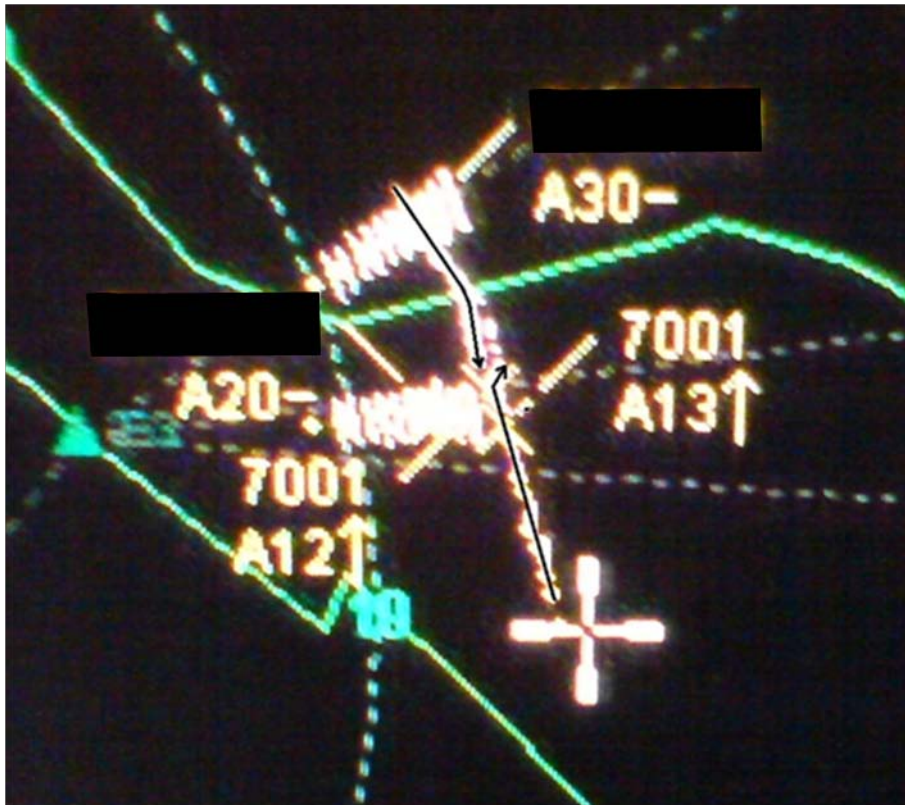
Picture 2: 1543:54 - Humberside radar

At 1543:54, the Humberside radar showed the Spitfire passing 0.25nm (CPA) NW of the formation, as shown on picture 2 below. For clarity, a black line and arrow has been added to highlight the tracks of the Spitfire and Tucano formation leader.
