AIRPROX REPORT No 2022171

Date: 12 Aug 2022 Time: 1712Z Position: 5053N 00057W Location: 1NM NE Havant

PART A: SUMMARY OF INFORMATION REPORTED TO UKAB

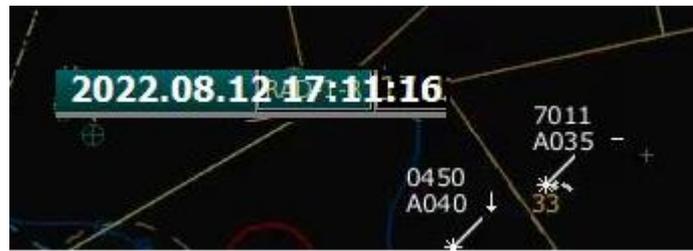
At 1711:20, the 0450 squawk appeared on the bottom of the radar display converging with [an aircraft displaying a] 7011 (Solent Radar listening) squawk. The 7011 indicated 3500ft, which was unvalidated and unverified due to 7011 being a conspicuity squawk. Figure 1.

Figure 1 – SR22 appeared on screen.

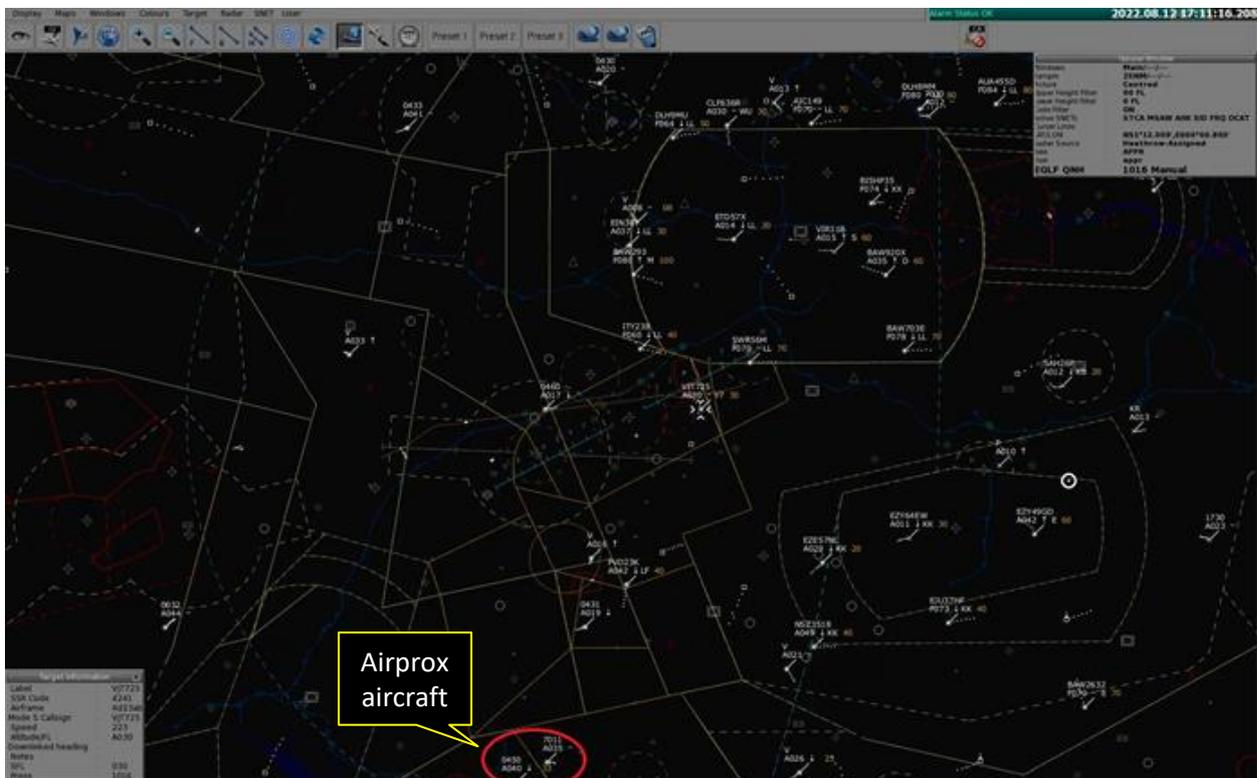
The next shot is the whole radar screen for context, Figure 2.

Figure 2 – Entire radar screen as seen by controller.

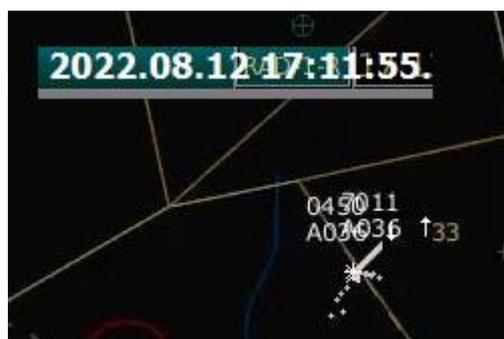
Figure 3 – 1711:56

The raw radar-feed showed, at 1711:56, the aircraft were 0.11NM and 100ft apart, Figure 3.

An analysis of the NATS radar replay was undertaken and both aircraft were detected and identified using Mode S data. The SR22 pilot had been maintaining a steady track and descent in the lead-up to the Airprox and the DR400 had been straight and level until 8sec before CPA, when the radar detected a climb of 100ft. The orbit described by the DR400 pilot was detected by the radar 8 seconds (2 radar sweeps) after CPA.

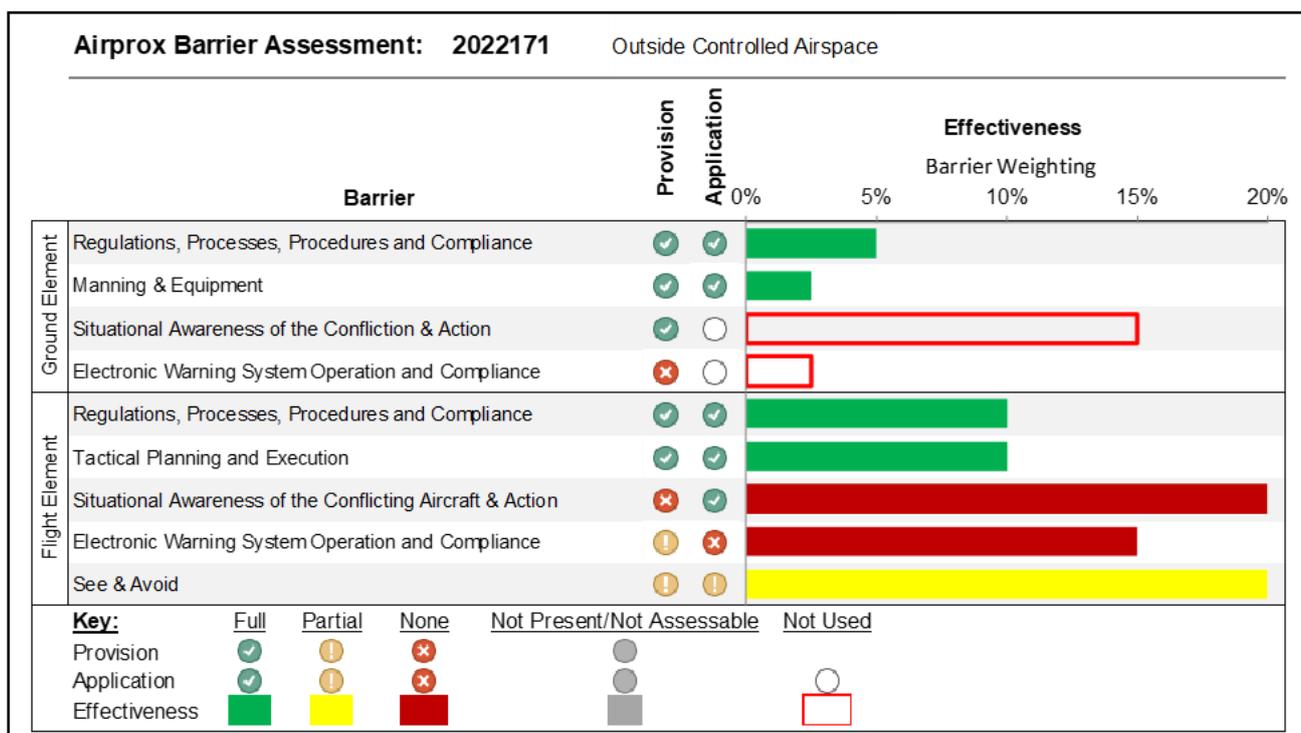
Electronic Warning System Operation and Compliance were assessed as **ineffective** because the EC equipment fitted to the SR22 should have alerted the pilot to the presence of the DR400 prior to CPA.

See and Avoid were assessed as **partially effective** because the DR400 pilot had become visual with the SR22 at a later than optimum stage, and the SR22 pilot had become visual with the DR400 at a point when it had been too late for them to have been able to take any effective avoiding action.
