AIRPROX REPORT No 2023004

Date: 11 Jan 2023 Time: 0934Z Position: 5217N 00001E Location: 7NM NNW Cambridge

PART A: SUMMARY OF INFORMATION REPORTED TO UKAB

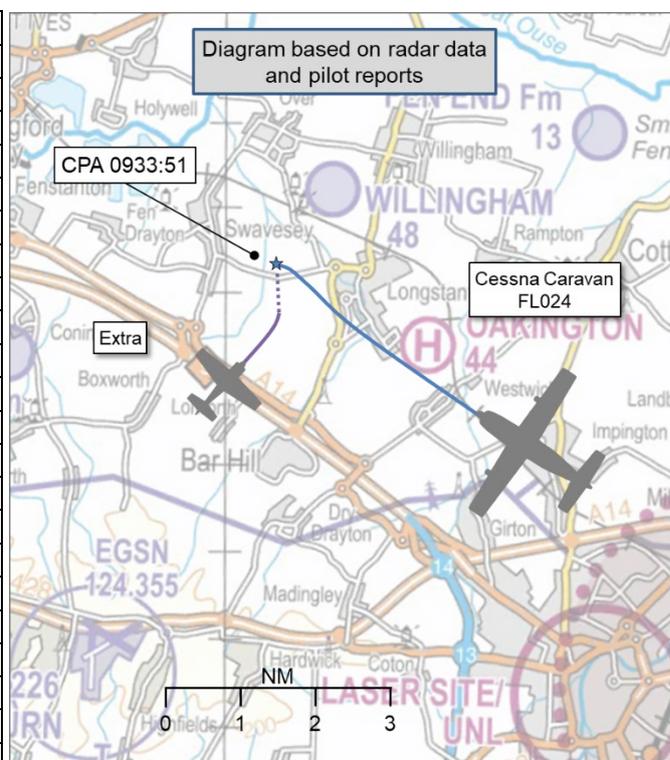
Recorded	Aircraft 1	Aircraft 2
Aircraft	Cessna Caravan	Extra 200
Operator	Civ Comm	Civ FW
Airspace	London FIR	London FIR
Class	G	G
Rules	VFR	VFR
Service	Basic	AGCS
Provider	London Info	Fowlmere
Altitude/FL	FL024	NK
Transponder	A, C, S	A, C, S ¹
Reported		
Colours	White, Red, Blue	Red, White
Lighting	Nav Anti-Cols	Strobe, Nav
Conditions	VMC	VMC
Visibility	>10km	>10km
Altitude/FL	2300ft	3000ft
Altimeter	QNH (1008hPa)	QNH
Heading	300°	NK
Speed	200kt	124kt
ACAS/TAS	SkyEcho	Not fitted
Alert	None	N/A
Separation at CPA		
Reported	0ft V/300m H	Not Seen
Recorded	NK

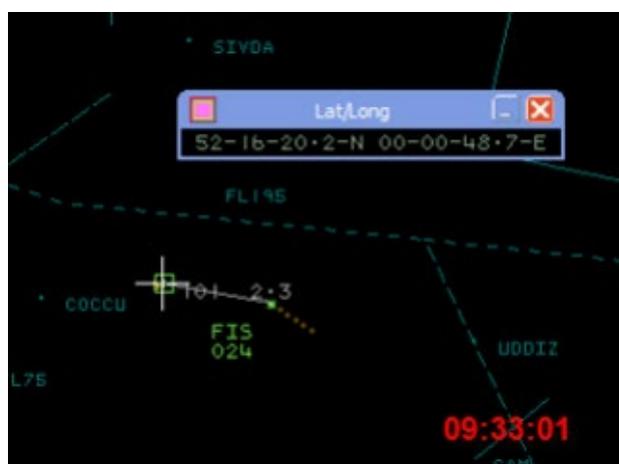
As described within the [Cessna Caravan C/S] pilot report, the aircraft was maintaining altitude 2400ft on a westerly track, turning onto a north-westerly track immediately after passing overhead Cambridge Airfield (see Figure 1 displaying positions of two aircraft prior to conflict). [Extra C/S] displayed as a primary contact only. The primary target of [Extra C/S] subsequently disappeared from radar. The target re-appeared for 1 radar update at 0933:31 on the single source radar S10, (see Figure 2) which was deemed as the closest point of approach between the two aircraft based on NODE radar data alone. At 0933:43, radar indicated [Cessna Caravan C/S] turned right, followed by an immediate left turn. The [Cessna Caravan C/S] pilot’s Airprox report described this as a 60° avoidance manoeuvre followed by an ‘immediate left to remain visual with other aircraft’.

With assistance from Cambridge ATC, SI were able to establish the identity of the second aircraft as [C/S redacted], an Extra 200 aerobatic aircraft. NODE radar displayed [Extra C/S] was airborne from [departure airfield] at approximately 0909:11 and subsequently tracked northbound to establish abeam the position of the Airprox. This was confirmed by the pilot of [Extra C/S]'s Airprox report. The aircraft was identified by the Mode-S aircraft address. Mode A and C were displayed until 0918:55 when radar displayed the aircraft as a primary track only. The primary track proceeded to display as if performing high energy aerobatic manoeuvres abeam the area pictured in Figure 1.

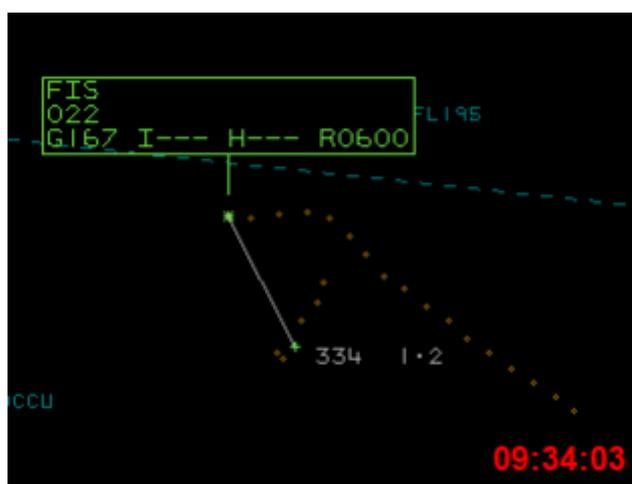
[Extra C/S] was not displayed as a primary contact on NODE Radar at the time of this manoeuvre, but was subsequently displayed again, after the conflict, at 0934:03 (see Figure 3).

Figure 3 displaying avoidance turn and position of Extra when primary target reappeared.
