AIRPROX REPORT No 2023175

Date: 09 Aug 2023 Time: 1255Z Position: 5339N 00124E Location: Below EGD323

PART A: SUMMARY OF INFORMATION REPORTED TO UKAB

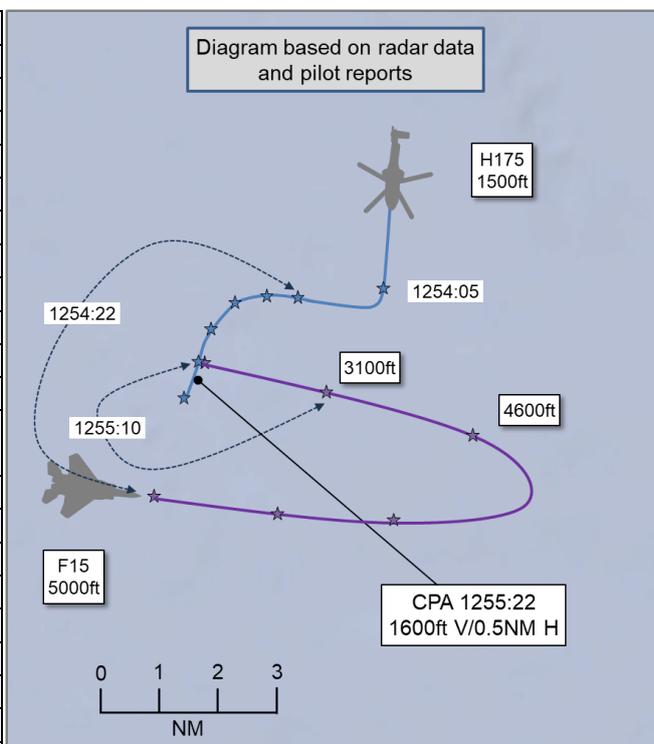
Recorded	Aircraft 1	Aircraft 2
Aircraft	H175	F15
Operator	Civ Comm	Foreign Mil
Airspace	London FIR	London FIR
Class	G	G
Rules	IFR	VFR
Service	Offshore Deconfliction	In contact with
Provider	Anglia Radar	Anglia Radar
Altitude/FL	1300ft	2900ft
Transponder	A, C, S+	A, C, S
Reported		
Colours	Red/White/Blue	Grey
Lighting	Strobe, Beacon, Navigation	Navigation
Conditions	VMC	VMC
Visibility	>10km	>10km
Altitude/FL	1500ft	3500ft
Altimeter	QNH (1012hPa)	RPS
Heading	185°	270°
Speed	140kt	'450+kt'
ACAS/TAS	TCAS II	Other
Alert	RA	Information
Separation at CPA		
Reported	NK V/NK H	'Well clear' V/>5NM H
Recorded	1600ft V/0.5NM H

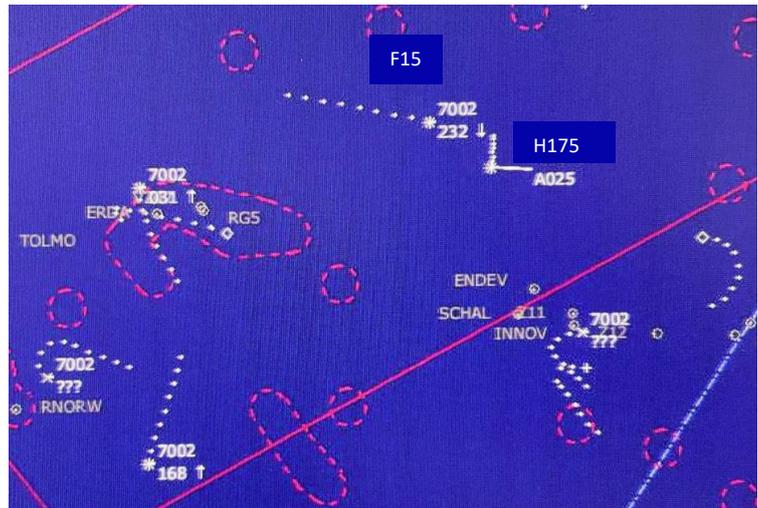
1243:40 - An aircraft displaying 7002 (identified as [F15 callsign] by Mode S data) changed from a PSR-only contact to displaying SSR with Mode C indicating 3100ft. At this time the aircraft had been 28NM west of the H175 and manoeuvring.

1244:11 – The F15 rolled out onto a track of 070°. ANG connected the H175 and the F15 using the RDP BRM function which indicated that the F15 callsign had been on a bearing of 278° at 24.9NM from the H175. ANG had repeatedly moved the SSR label blocks of the manoeuvring 7002 contacts in order to maintain a clear view of the data.

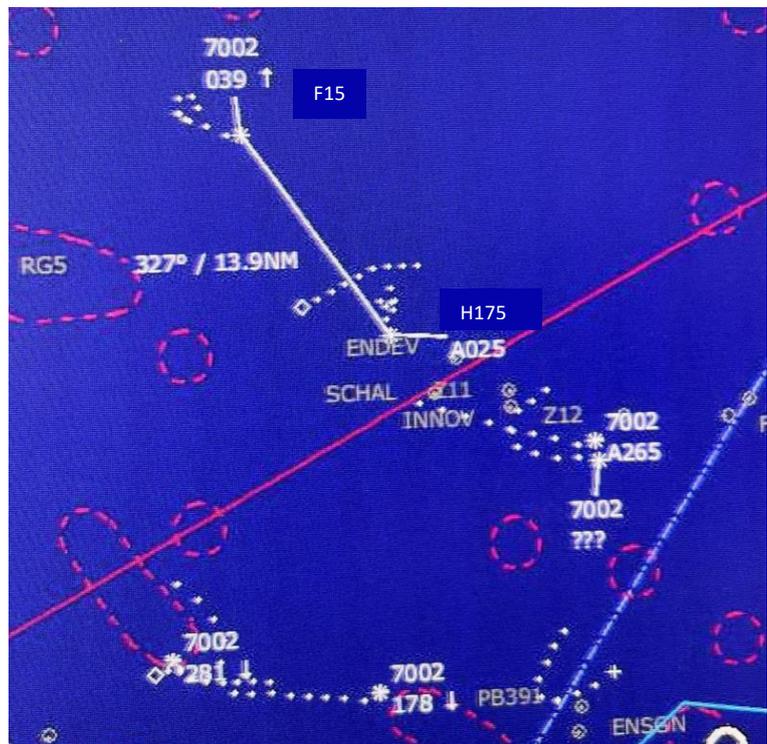
1247:00
 ANG: “[H175 callsign] one fast moving aircraft behind you at the moment, it's 5 o'clock 13 miles indicating altitude 4000ft.”
 [H175 callsign]: “Copied [H175 callsign].”

1248:02 – ANG: “[H175 callsign] aircraft behind you now 6 o'clock 10 miles indicating altitude 3000ft.” This contact turned south towards the H175 but then climbed to FL110.
 [H175 callsign]: “Roger copied that. We might take a descent to 1500ft if possible.”
 ANG: “[H175 callsign] affirm, descend to altitude 1500ft. That aircraft has climbed now, it is high level.”
 [H175 callsign]: “Copied, descending to 1500ft, it's below MSA with the windfarm but we are Victor Mike Charlie.”

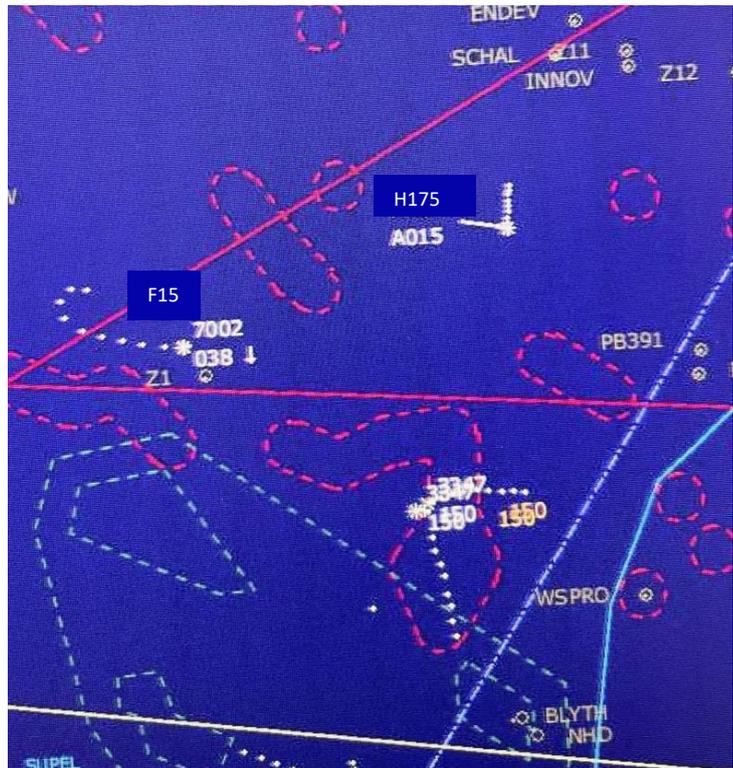
ANG: “[H175 callsign] *2 o’clock range 14 miles indicating 3000ft now.*”

The 7002 contact then turned to the east.

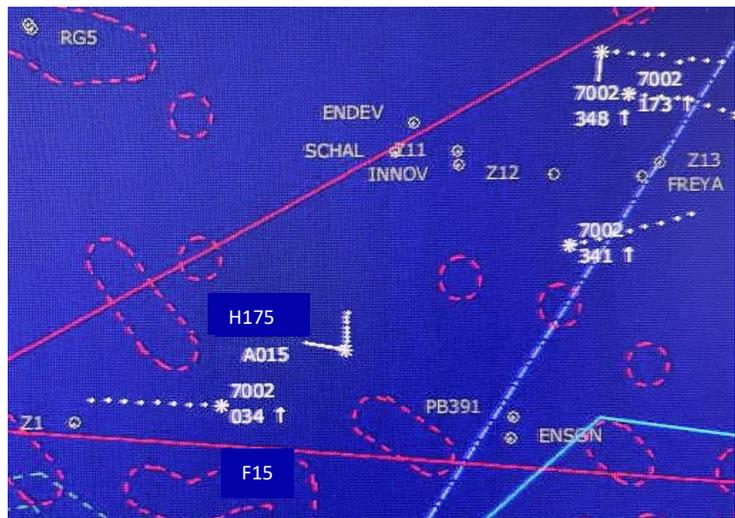
1253:42 - ANG: “[H175 callsign] *avoiding action turn right heading 280°.*”

The conflicting traffic had been 8.26NM to the southwest of the H175 and 2000ft above it.

ANG: “*It should take you down left side of the contact.*”

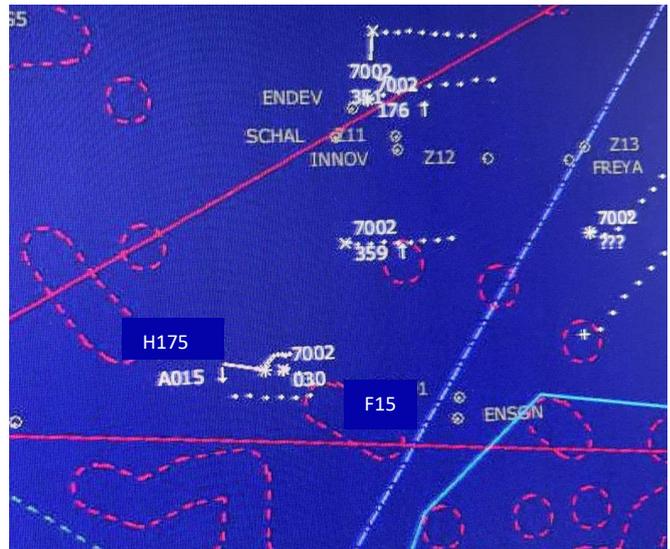
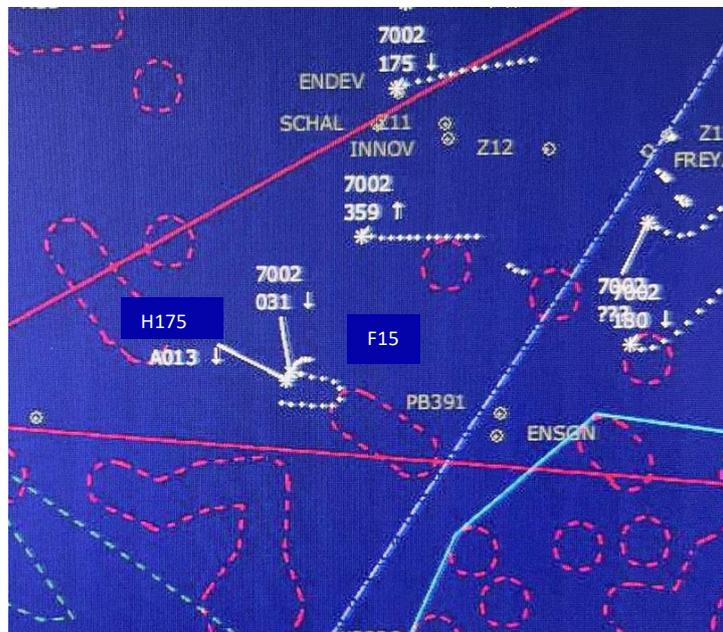
[H175 callsign]: “Roger copied, TCAS RA descending.” 7002 contact was 1.25NM east and 1475ft above the H175.

[H175 callsign]: “Roger copied, TCAS RA descending.” 7002 contact was 1.25NM east and 1475ft above [H175 callsign].

1155:22 CPA – approximately 0.5NM/1600ft.
