AIRPROX REPORT No 2024257

Date: 10 Oct 2024 Time: 1505Z Position: 5336N 00232W Location: 4NM W Bolton

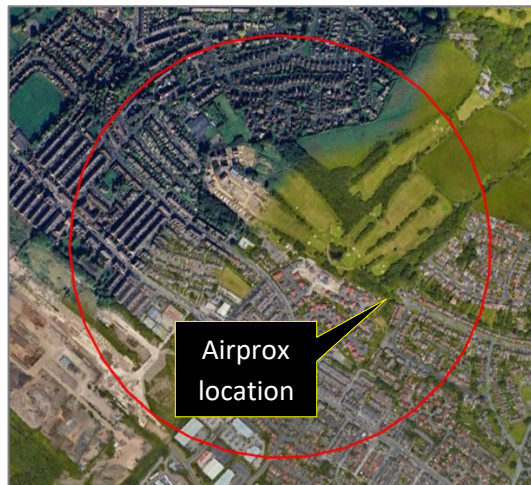
A representative from the drone flight planning app company confirmed that a 'flightplan' for the Matrice 300 had been submitted on the 10th October at 1454:48 (3min after the Matrice 300 had first taken-off). The 'flightplan' stated an intended flight from 1457 to 1527 within the bounds shown in Figure 2 and up to a height of 100m AGL. However, the status of the flight could not be confirmed as, reportedly, there had been no notification of it having commenced.

Figure 2 – The area indicated by the 'flightplan' submitted by the pilot of the Matrice 300.
