**AIRPROX REPORT No 2024262**

Date: 10 Oct 2024 Time: ~1212Z Position: 5104N 00258W Location: Hedging, Somerset

**PART A: SUMMARY OF INFORMATION REPORTED TO UKAB**

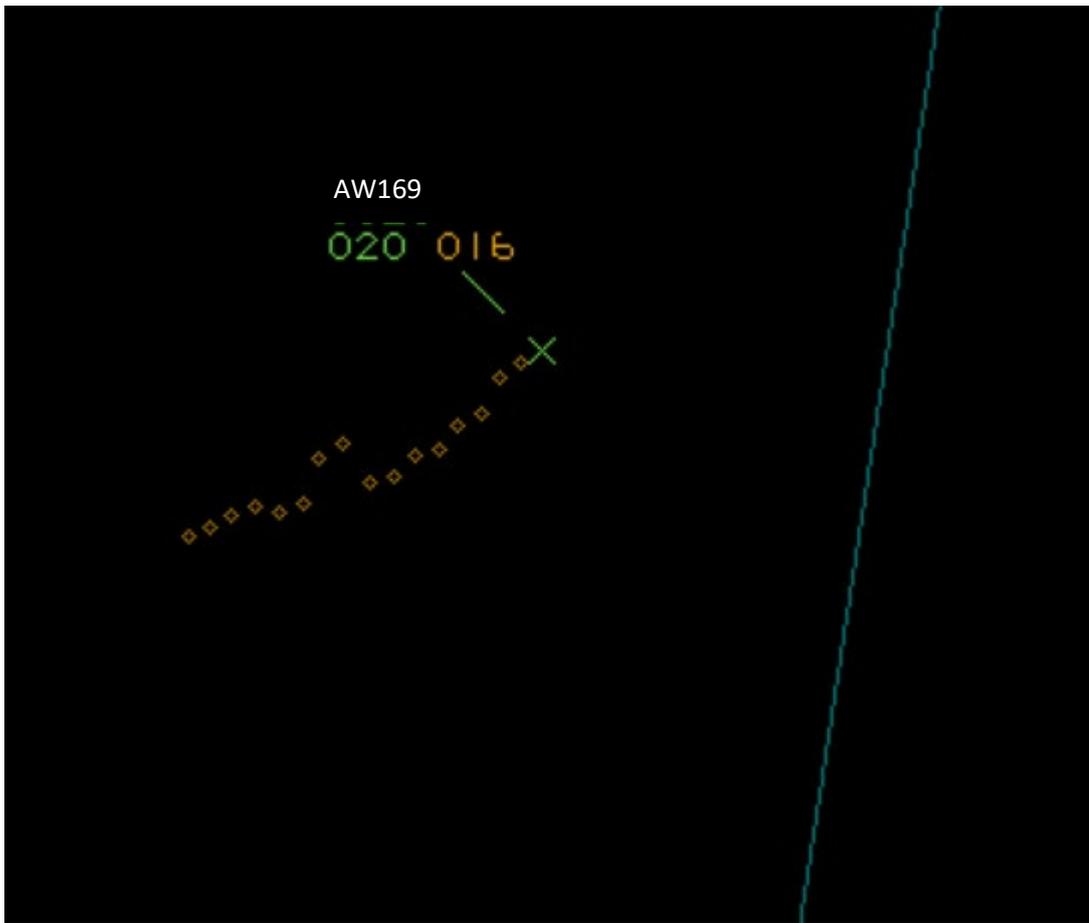
Figure 1 – 1212:11 approximate CPA

An analysis of the NATS radar replay was undertaken and the AW169 could be identified using Mode S data, indicating FL014 (radar QNH 1007hPa). The Ikarus could not be seen on the radar replay (Figure 1). Although the radar return for the AW169 displayed some 'jitter', probably due to the height of the aircraft, a climb could be seen in the final few sweeps before CPA. An analysis of an ADS-B data tool also did not display the Ikarus, however, the Ikarus pilot provided GPS data of their flight and so the diagram at the top of the report was compiled by comparing both data sets and a separation could be approximated.

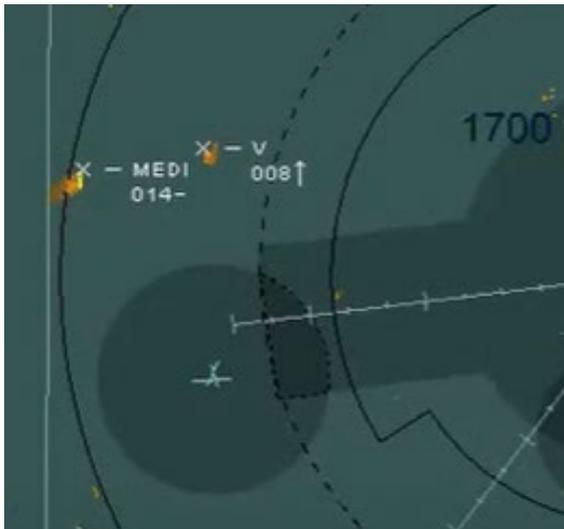
Figure 3 – screenshot taken from Yeovilton radar replay at 1209:41

Yeovilton provided a radar replay of their radar. The timing on the radar replay was nearly two minutes adrift of the NATS radar replay and the replay could not be manipulated to be able to measure the separation between the two aircraft. At Figure 3 the AW169 and the aircraft believed

to be the Ikarus could be seen on the Yeovilton radar (radar range 40NM). CPA on the Yeovilton radar was timed at 1210:47 (Figure 4) with an indicated 700ft radar separation (radar QNH not known).
