AIRPROX REPORT No 2024270

Date: 03 Nov 2024 Time: 1318Z Position: 5104N 00051E Location: Ham Street, Kent

PART A: SUMMARY OF INFORMATION REPORTED TO UKAB

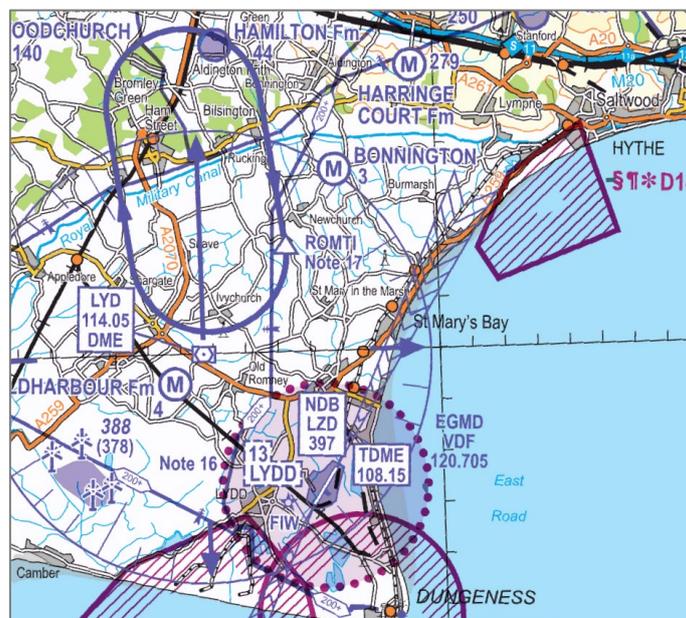
Figure 1

The UK topographical VFR chart 1:250,000 depicts the Lydd hold as:

THE LYDD CONTROLLER reports that the AA5 was in the holding pattern at ROMTI (3.2A, right-hand), and cleared for the ILS/DME RW20 approach. At 1116 UTC, the pilot reported over ROMTI starting the procedure. A couple of minutes later, the pilot reported manoeuvring to avoid an aircraft at a similar level nearby. This aircraft was unknown as there is no radar at Lydd and the AA5 pilot was informed of this. The pilot later reported back on heading to intercept the 14DME arc, they also reported the registration of the subject aircraft as [DR400 C/S]. The controller confirmed that this aircraft was unknown to them. At no time did the pilot of the AA5 state that they wished to file an Airprox or an MOR.

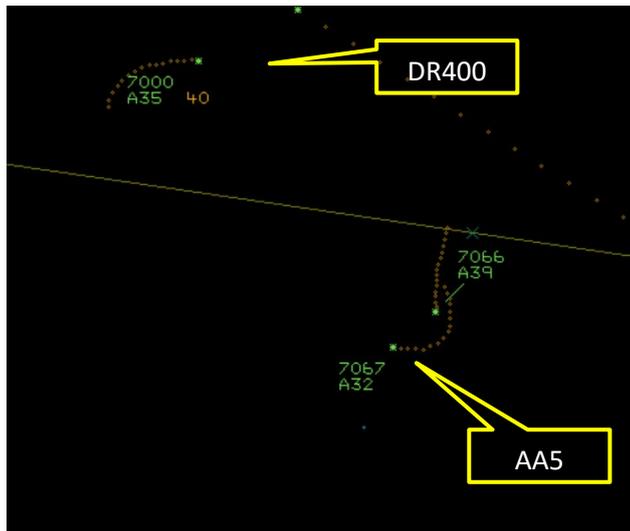
Figure 2 – 1317:11

An analysis of the NATS radar replay was undertaken and both aircraft could be seen and identified using Mode S data (see Figure 2). The UKAB Secretariat also had access to the Lydd RT recordings.

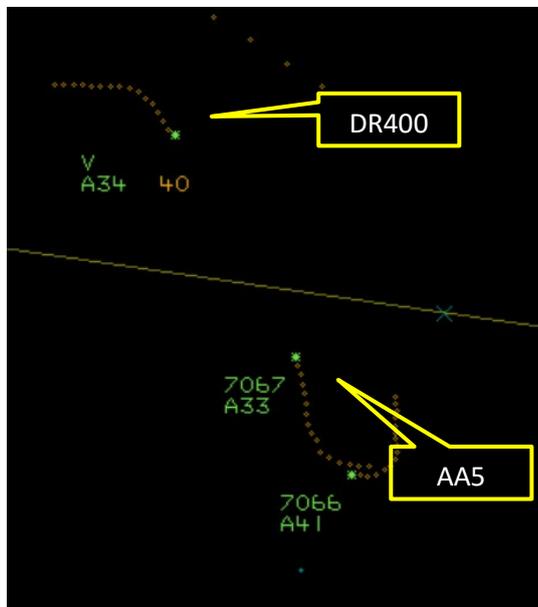
Figure 3 – 1318:01

As the AA5 continued in the hold, the DR400 headed south, see Figure 3.

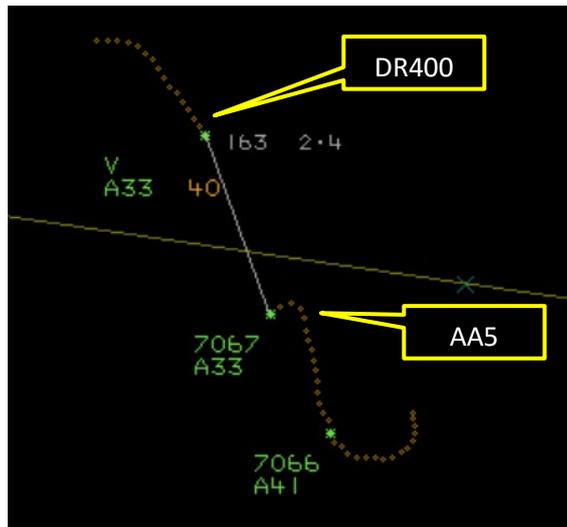
Figure 4 -1318:21

At 1318:20, the AA5 pilot reported on the Lydd frequency that they had turned off the procedure due a 'conflicting aircraft', however, they did not report the incident as an Airprox. At that stage, the two aircraft were 2.4NM apart and the AA5 could be seen to have turned onto a westerly heading. See Figure 4.

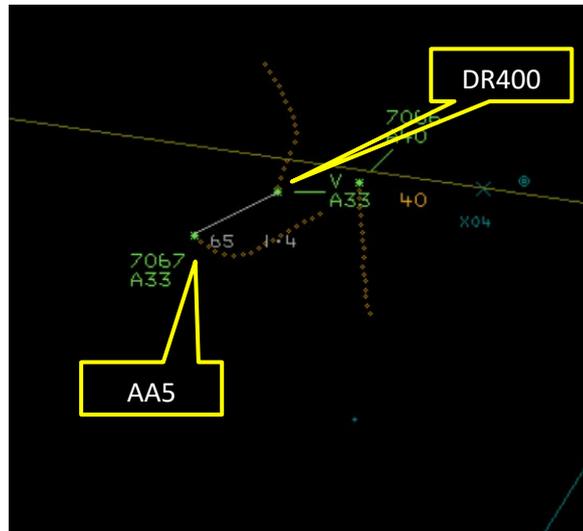
Figure 5 - 1319:23

Although this was the point at which the AA5 pilot had reported the Airprox, the two aircraft did continue to get closer, albeit the AA5 pilot had turned away and they were no longer on a conflicting course.

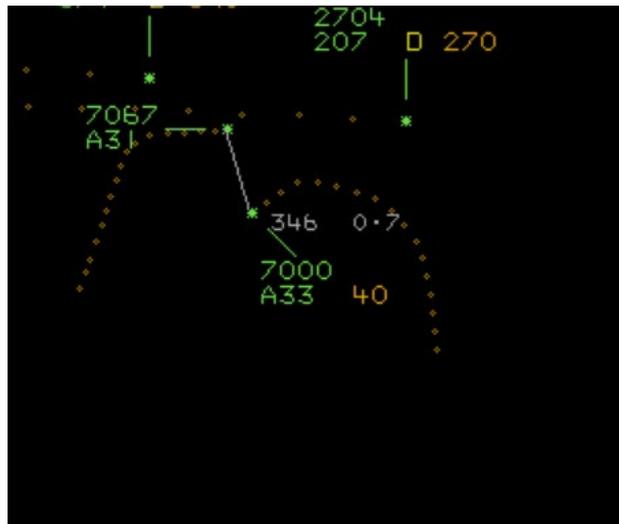
Figure 6 – 1323:47

At 1320 the AA5 pilot reported the callsign of the DR400 and told the controller that the other aircraft was at the same level as them and wondered whether it was talking to anyone, to which the controller stated that they had no knowledge about the other aircraft. Although the AA5 pilot did not mention the other aircraft again, at 1323:47 the two aircraft were 0.7NM and 200ft apart, see Figure 6.
