AIRPROX REPORT No 2024284

Date: 17 Nov 2024 Time: 1511Z Position: 5118N 00033W Location: Woking

PART A: SUMMARY OF INFORMATION REPORTED TO UKAB

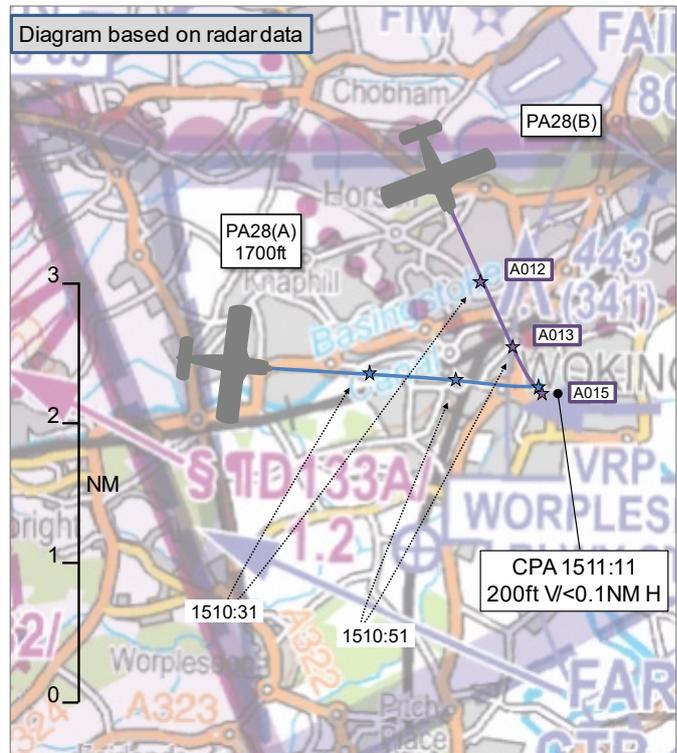
| Recorded | Aircraft 1 | Aircraft 2 |
|---|---|--|
| Recorded | 200ft V/<0.1NM H | |

When determining the risk of the Airprox, members considered the reports from both pilots and the controller, together with the radar replay screenshots. They noted that the PA28(A) student pilot had not seen the other aircraft in time to take any avoiding action and the PA28(B) pilot had not seen the other aircraft at all as they had been climbing beneath it. The separation had been 300ft vertically when the two aircraft crossed and 200ft and less than 0.1NM at CPA. Members agreed that there had been a risk of collision; they thought that the separation had been fortuitous and that safety had been much reduced (**CF9**). Risk Category B.

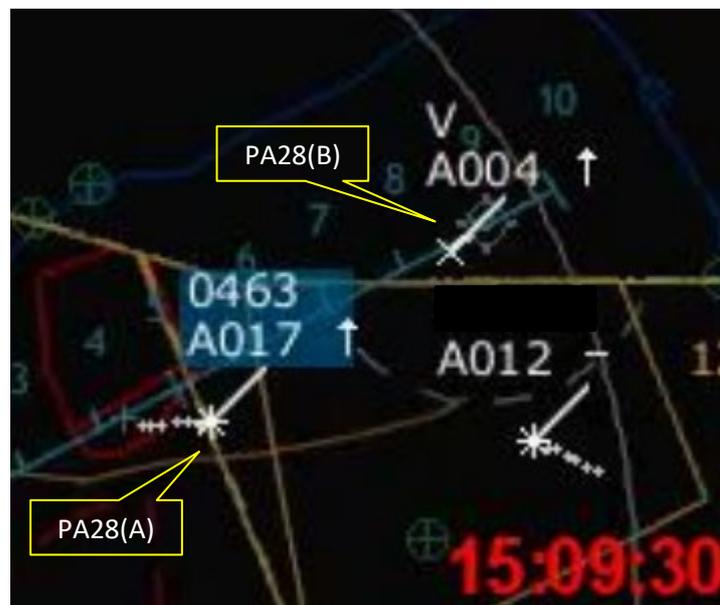
Figure 1

PA28(B) had just departed Fairoaks RW24 passing 400ft on VFR conspicuity code 7000 (Figure 1).

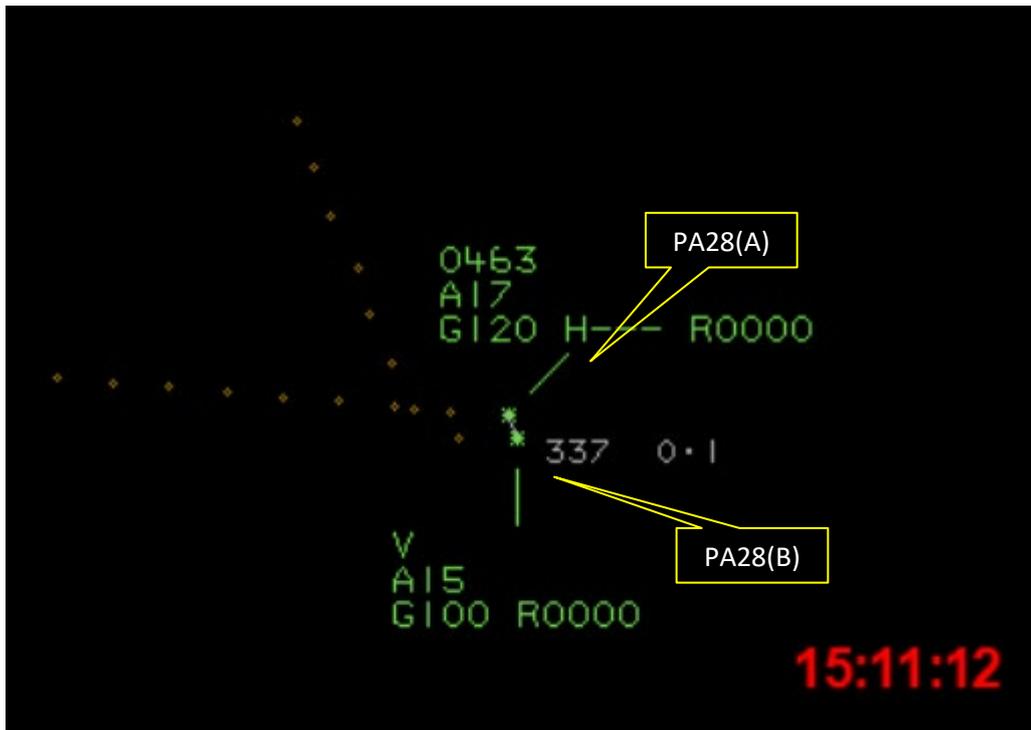
Figure 2 - CPA

The Closest Point of Approach between PA28(A) and PA28(B) occurred at 1511:12 and was recorded on the NODE Multi-Track radar as 0.1NM and 200ft (Figure 2).

Safety Investigations reviewed the radar replay of the event and the closest point of approach occurred at 1511:12 (Figure 2 above), this was assessed to be the point when the Airprox as described by the pilot of PA28(A) occurred.

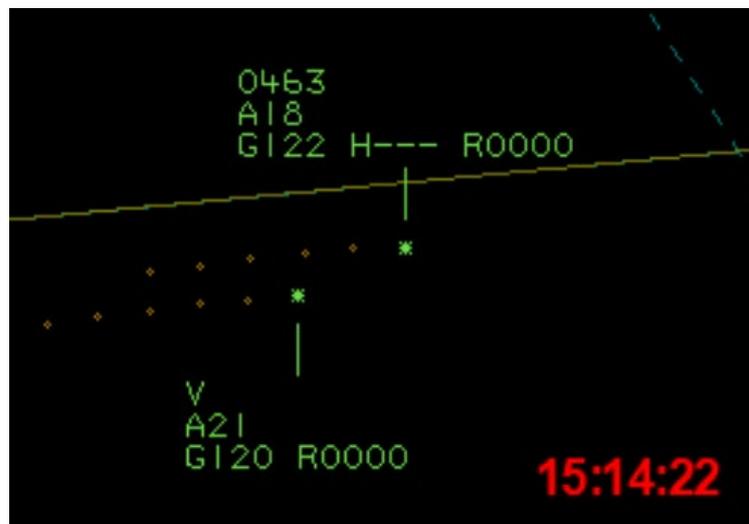
Figure 3

Whilst still on the Farnborough frequency, PA28(A) pilot reported at 1514:22 "we've just had another aircraft popped out of Fairoaks and went under us and is now sort of trailing just behind us I believe", the LF controller replied, "ah yes, I've got one in about your four o'clock, half a mile, showing three hundred feet above" (Figure 3).

The pilot responded, "*Affirm. er we may take evasive action on them*", the LF controller replied, "*Er ok, that's copied did you want to stay with me?*" PA28(A) pilot responded "*er, we'll stay with you for a moment*". The LF controller passed further Traffic Information at 1514:46, advising that PA28(B) was "*still in that same position four o'clock, half a mile showing three hundred feet above*" which was acknowledged by the pilot.
