AIRPROX REPORT No 2024301

Date: 29 Dec 2024 Time: 1329Z Position: 5258N 00103W Location: 3.5NM NNE Nottingham

PART A: SUMMARY OF INFORMATION REPORTED TO UKAB

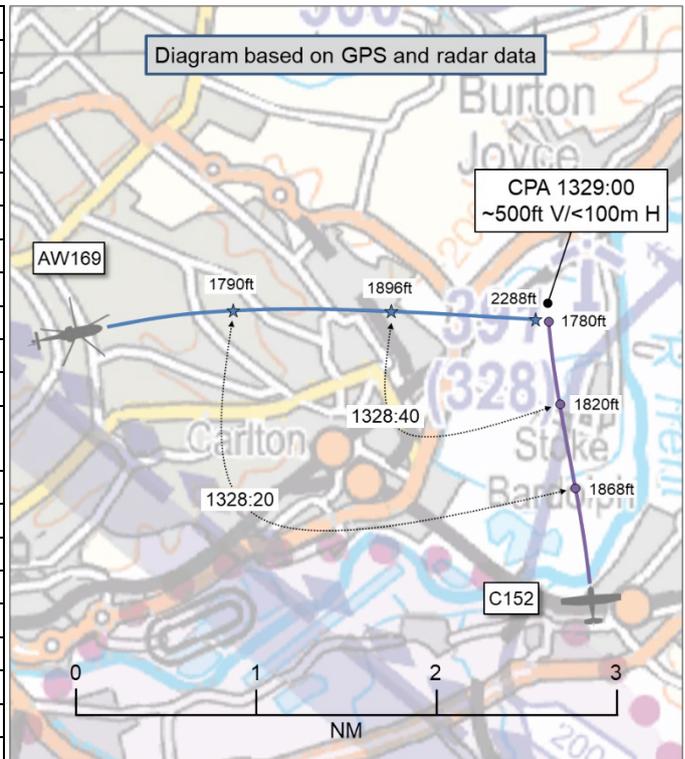
THE AW169 PILOT reports that they departed [a tasking location] near Nottingham en-route to their base. Their intention was to join at EDPAZ in the vicinity of Grantham, to practice a coupled-up approach to RW02 at RAF Waddington, then to break-off and land at their base (situated within the Waddington ATZ but outside the airfield fence). The initial FMS programming was all conducted on the ground prior to departure. Initially, a Basic Service was requested from East Midlands Radar on departure, however, a Traffic Service was subsequently requested as there had been potential to go into cloud at the level of EDPAZ. East Midlands Radar acknowledged a Traffic Service, but also declared limited coverage. East Midlands Radar appeared to be quite busy at the time. Tollerton Radio [Nottingham Radio] was dialled up on the second radio and was also being monitored. The AW169 upper modes were engaged (Alt Acquire, IAS and Heading) to allow them to clear the area between Tollerton and Syerston and continue climbing towards EDPAZ as the joining point. Their next plan would have been to engage Nav mode once clear of that area, however, the Airprox happened before that.

Prior to the Airprox, the East Midlands Radar controller reported a contact on a northerly heading. This was not seen by them or the Pilot Monitoring and the only contact they recall on TCAS was to the north of them 200ft above. They do not recollect any other TCAS contacts close by to cause potential conflict. A few seconds later, a Resolution Advisory ordered them to "Climb, Climb" and a red traffic warning appeared on their PFD. They deselected the upper modes by pressing Attitude Hold (ATT) and climbed to carry out corrective action. The Pilot Monitoring recalled hearing "Traffic, Traffic" immediately before the "Climb, Climb" order and had looked out to see if they could spot the aircraft. However, [the AW169 Pilot Handling] just remembered hearing "Climb, Climb" and seeing a red traffic warning on the PFD. It all happened within a 5-10sec period. Shortly afterwards, they saw a white SEP high-wing aircraft appear in the footwell window crossing from right-to-left in what they believed to have been a climbing

attitude (from south-to-north). The Airprox took place at approximately 1330 outside controlled airspace in Class G airspace to the north of Nottingham aerodrome whilst climbing towards EDPAZ. The weather at the time was: visibility in excess of 10km, wind 240/25kt, cloud cover was broken but this was at around 2600-2700ft altitude. The Resolution Advisory was initially reported to East Midlands Radar and Nottingham aerodrome after landing.

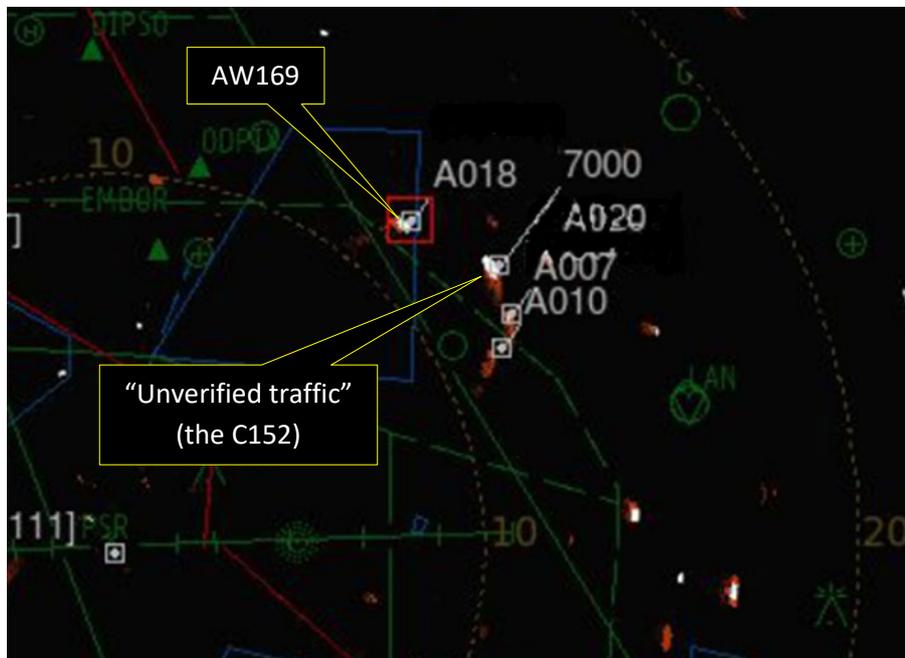
Figure 1

1328:20 AW169 C/S: "Er looking for traffic, that's all copied, [AW169 C/S], Traffic Service."
 1328:34 Radar: "[AW169 C/S], previously reported traffic, right 1 o'clock, 1 mile, right - left, indicating 100 feet above."

The AW169 C/S indicated A018, the converging 7000 squawk indicated A020

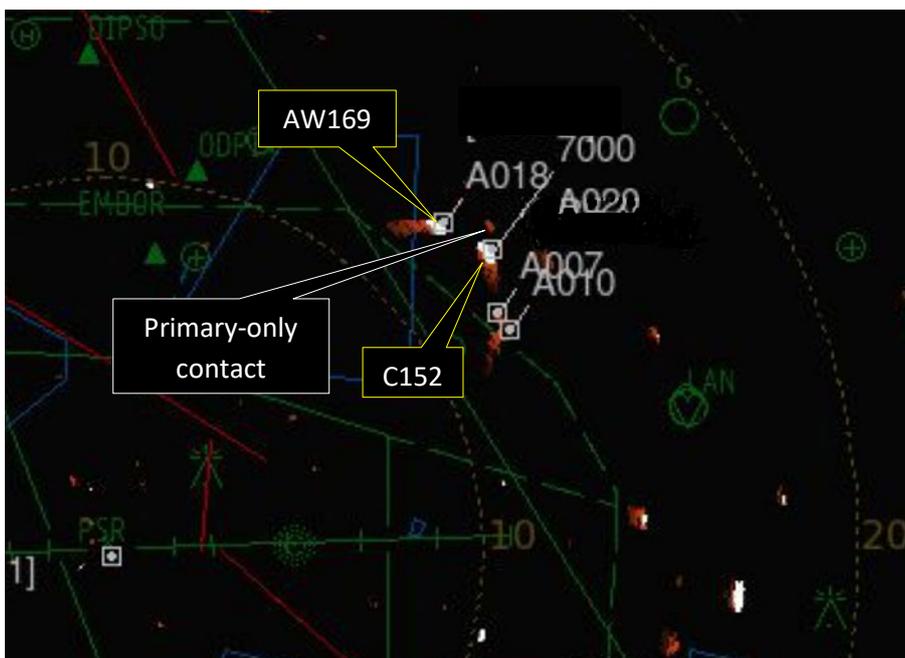
Figure 2

1328:46 AW169 C/S: *"Er visual with that traffic and we are above that traffic, traffic."*

(There was, potentially, a primary-only contact in the AW169 pilot's 12 o'clock, no height showing).

1328:51 Radar: *"Yep, just passing through your 12 now."*

The AW169 C/S and 7000 squawks converged. Other labels also merged. AW169 C/S indicated A023 and the 7000 squawk at A020.

Points to note: Radar was controlling with MLAT displayed. At 1328:34, the screenshot showed that, at the time Traffic Information was issued on the 7000 squawk indicating 100ft above, there was also a potential primary-only contact in the [AW169 pilot's] 12 o'clock: a faint contact with no height information. There were also labels that merged on the radar screen to the south of the AW169, particularly [an uninvolved PA28].

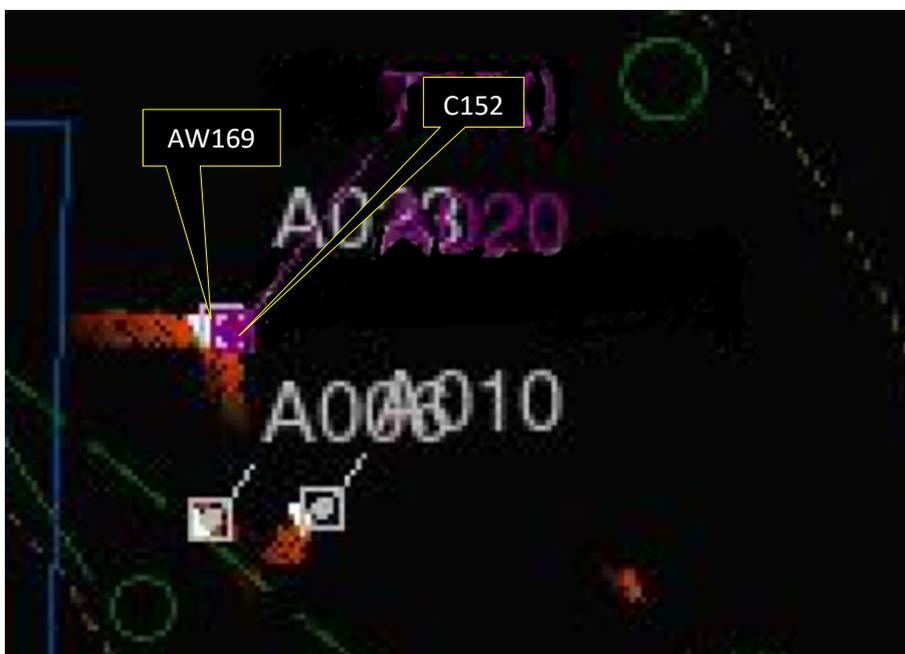
Figure 3

AW169 C/S climbed to 2500ft with the other contact tracking northbound.

The primary contact could be seen tracking north-bound, no height information.

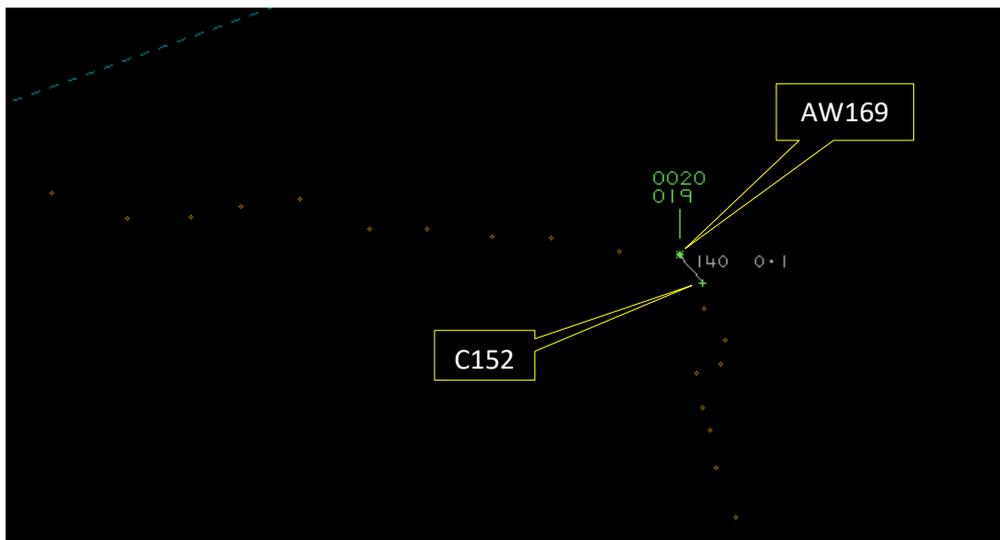
Figure 4

An analysis of the NATS radar replay was undertaken and the AW169 could be positively identified from Mode S data (Figure 4). Both pilots kindly supplied GPS track data for their respective flights. The track of the C152 correlated to a primary-only return on the NATS radar replay.
