**AIRPROX REPORT No 2025139**

Date: 07 Jul 2025 Time: 1059Z Position: 5606N 00514W Location: Lachlan Bay

**PART A: SUMMARY OF INFORMATION REPORTED TO UKAB**

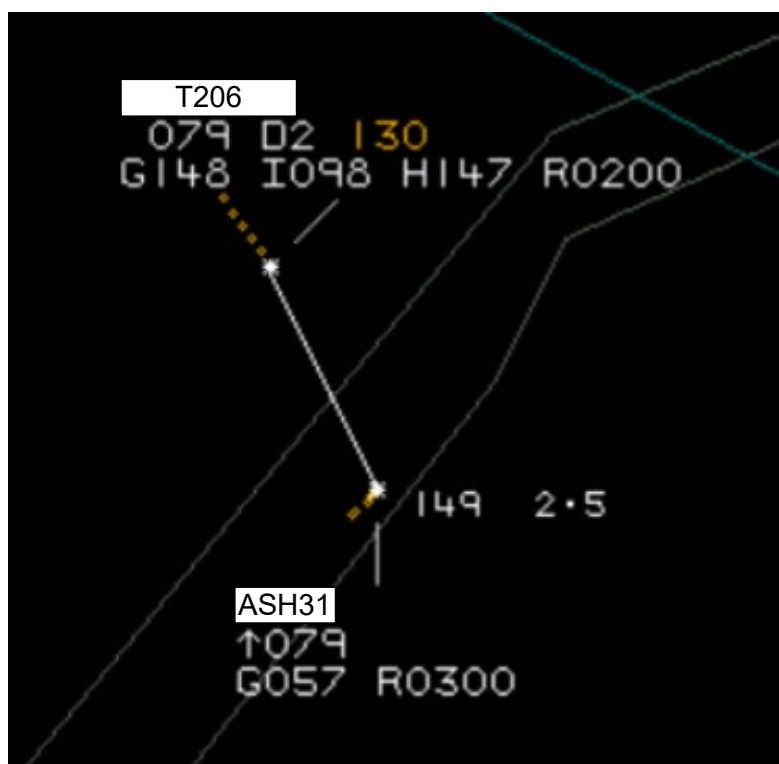
Figure 3

The controller then answered a telephone call from Inverness. Whilst the controller was in the call, at 1058:10, the pilot of [T206 C/S] requested, “*right thirty degrees to the left?*” and the controller responded that the heading was approved and passed further Traffic Information. The controller ended their transmission with, “*...heading left twenty degrees to avoid*”. The locations of the aircraft at this time are shown in Figure 3.

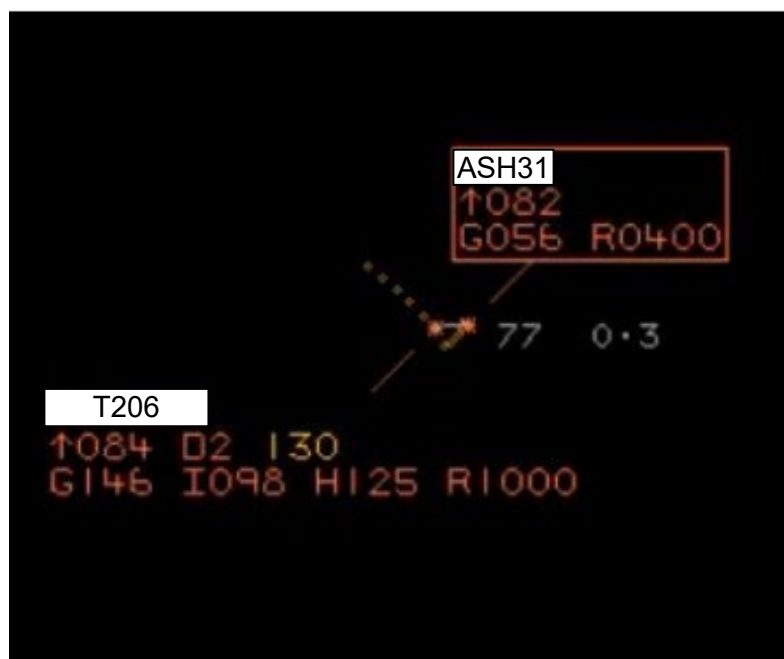
Figure 4

The closest point of approach between [T206 C/S] and [ASH31 C/S] also occurred during this R/T exchange, at 1059:04, and was recorded on Multi-Track radar as 0.3NM and 200ft as shown in Figure 4.

The Closest Point of Approach occurred at 1059:04 and was recorded on Multi-Track Radar as 0.3NM and 200ft. There was no prescribed separation requirement between [T206 C/S] and [ASH31 C/S] as the latter was VFR in Class E airspace, and [T206 C/S] was IFR.

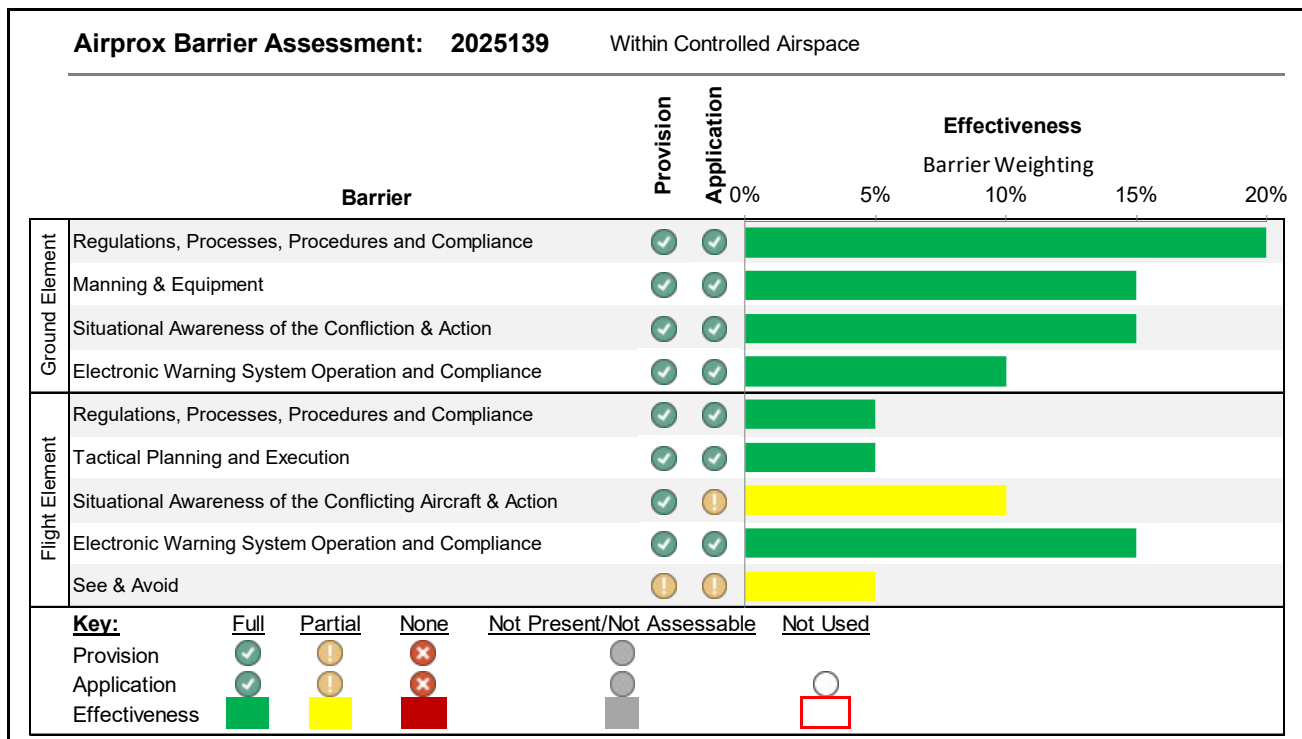
**Situational Awareness of the Conflicting Aircraft and Action** were assessed as **partially effective** because the T206 pilot flew close enough to the ASH31 to cause the Prestwick controller concern.

**See and Avoid** were assessed as **partially effective** because the T206 pilot saw the ASH31 at about CPA, effectively a non-sighting.
