AIRPROX REPORT No 2025158

Date: 11 Jul 2025 Time: 1518Z Position: 5149N 00201W Location: 5NM SSE Cheltenham

PART A: SUMMARY OF INFORMATION REPORTED TO UKAB

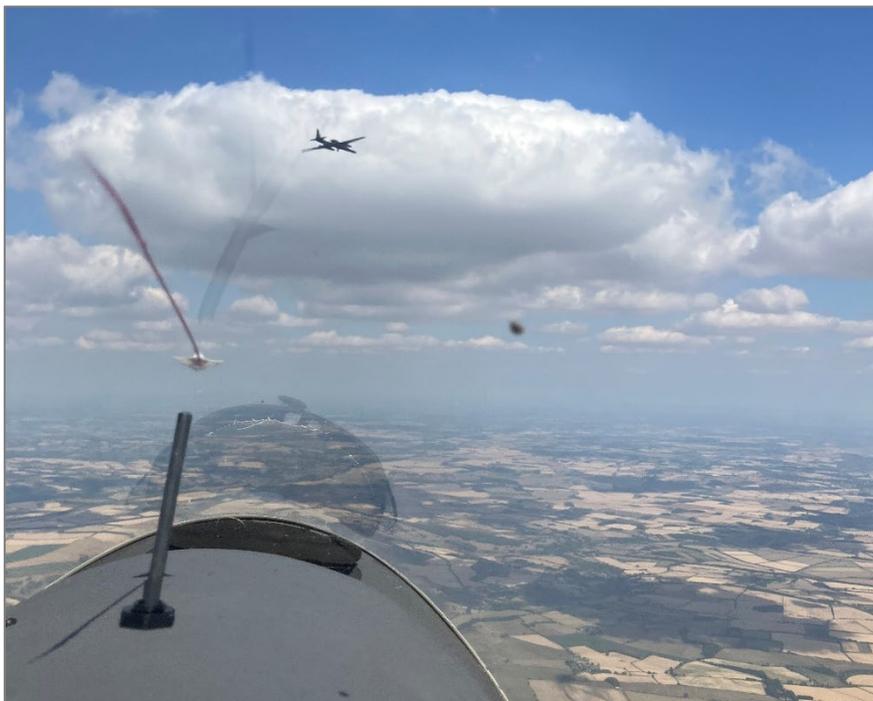
Figure 1 – A photograph taken just after CPA by the pilot of the ASG29.

Because of the sight-line rate, both vertically and horizontally, they maintained their track of approximately 090° and their speed which, in the prevailing conditions, had given them a rate of descent of 5kt or 500ft/min. They assumed that the pilot of the U2 would have been unlikely to have seen them. As the U2 passed ahead of them, they took a photograph.

Members noted that the ASG29 pilot's recall of the event suggested that they had had ample time to have assessed the situation and to have considered that urgent action had not been necessary. Indeed, taking a moment to capture a photograph of the U2 as it had passed suggested that, from their perspective, the encounter had been entirely benign. One member suggested that the gentle turn of 20° to the right may not have increased their separation from the U2 as the ASG29 pilot had opined, but may have prolonged the time that the U2 had been in a favourable position to have taken a photograph.

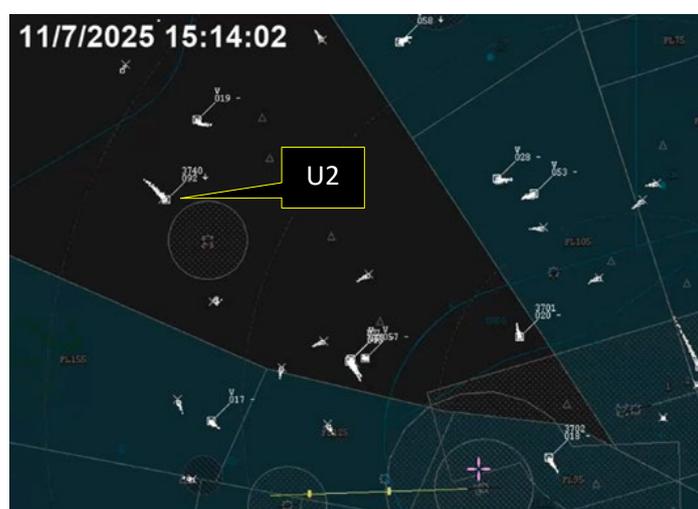
Figure 2 (1514:02) shows the U2 (Mode A 3740) and the high traffic density on its route.
