AIRPROX

AIRPROX DIGEST 2026

Welcome to this year's annual Airprox magazine

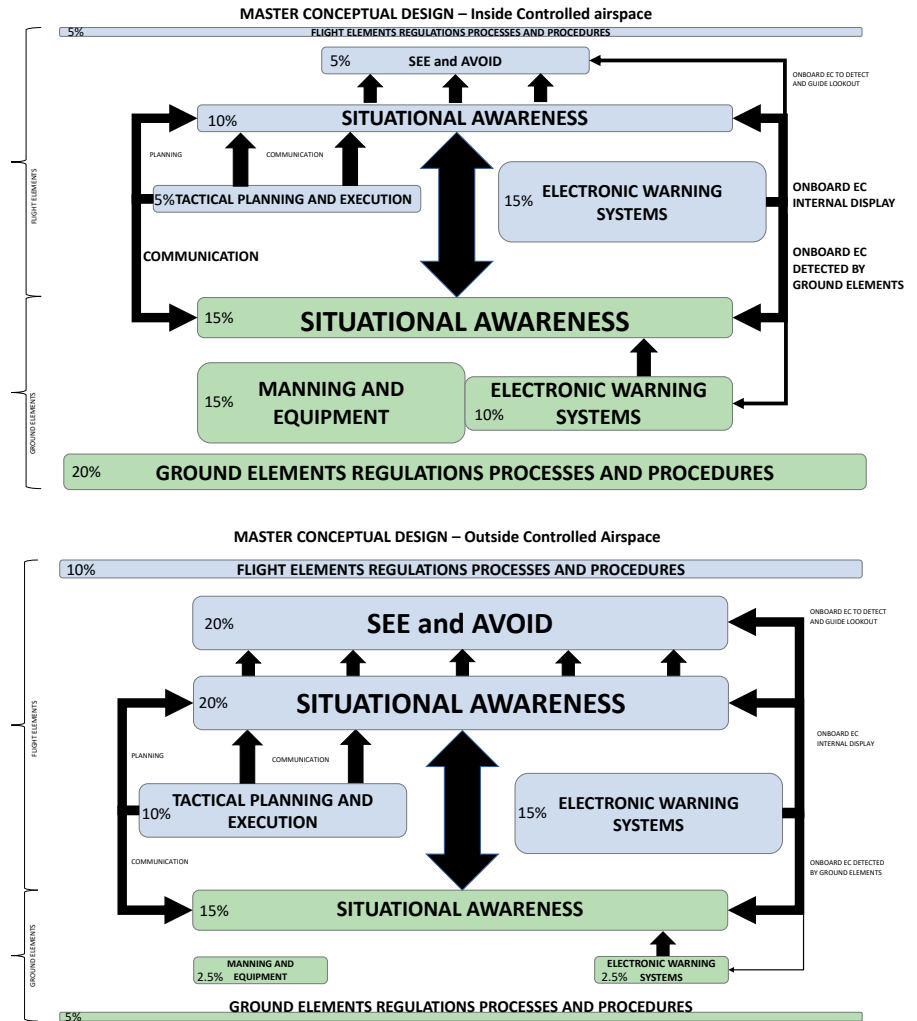
The simplest way to explain this, as with many things, is a visual representation — in the diagrams that follow, the *Flight Elements* are coloured blue, and the *Ground Elements* are coloured green.

For encounters **inside** controlled airspace, 60% of the defence against mid-air collision resides with the *Ground Elements*.

For encounters **outside** controlled airspace (where the vast majority of Airprox events in the UK occur) the barriers are exactly the same, but the weighting is markedly different.

Here we can see that there's much more of a contribution from the Flight Elements (75% in total) and much less of a contribution from the Ground Elements. However, and this is important to note, the Ground Elements do still make a contribution for flights outside controlled airspace, so if we decide not to seek a service from a LARS unit (or similar) we are immediately losing a

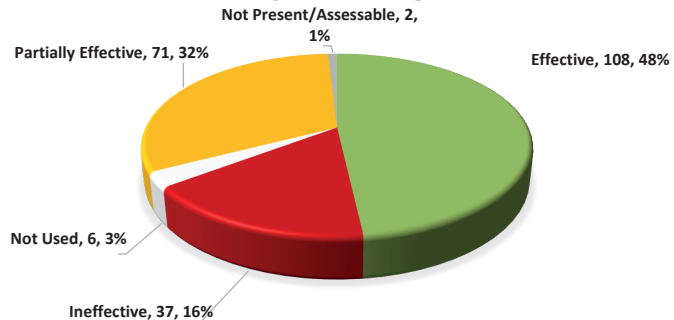
FE - SEE AND AVOID

The pie chart shows that the See & Avoid barrier is only Fully Effective for just under half of the time, so it is really important not to put all your eggs in one basket and rely on seeing and avoiding any threats...
