AIRPROX REPORT No 2012085

Date/Time: 20 Jun 2012 0935Z

Position: 5141N 00215W (2nm SE
Nympsfield G/S - elev 700ft)

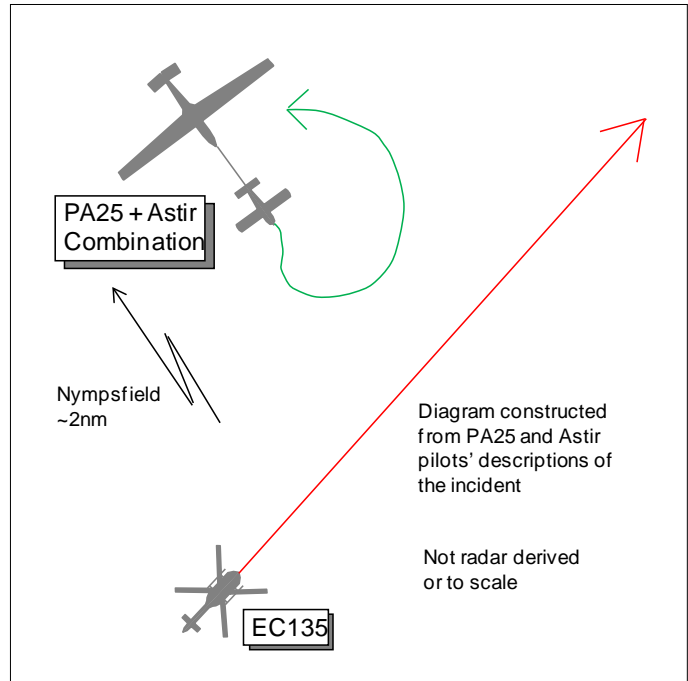
Returns merge (See ATSI report)

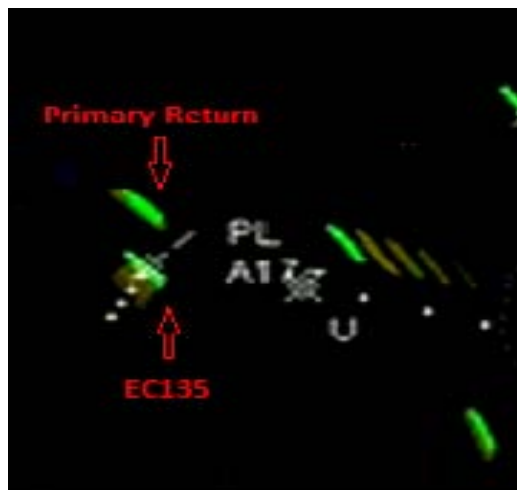
Figure 1

At 0933:27 the EC135 was approximately 4nm to the S of Nympsfield, tracking NE, at altitude 1700ft, while a faint primary return was showing in the vicinity of the Nympsfield gliding site. The primary return remained visible as the EC135 continued to track NE (Figure 1). By 0935:05 the EC135 was approximately 2nm SE of Nympsfield with the primary return in its 10 o'clock position at a range of approximately 0.5nm (Figure 2). At 0935:18 the primary return and the EC135 appeared to merge (Figure 3) before the primary return separated and tracked to the W at 0935:35 (Figure 4).
