AIRPROX REPORT No 2012163

Date/Time: 13 Nov 2012 1007Z

Position: 5253N 00231W (1.2nm NE
Ternhill - elev 272ft)

Airspace: Ternhill ATZ (Class: G)
Reporting Ac Reporting Ac Reported Ac

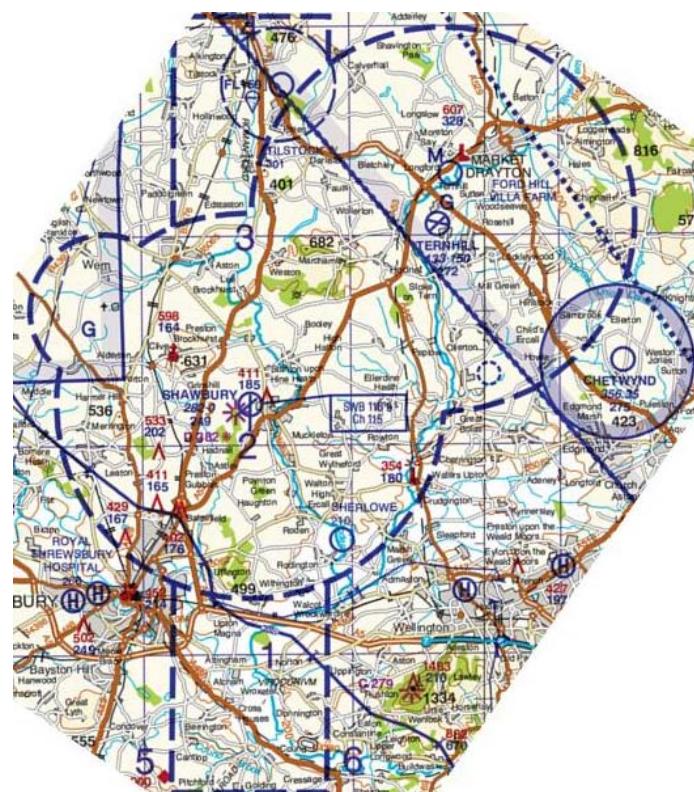
Figure 2: Local Area Map.

In addition to providing an Aerodrome Control Service at Ternhill on UHF 'Stud 7', the ADC also provides a BS (effectively an A/G service) to ac operating at Chetwynd field on a separate UHF (Stud 8 'Chetwynd Radio'). Two controllers are rostered to operate at Ternhill, with the additional controller providing the ability to 'split' the Ternhill Tower and Chetwynd Radio tasks during periods of increased workload. Figure 2 depicts the respective locations of Shawbury, Ternhill and Chetwynd; Chetwynd lays 6nm SE of Ternhill. No Hi-Brite VRD is available to the Ternhill ADC.
