AIRPROX REPORT No 2012164

Date/Time: 15 Nov 2012 1510Z

Position: 5245N 00139E (8nm
NNE of North Denes)

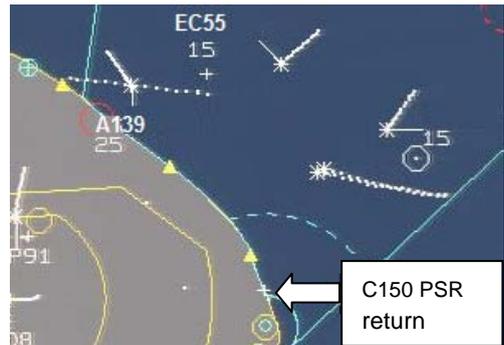
Figure 1 Anglia Radar 1508:50

At 1508:50 (Figure 1) the AW139 was tracking SSE at 2500ft with the EC155 at 1500ft on its LHS. The primary return from the C150 can be seen on the coast as indicated.

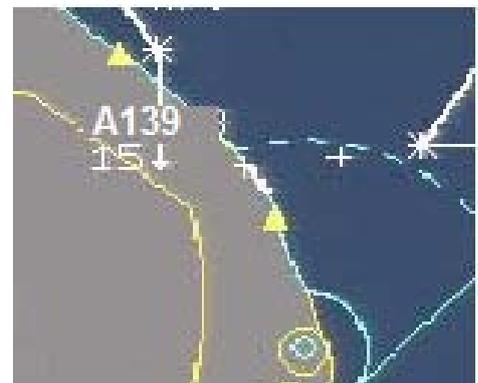
Figure 2 Anglia Radar display at 1511:40

At 1511:40 the Norwich Radar controller instructed the C150 pilot to squawk A7370 if he was transponder equipped; to which the pilot replied that the C150 was negative transponder. The Norwich Radar controller updated the TI on the helicopter stating that it was "twelve o'clock three miles has descended 1600ft". The C150 pilot acknowledged the transmission and stated that he was at 2000ft. Figure 2 shows the Anglia Radar display at 1511:40 highlighting the lack of conspicuity between the C150 primary return and the coastline map.

The unit investigation stated that the Anglia Radar controller did not see the primary return of the C150 at any time prior to the incident. When the AW139 reported taking evasive action the controller replied that nothing was seen on radar. Although the white primary return from the C150 could be seen on the Anglia replay it followed the coastline (also in white on the video map) very closely and is somewhat indistinct (see Figures 1, 2, and 3) particularly in comparison to other primary returns and secondary returns on the situation display. According to the unit report PSR clutter over the sea caused by both wave tops and wind turbines is not uncommon on the Anglia Radar sector. It is also possible that the controller may have subconsciously filtered out the target. Before the Airprox occurred the Anglia Radar controller's focus was on the confliction between the EC155 and the AW139, which may have reduced the possibility of seeing the primary return from the C150.

encounter becoming so close. The Board noted that the Anglia Radar controller was controlling a large area of airspace and was also focussing on deconflicting the AW139 from another helicopter. Members were clear that the colour of the coastline on the Anglia Radar display would have made it very difficult for the Anglia Radar controller to spot the primary return of the C150, especially so given that the Anglia Radar controller had to divide his attention at the time. The Board concluded that the Anglia Radar map was a significant factor contributing to the lack of TI provided to the AW139 crew and the display design should be reviewed.

Recommendation: The current RDP design for the Anglia Radar sector highlights the coastline in white, which is the same colour as radar tracks. NATS Ltd is recommended to amend the RDP to provide greater clarity between radar tracks and map features.

Post UKAB Note: Following further investigation, NATS Ltd report that the media used for the AIRPROX investigation shows the radar map and the ac returns to be coloured white; this is not the case with radar display that the controller actually sees. The coastline, as displayed to the controller, is shown in beige but there is also a cyan coloured line along this section of the coast which denotes the boundary of the Anglia Offshore Safety Area (OSA); this combination of colours created the impression of white on the media used for the Board. NATS Ltd have concluded that the removal of the cyan line from the coastal boundary (whilst retaining it in the offshore areas) would not reduce the ATCOs' knowledge of the extent of the OSA, and may increase the possibility of the ATCO identifying a slow moving aircraft following the coastline. Consequently, NATS Ltd have accepted the recommendation and will take appropriate action to amend the way the maps on the radar displays.

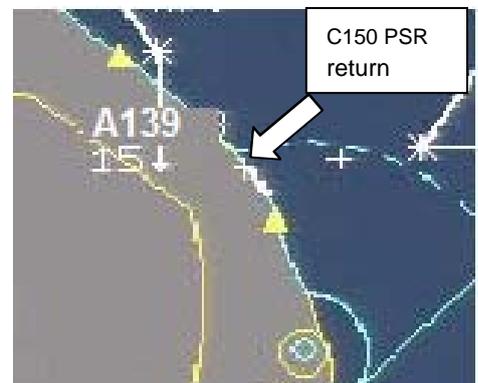
Figure 3 Anglia Radar display at 1511:40

On Figure 3, also at 1511:40, the Primary return of the C150 has been highlighted.
