## **AIRPROX REPORT No 2013038**

**Date/Time:** 15 May 2013 1057Z

**Position:** 5321N 00009W  
(20nm S of OTR VOR)

**Type:** A320 Typhoon

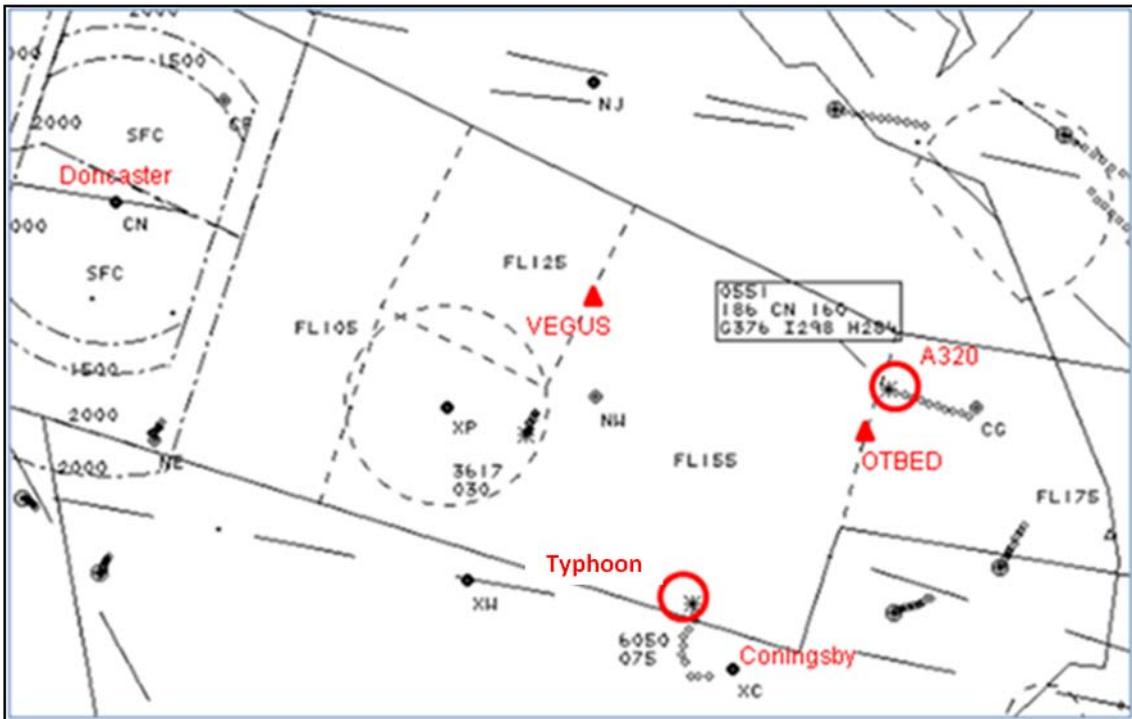
Figure 1: Area Multi Radar Tracking – 1055:40 UTC

The A320 called Doncaster APR at 1055:20, "descending flight level 160 on course to VEGUS information Romeo ready for deconfliction service." APR replied, "...vectors I L S approach runway 20 and er descend [1055:40] initially flight level 130." This was read-back correctly. See Figure 1.

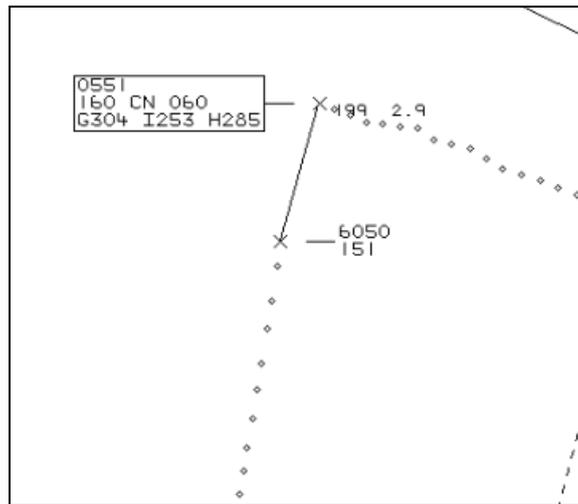
Figure 2: St. Annes – 1056:55 UTC.

At 1056:55 the A320 was in the Typhoon's 12 o'clock range 2.9nm passing FL160 (Figure 2). The A320's rate of descent at this time was 1728fpm.

NOTE: The Mode S data (SFL, IAS etc. was not available to APR)

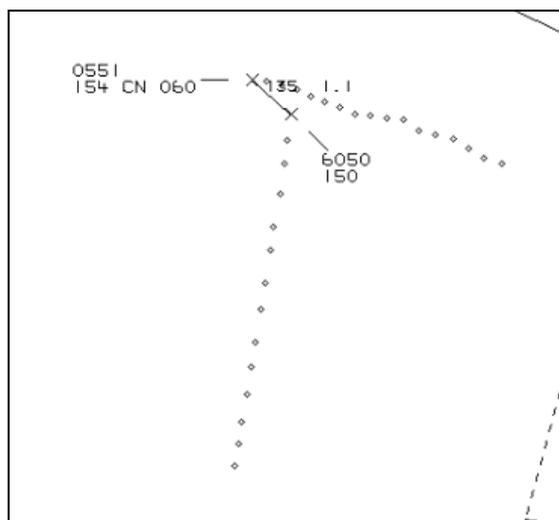
Figure 3: St Annes – 1057:11 UTC

At 1057:11 the A320 passed FL154, leaving CAS, still descending as the Typhoon, maintaining FL150, flew behind it from left to right at a range of 1.1nm (Figure 3). This was the closest radar-derived point of approach: 6695ft ac to ac distance. [UKAB Note 1: The Claxby Radar indicates a CPA of 1nm/400ft V.] The Typhoon subsequently reported a minimum slant range of 6357ft.

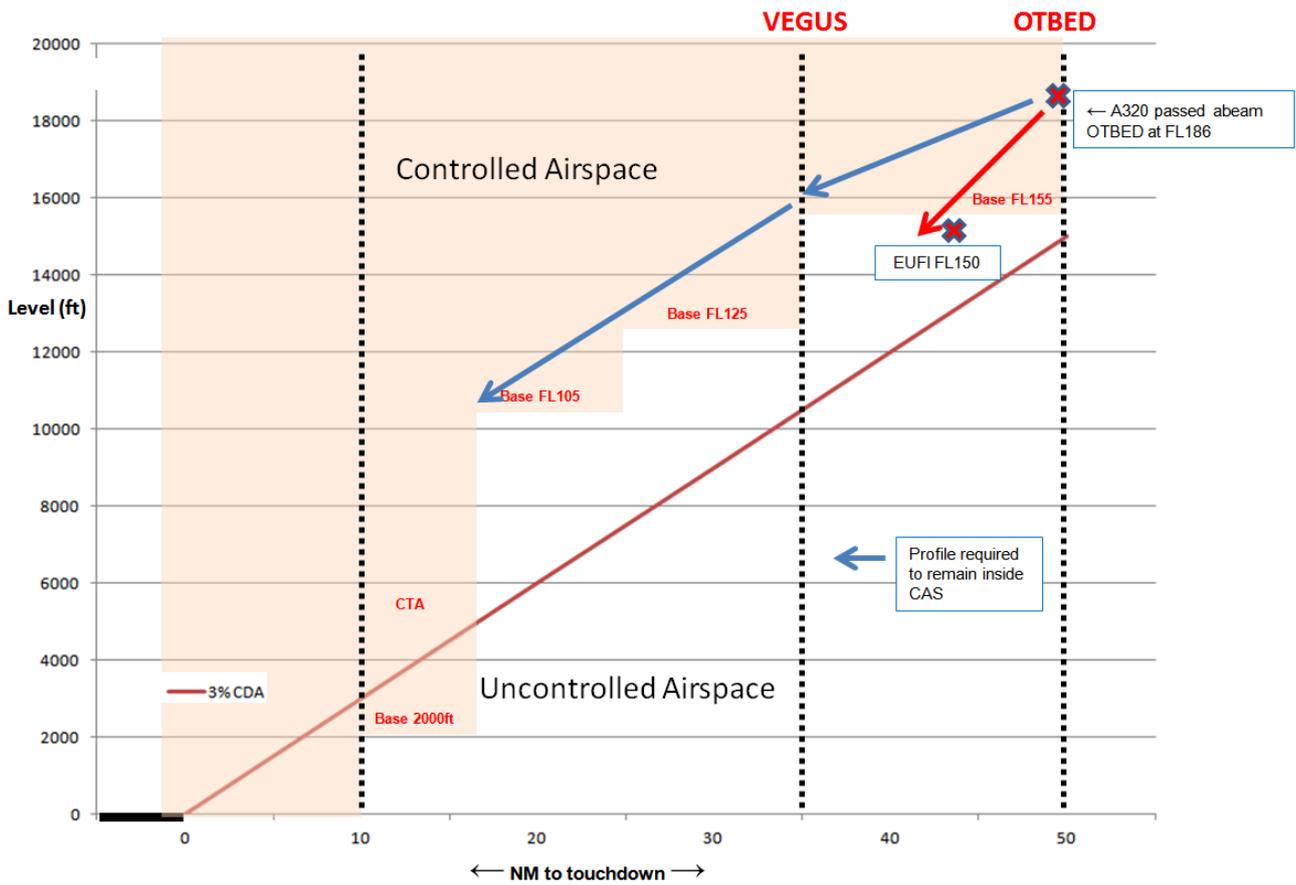
Figure 4: Descent Profiles

The A320 passed abeam OTBED at FL186. The Figure 4, annotated with a nominal 3% continuous descent from OTBED (50nm from touchdown), shows that the A320 would have needed a shallower rate of descent to remain inside CAS until VEGUS. The blue arrows on Figure 4 illustrate the descent profile required to remain inside CAS; it can be seen that, for a straight-in approach (with no extending vectors), the base of CAS only reduces from FL105 to altitude 2000ft at approximately 16nm from touchdown.

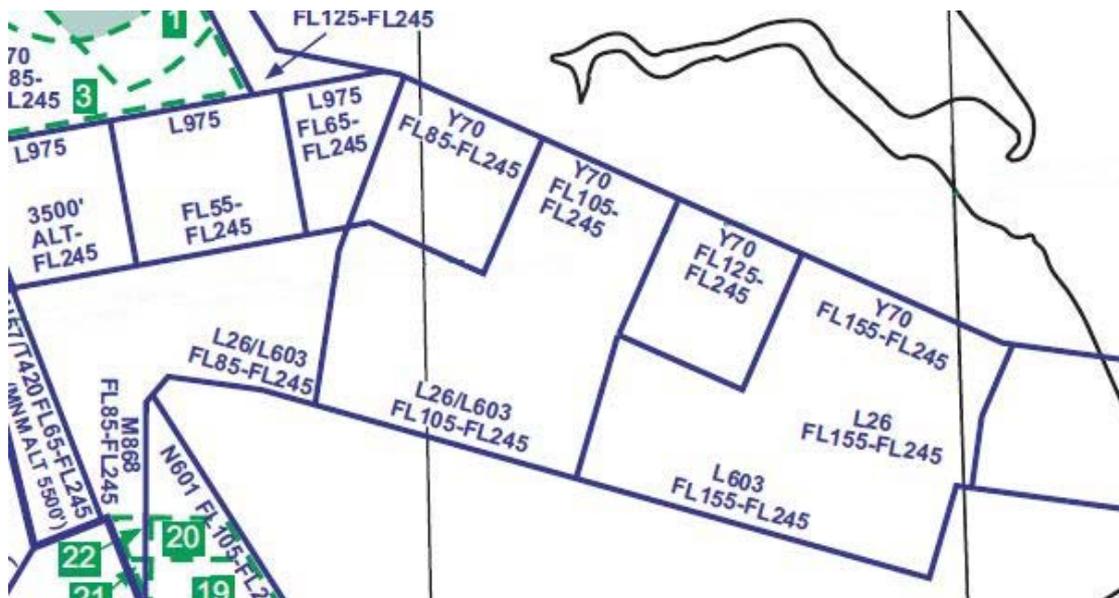
Figure 5: UK AIP ENR 6.1 AIRAC 08/2008

Prior to the establishment of CAS in the vicinity of Doncaster Airport in 2008 the pre-existing airways structure was as shown below in Figure 5. It can be seen that the bases of airway Y70 were, as they are now, from N to E: FL85, FL105, FL125, FL155. This facilitated climbs and descents for Manchester TMA and Leeds-Bradford traffic. When the Doncaster's CTAs were introduced there was no similar allowance made in airspace design.

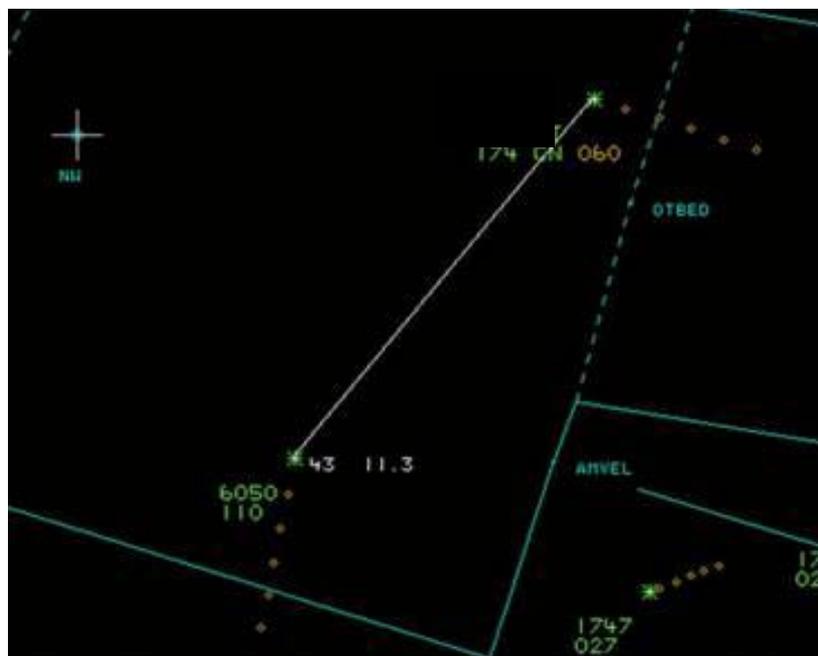
Figure 6: Incident Geometry at 1056:07.

The incident sequence commenced with the handover of the Typhoon from Coningsby ATC to NE Tac, which occurred between 1056:16 and 1056:45. Immediately prior to the handover, at 1056:07, the Mode S 'selected level' data for the A320 changed to indicate that the pilot had selected FL60; Figure 6 depicts the incident geometry at this point, with the Typhoon climbing to FL150.

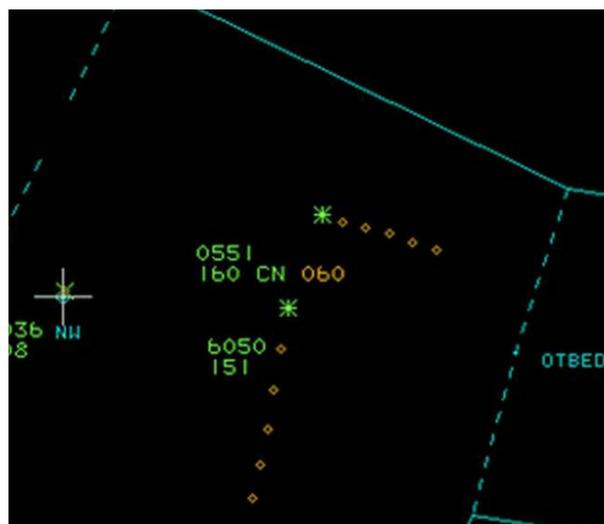
Figure 7: Incident Geometry at 1056:53.

At 1056:53, the Typhoon made initial contact with NE Tac who replied immediately "[Typhoon c/s] London Mil, identified FL150 Traffic Service. Traffic 12 o'clock, 3 miles, crossing right-left, indicating 800ft above, descending inbound to Doncaster." The Typhoon's pilot replied that they were "visual", later reporting that they had acquired the A320 on AI radar at 12nm and visually acquired it at 10nms. Figure 7 depicts the incident geometry at the time of the Typhoon's initial call to NE Tac.

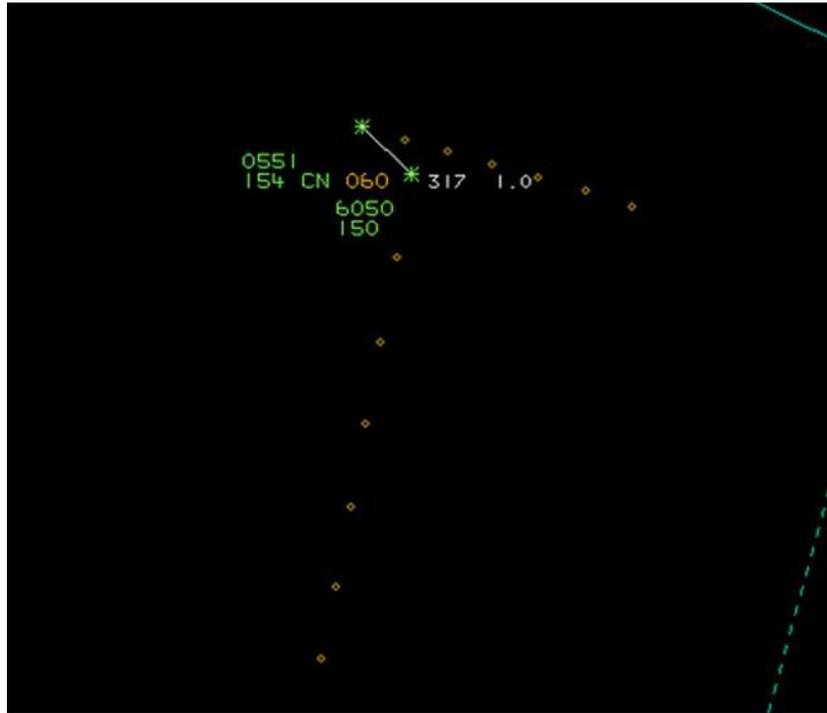
Figure 8: Incident Geometry at 1057:10

At 1057:03, the A320 indicated descent through FL157. Based upon the report of the A320 pilot, there may have been some confusion between the A320 and the Doncaster Sheffield controller over the A320's cleared level, which appears to have resulted in the A320 descending beneath the Base of CAS. The CPA occurred at 1057:10 as the Typhoon passed 1nm ESE of the A320; Figure 8 depicts the incident geometry at this point.
