## **AIRPROX REPORT No 2013045**

Date/Time: 22 May 2013 1326Z

Position: 56 49.6N 004 13.5W  
(1nm N of Loch Garry)

Type: AS350    Tornado GR4

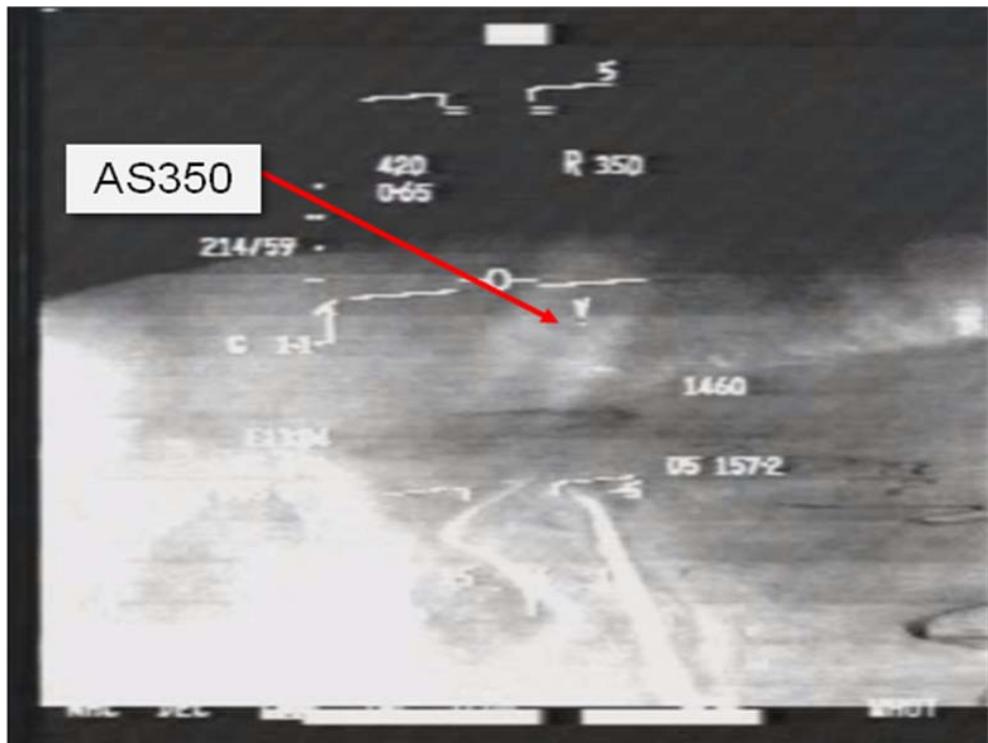
Figure 1 shows the image from the FLIR recording as it would have been displayed on the Weapons System Operator's (WSO's) TV1 display at 1326:03. The AS350 first appears as a Thermal Cue at an estimated range of 1050m with a closing speed of 300kt, 7sec prior to the estimated CPA.

As the helicopter is shown in the FLIR video, a Board Member asked if this would have been easily seen by the Tornado crew. An Advisor answered that whilst the FLIR video can be displayed to both the pilot and the WSO, it would be normal and more effective for the crew to prioritise their external lookout over scanning internal cockpit displays. Although in this event the FLIR cueing indicated the position of the helicopter, it is frequently the case that the FLIR indicates multiple hotspots on the ground thereby disguising potential airborne conflicts. Many previous Airprox have highlighted the problems with prioritising the use of internal displays over visual scanning in the low-level flying environment and it was agreed that the crew were correct to concentrate on external lookout.

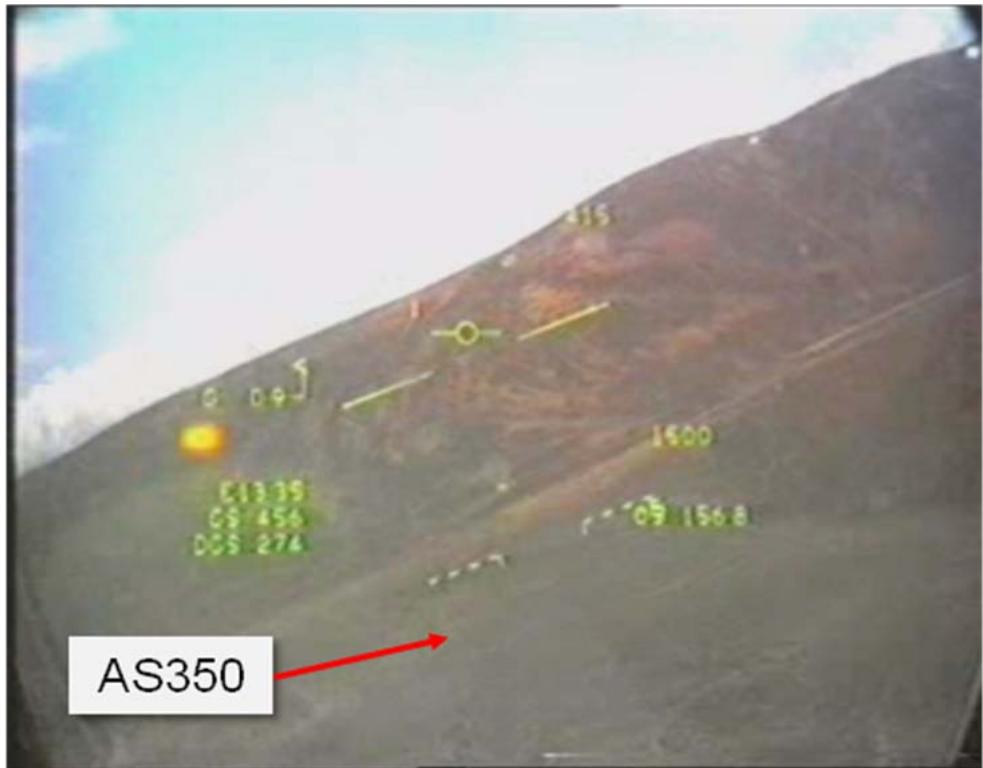
Figure 3 shows the image from the HUD recording at 1326:09 (the same time as Figure 2).

**HQ AIR(OPS)** comments that the incident occurred clear of the area NOTAM'd for use by the AS350; the helicopter was not sighted by the crew. The AS350 is barely perceptible in the HUD and RAF FS requested the operators to review their HUD and windscreen cleanliness practices. In the event, the smearing evident in the lower portion of the HUD display is likely to be on the horizontal projecting glass rather than the HUD glass itself. The operating height of the Tornado was not unusual for low level operations and the 250-1000ft AGL level must be considered by other operators to be a relatively higher risk band. The ongoing programme to fit TCAS to Tornado might reduce the likelihood of a repeat of this type of incident in the near future. All military users of the Low Flying System are required to have a serviceable transponder, making them visible to TCAS-equipped operators.

All of the Members with fast-jet experience agreed that the helicopter was barely visible in the HUD video and that the video picture was not clear in certain areas. It was likely that any distortion was a result of smearing on the recording equipment so this effect would not have affected the Tornado pilot's lookout. HQ Air is reviewing procedures to ensure that the HUD recording equipment is maintained to produce clearer recordings.
