## **AIRPROX REPORT No 2013069**

Date/Time: 6 Jul 2013 1202Z (Saturday)

Position: 5047N 00114W  
(2nm SW Lee-on-Solent G/S)

Type: Chipmunk PA24

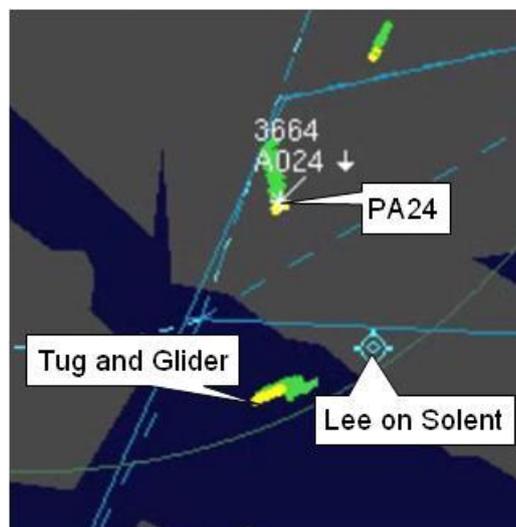
Figure 1 – Southampton radar at 1202:30

The PA24 pilot had been cleared to transit the Solent CTA, routing via Bishop Waltham. The Solent ATSU reported that he was instructed to contact Lee Radio for traffic information on their busy ATZ. The PA24 pilot's written report indicated that, after passing abeam Bishop Waltham, he contacted Lee Radio and passed his flight details. In response, the A/G operator reported that there was a lot of traffic in the area and suggested that the pilot keep a good lookout. The PA24 pilot indicated he had visual contact with a glider and tug (he thought) which were over the Solent. At 1202:30, radar showed the PA24, 2.7nm NW of Lee-on-Solent with the tug and glider in its half past 12 at a range of 3nm (see Figure 1).

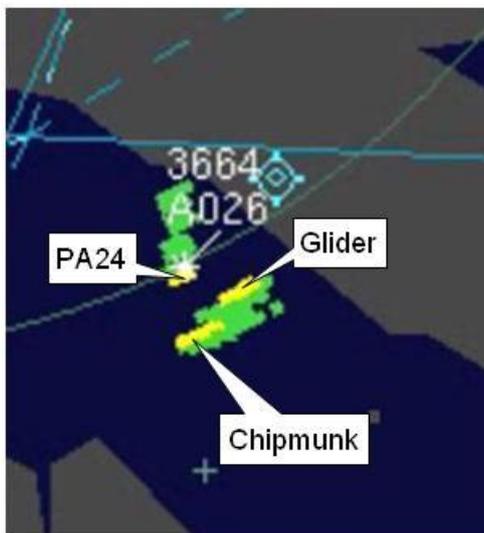
Figure 2 – Southampton radar at 1204:02

The Chipmunk pilot reported being aware of the transit aircraft [the PA24] talking to Lee Radio and of hearing Lee Radio advise the PA24 pilot of intense glider activity in the area. The PA24 pilot indicated that he sighted the Chipmunk release the glider and then observed the Chipmunk turn towards Lee-on-Solent. At 1204:02, radar showed the Chipmunk in the PA24's 12 o'clock at a range of 0.7nm and the glider in its 10 o'clock at 0.5nm (see Figure 2).

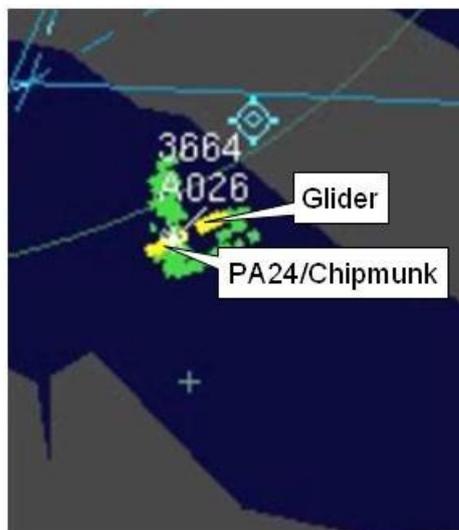
Figure 3 – Southampton radar at 1204:11

The PA24 pilot indicated that he heard a transmission, *“I have that plane visual”*, which he presumed was from the Chipmunk pilot. Radar showed the Chipmunk track prior to the incident. The Chipmunk pilot had initially rolled out onto a NE'ly track, followed by a turn onto a NW'ly track as it passed abeam the PA24. At 1204:11, the PA24 and Chipmunk are shown in close proximity as the Chipmunk passed down the RH side of the PA24 (see Figure 3).

The Board considered the cause and decided unanimously that the Chipmunk pilot had flown into conflict with the PA24 during his turn back to Lee-on-Solent. Given the reported separation at CPA, the Chipmunk pilot's very late sighting, and the PA24 pilot's concern with avoiding the tow rope, Board members were also unanimous in their opinion that separation had been reduced to the minimum and that chance had played a major part in events.

<u>Cause:</u>	The Chipmunk pilot turned into conflict with the PA24.
<u>Degree of Risk:</u>	A.
<u>ERC Score:</u>	20 <sup>1</sup>
