AIRPROX REPORT No 2013123

Date/Time: 27 Aug 2013 1452Z

Position: 5225N 00122W
(5nm NE Coventry Airport)

Airspace: London FIR (Class: G)

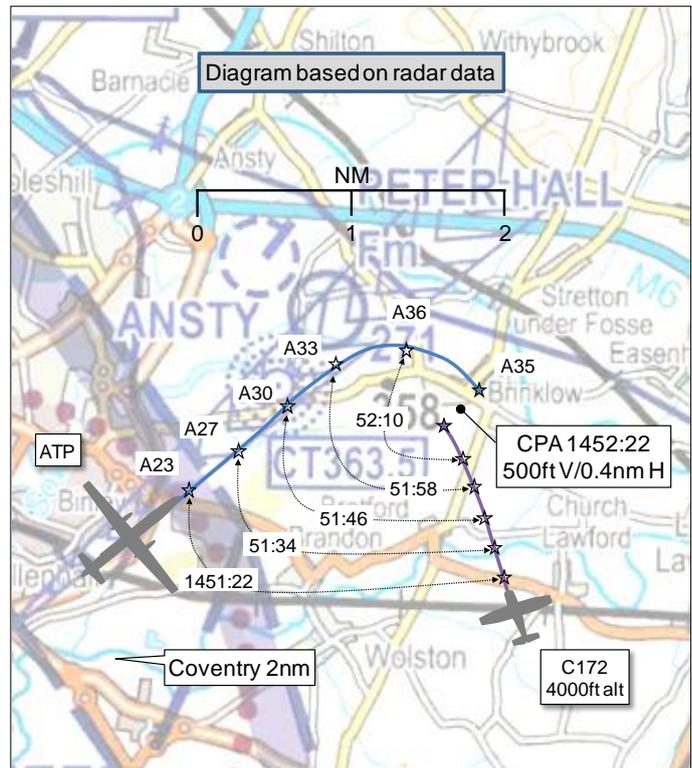
500ft V/0.5nm (925m) H

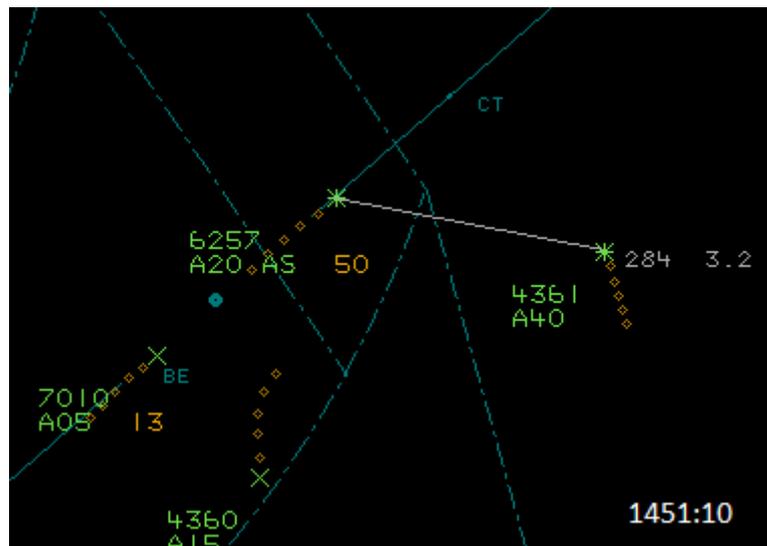
Figure 3

At 1451:10 the C172 pilot was again passed traffic information on the ATP stating that it was, “now left ten o'clock range of two miles, two thousand feet in the climb through your level” (Fig 3). The pilot replied that he was looking.

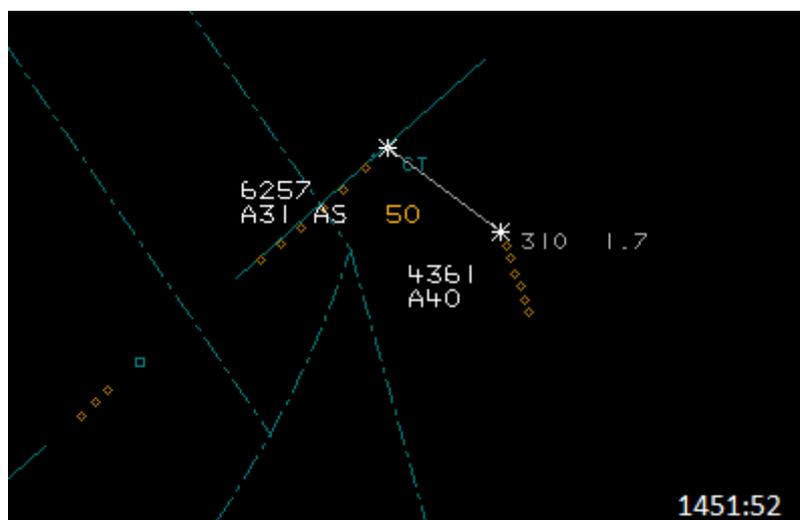
Figure 4.

At 1451:52 CVT Radar updated the traffic information to the ATP pilot as, “now right half past two two miles right to left at four thousand feet”. The ATP was passing 3100ft, 1.7nm to the northwest of the C172 (Fig 4) and reported that he was not visual with the C172.

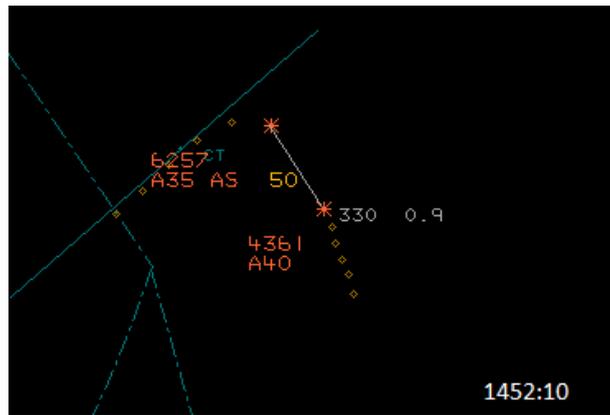
Figure 5.

There was a crossed transmission between the controller and the ATP pilot before, at 1452:10, the traffic information was updated to the ATP pilot stating that the C172 was, “now right one o'clock one mile at four thousand feet” (Fig 5). The ATP pilot reported receiving a TCAS RA, which was acknowledged by the controller.

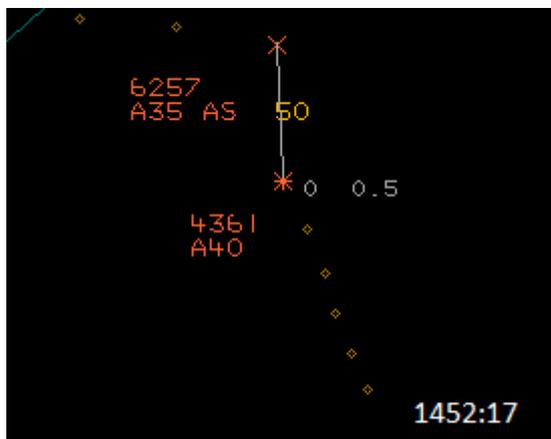
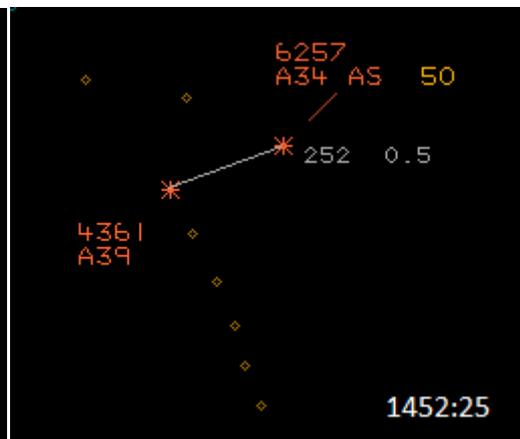
Figure 6.

The two aircraft continued to converge as the ATP turned right. The CPA was 0.5nm horizontal and 500ft vertical, as shown by the Cleve Hill radar replay (Figs 6 and 7). The aircraft passed each other and the ATP pilot continued his climb to 5000ft.
