AIRPROX REPORT No 2014079Date/Time: 6 Jun 2014 1529ZPosition: 5327N 00027W
(8nm SSW of Humberside)Airspace: London FIR (Class: G)Aircraft 1 Aircraft 2Type: Grob Tutor Untraced GliderOperator: HQ Air (Trg) UnknownAlt/FL: 2000ft NK
RPS (1002hPa) NKConditions: VMC NKVisibility: 40km NKReported Separation:

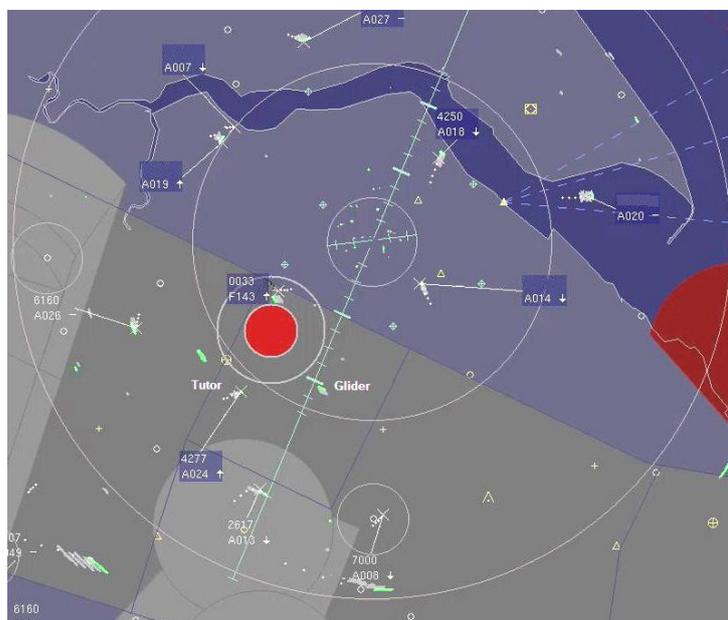
Figure 1 – extract from the Humberside radar recording 1528:49

At 1528:49, the Radar controller advised, *"(Tutor)c/s identified reduced Traffic Service base of surveillance cover traffic 12 o'clock 4 miles right left no height information possible glider traffic"*. This transmission was not acknowledged by the Tutor pilot and another aircraft then started to transmit and RTF loading remained high – Figure 1.

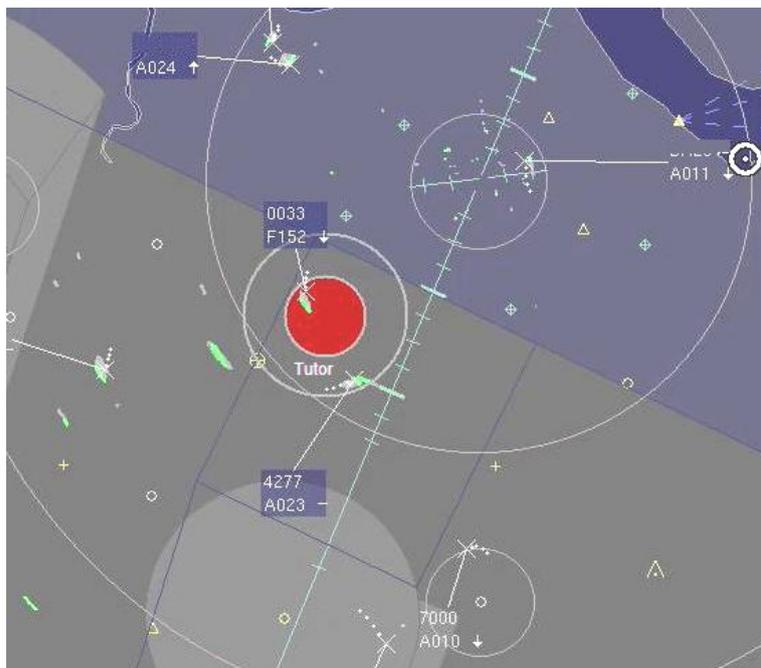
At 1529:32 the glider had faded from the Humberside radar and any intermittent returns are likely to have been masked by the 8nm-from-touchdown radar marker - Figure 2.

The radar return from the Glider was intermittent. The Radar controller was aware of the radar contact (likely a Glider) having passed specific Traffic Information, but the controller reported that when he subsequently checked to update the information, the contact had faded (Figure 2). Any subsequent radar returns may have been masked by the 8nm marker on the radar. When the Glider appeared again (Figure 3), it was not observed by the controller who was likely prioritising his workload.

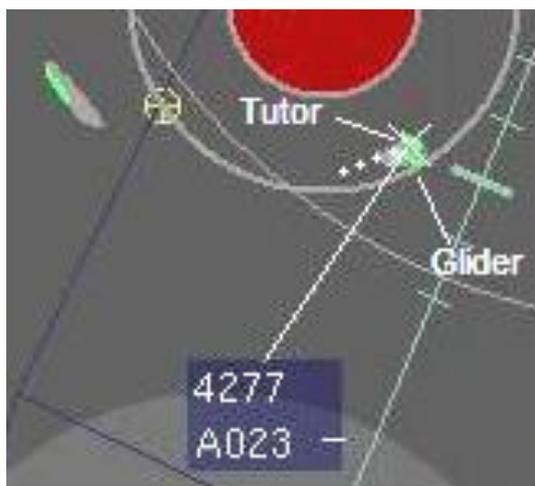
Figure 5 – extract at 1530:23

The expanded range extracts taken at 1530:23 (Figure 5) and at 1530:27 (Figure 6) showed that the glider passed just to the south of the Tutor as they passed abeam.
