AIRPROX REPORT No 2014100

Date/Time: 28 Jun 2014 1535Z (Saturday)

Position: 5052N 00046W
(0.5nm NW of Goodwood)

Airspace: Goodwood ATZ (**Class:** G)

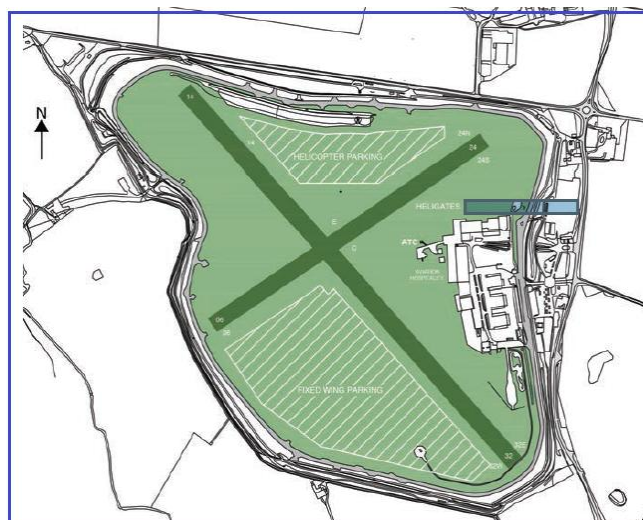
Figure 1 – Aerodrome layout – Festival of Speed

Helicopters were being allowed inbound and outbound from the north via 'Trundle Gate (N)' not above 900ft, with the fixed-wing circuit at 1200ft. Helicopter pleasure flights were operating from Goodwood House, not above 600ft, within a defined area. During the flying display at Goodwood house the airfield was closed to all movements. The Pilot instructions booklet Page 4 and 5 state:

RW14 was in use for fixed-wing aircraft, with helicopters departing from the threshold of RW24. Goodwood were hosting the 'Festival of Speed' event and all aircraft movements were strictly prior permission only. A 'Special Event Aviation Arrangements and Pilot Instructions' booklet was available to all pilots, and was available via the Goodwood website; page 6 shows the Aerodrome layout for the Festival of Speed – Figure 1.

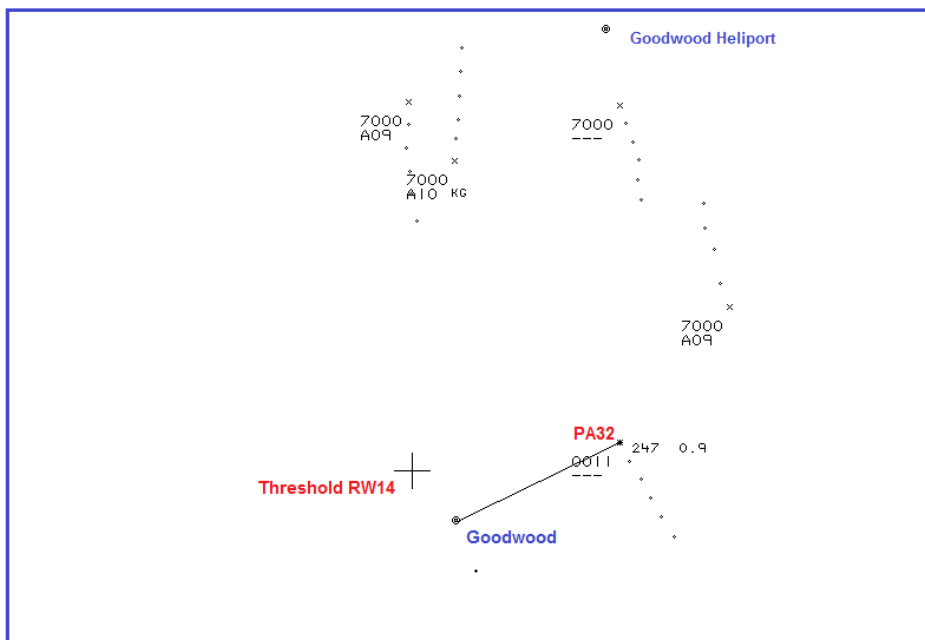
At 1538:27 the radar showed the PA32 downwind 0.9nm east-northeast of Goodwood with a number of other aircraft in the vicinity – Figure 4.

Figure 4 – Swanwick MRT at 1538:27

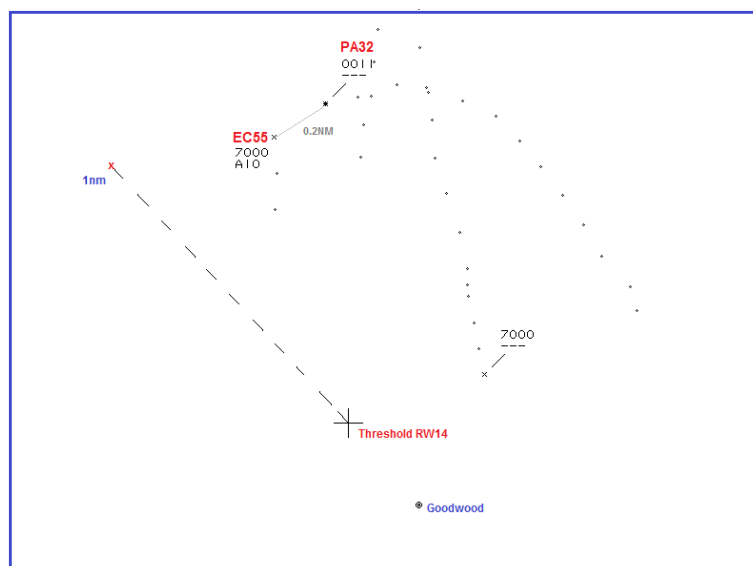
At 1539:22 the distance between the two aircraft was 0.2nm. At this point it was believed that the PA32 took avoiding action (Figure 7).

Figure 7 – Swanwick MRT at 1539:14

On the next radar update the PA32 passed 0.1nm behind the EC155, which was at an altitude of 1000ft.

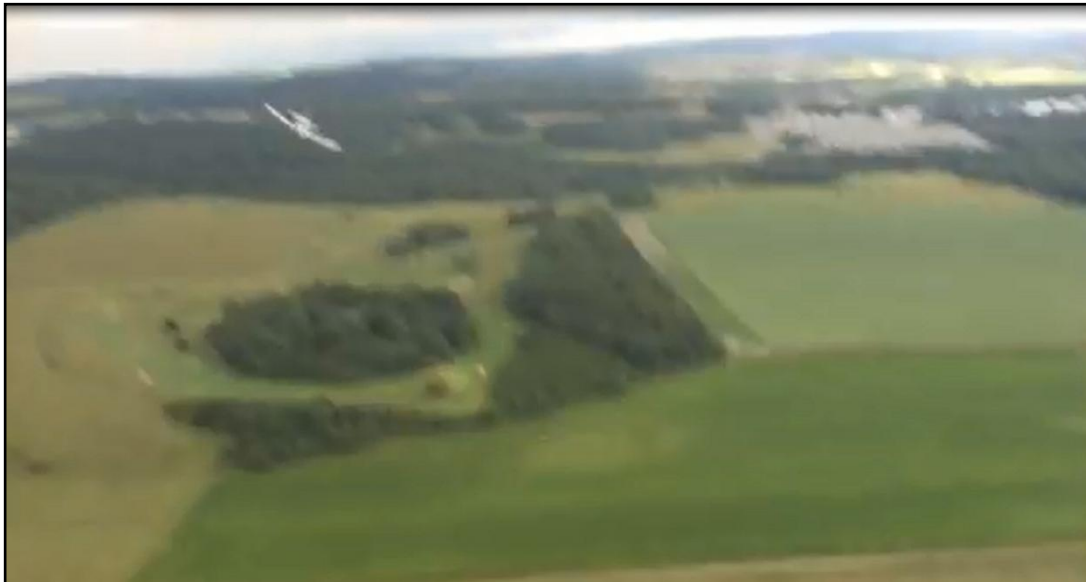
A photo was extracted from video footage taken by a passenger on the EC155, which showed the PA32 banking left- Figure 8.

Figure 8 – Photograph taken by EC155 passenger
