AIRPROX REPORT No 2014129

Date/Time: 26 Jul 2014 1129Z (Saturday)

Position: 5103N 00024E
(SE Bewl Water)

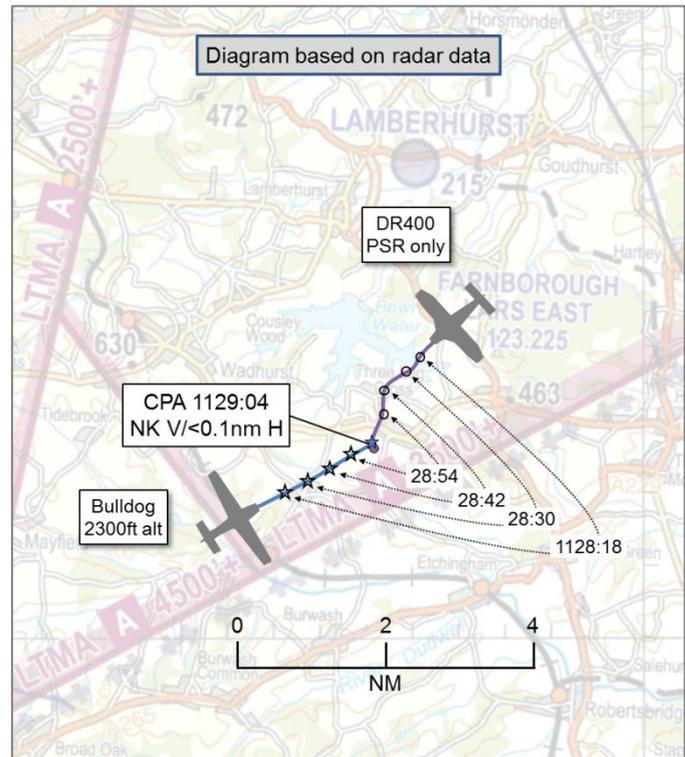
Reported Separation:

0ft V/500m H NK

Recorded Separation:

NK V/<0.1nm H

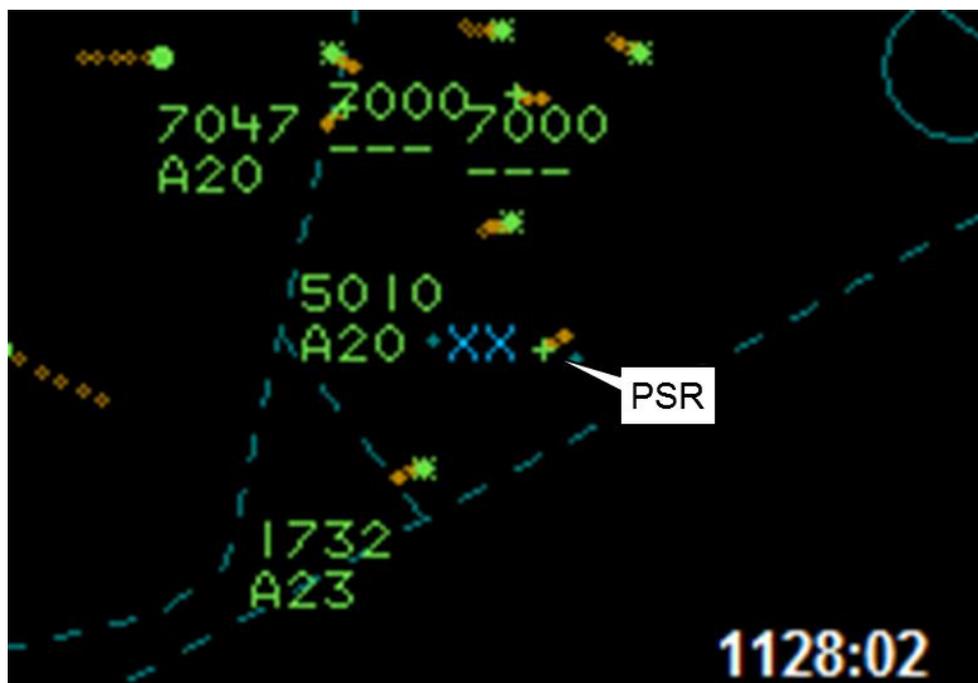
Figure 1

At 1128:02, area radar showed a primary return, opposite direction to the Bulldog at a range of 3.3nm, see Figure 1.

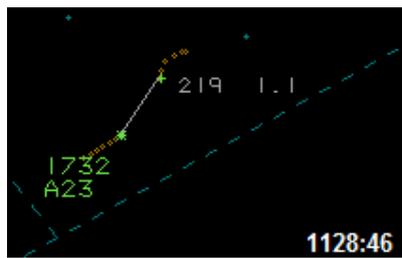
Figure 2

The Bulldog and the primary return continued to converge (see Figures 2 and 3) until the tracks crossed (see Figure 4).

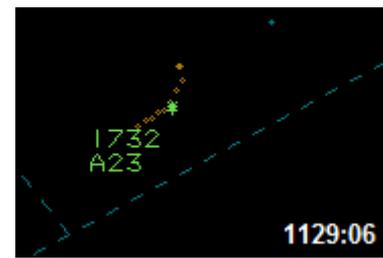
Figure 4

At 1129:15, when the RT conversation between Farnborough LARS(E) and the helicopter pilot ended, the Bulldog pilot reported that he had just come very close to a midair collision with a DR400. The controller replied that nothing was seen on radar before stating that traffic had popped up tracking southbound, primary only. The Bulldog pilot reported that he would be filing an Airprox.
