AIRPROX REPORT No 2014185

Date/Time: 9 Sep 2014 1346Z

Position: 5346N 00246W
(4.5nm ENE Warton Airfield)

Airspace: London FIR (Class: G)

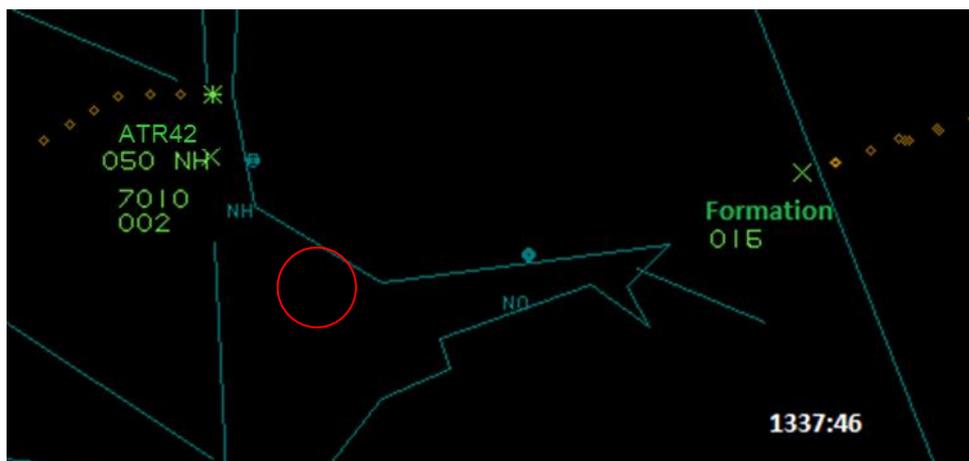
Figure 1

At 1337:46, the BLK Radar controller instructed the AT42 pilot to descend to 2000ft on the QNH 1022hPa (Figure 1) . The BLK Radar controller telephoned Warton to inform them that the ATR42 was downwind right-hand descending to 2000ft for the ILS and that he had warned the crew of the activity remaining south of the coast, or south of St. Cuthbert's church at Lytham (approximate position of St. Cuthbert's church circled in red on Figure 1). The Warton controller replied that the

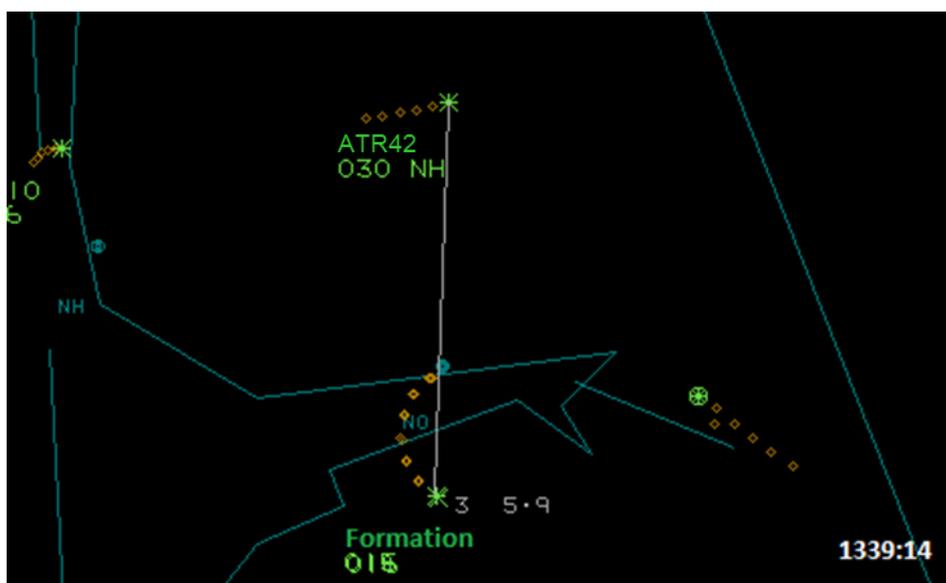
Figure 2

At 1339:14 (Figure 2) the BLK Radar controller instructed the ATR42 pilot to turn right heading 100° and then advised the AT42 pilot of pop-up traffic in their two o'clock range of 4nm southbound (no involvement in the Airprox).

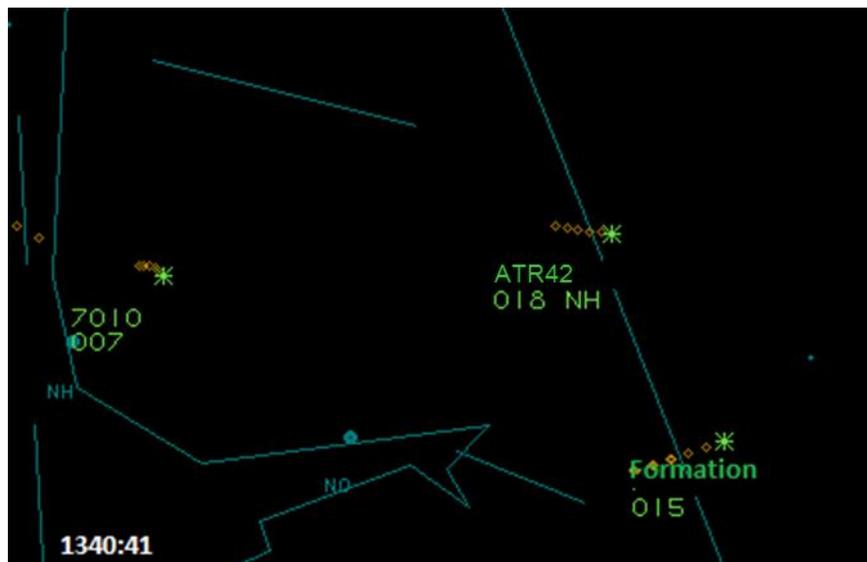
The BLK Radar controller telephoned Warton to discuss the Formation and, during the conversation, at 1340:24, the BLK Radar controller instructed the ATR42 pilot *“avoiding action turn left heading zero four zero that fast jet traffic is in your right two o'clock range of four miles crossing from right to left, you have further pop up traffic to the northwest of you range of four miles zero four zero is the best avoiding”* (Figure 3 at the end of this transmission). Warton Radar also passed Traffic Information to the Formation on the ATR42 at 2000ft. The Formation stated that they would descend to 1500ft. The BLK Radar controller stated that the Formation needed to stay out of the way for 5 minutes so that he could ‘bring the ATR42 in’ but the Warton controller stated that he could not see the Formation. BLK requested that the Formation be put to his frequency but this was refused.

Figure 3 – the ATR42 and Formation were 4.6nm apart

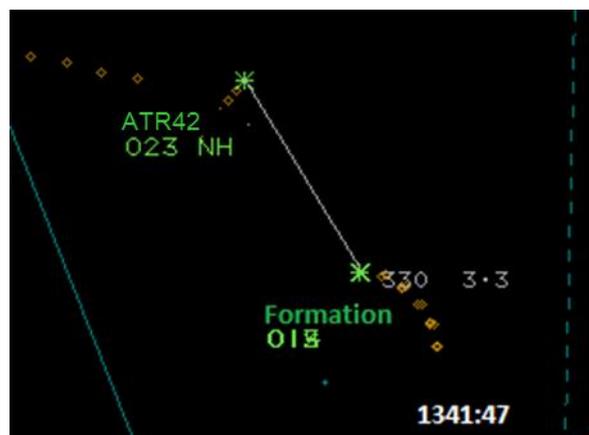
Figure 4

At 1341:20, the BLK Radar controller instructed the ATR42 pilot to climb to 3000ft. At 1341:47, the aircraft were 3.3nm and 1000ft apart. (Figure 4)

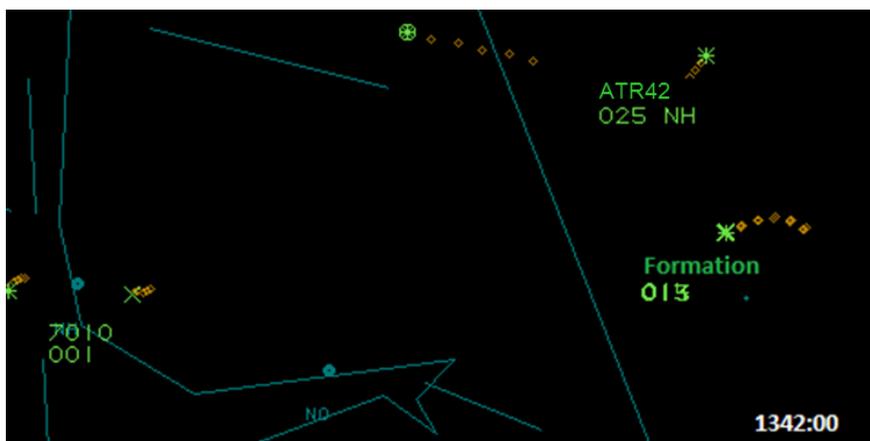
Figure 5

At 1342:00 (Figure 5), the BLK Radar controller instructed the ATR42 pilot to turn right heading 180° and to climb to 3500ft. The BLK Radar controller telephoned Warton again and informed them that the ATR42 was right base at 17nm, that he was bringing the ATR42 in, and that he would give avoiding action if the Formation was in the way again. The Warton controller started to say “*if I can get them to stay at 1500 feet*” but the BLK controller stated that he wanted the formation “*out of my final approach please, somewhere to the south*”. The Warton controller replied that he could not do that because he could not see them. BLK then asked for the Formation to hold at Marshside VRP approx 5nm south-southeast of BLK but was told by Warton that the Formation would not do that. The BLK controller then requested coordination on the Formation. Warton replied that they were unable to coordinate and then corrected that to state that the Formation could be not above 1500ft QFE which the Blackpool Radar controller read back as not above 1600ft QNH.

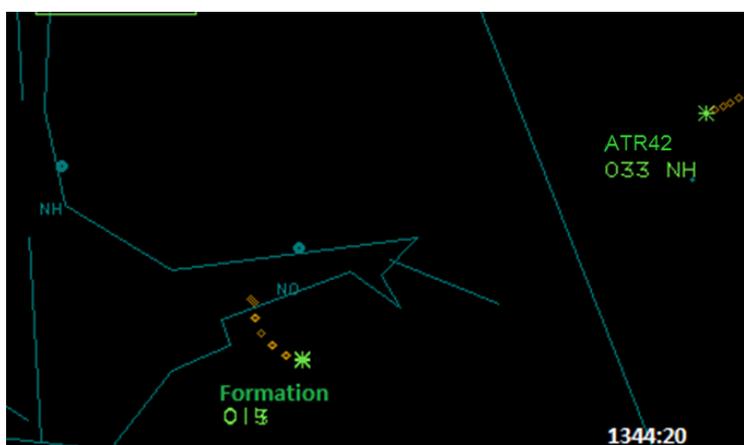
Figure 6

The BLK Radar controller subsequently instructed the ATR42 pilot to turn right heading 250° and, at 1344:20, to descend to altitude 2500ft. (Figure 6) The Warton Radar controller instructed the Formation to fly not above 1500ft QFE for co-ordination with BLK Radar. The height restriction was acknowledged by the Formation and Traffic Information was passed on the ATR42.

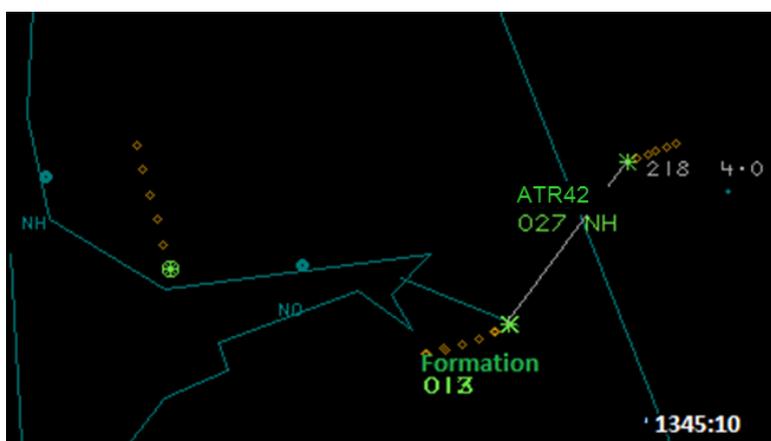
Figure 7

At 1345:10 (Figure 7), the BLK Radar controller again gave avoiding action to the AT42 pilot, with a right turn heading 350° and advised that the previously reported jet aircraft were closing from the left range of 2nm, crossing left to right. The ATR42 pilot reported that they were visual with the traffic and turning onto 350°. The BLK Radar controller asked the ATR42 pilot whether, as they had the traffic in sight, they wanted to continue on the heading for the localiser and the pilot stated that they could. The ATR42 pilot was instructed to close the localiser from heading 250° and to maintain their own separation from the jet traffic.
