**AIRPROX REPORT No 2015150**

Date: 11 Sep 2015 Time: 1012Z Position: 5202N 00002W Location: 2nm NW of BKY

**PART A: SUMMARY OF INFORMATION REPORTED TO UKAB**

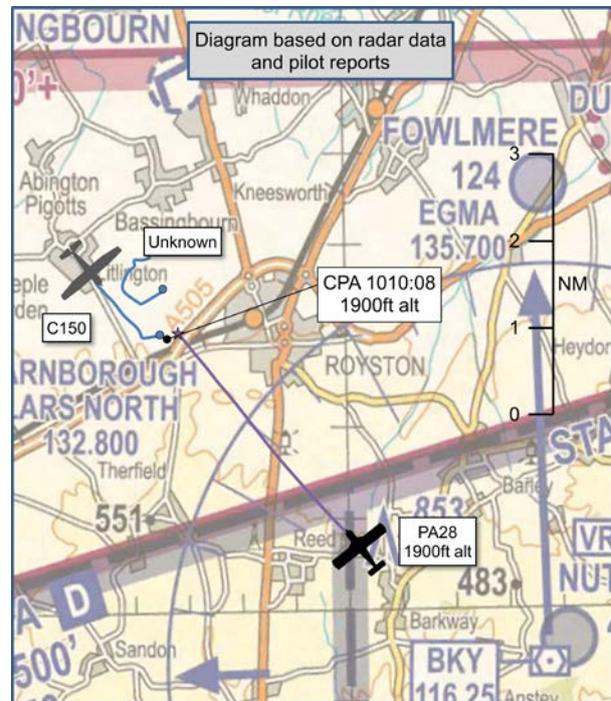
**THE PA28 PILOT** reports that he was flying VFR and tracking inbound to BKY on a heading of 149°. Approximately 1nm north of BKY he executed a 30° AoB level turn to the right onto a heading of 313° to his next waypoint of Littlington. During the turn, he contacted Cambridge Approach and requested a frequency change to Old Warden. Cambridge terminated his Basic Service. As he rolled wings level from the turn, he saw a white C150 in his 10 o'clock position, same altitude, heading roughly east, at a range of approximately 100m. He began a full-power climbing right turn, keeping tally on the other aircraft as he did so. The Cessna turned gently right and passed behind his aircraft. He could easily identify the type and read the registration. He had not had time to change frequency to Old Warden, so he re-established communications with Cambridge Approach and reported the Airprox. He had carried out a good lookout prior to his right turn, being mindful of the visual obstruction caused by a low-wing configuration such as the PA28. He apportioned no blame to the other pilot, but reinforced his need for a vigilant lookout during every flight.

**THE C150 PILOT** reports he believed this was a non-event. The test candidate saw the opposing traffic in excess of 1/2 nm away; indicated she had seen it, and took standard avoiding action by turning right and maintaining height and speed. The other aircraft was observed from the left seat doing a strange diving turn manoeuvre. Some minutes later he believed the same aircraft climbed from a manoeuvre to pass below the left-hand side in the opposite direction.

The Board then discussed the cause and risk of the Airprox and determined that it had been a late sighting by the PA28 pilot and a probable non-sighting by the C150 pilot. The Board agreed that the aircraft were in such proximity that safety margins had been much reduced from the norm, and that the actions of the PA28 pilot had had a material effect on increasing the separation. As a result, they assessed the risk as Category B.

Cause: A late sighting by the PA28 and a probable non-sighting by the C150.

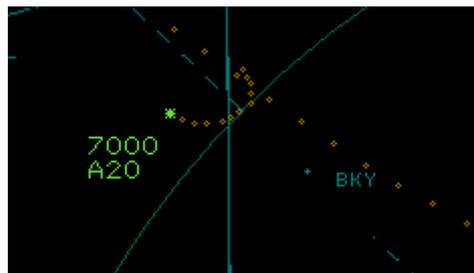
Figure 1: Swanwick MRT at 1010:10 (The P28 has code 7000)

The C150 pilot reported observing the other aircraft make an unusual diving manoeuvre which contradicts the report from the PA28 of making a climb. Having reviewed the radar, it is not possible to observe a CPA; although the PA28 remains in radar cover throughout, there is no other radar contact observed at the time stated (when the PA28 turns at BKY – Figure 1).

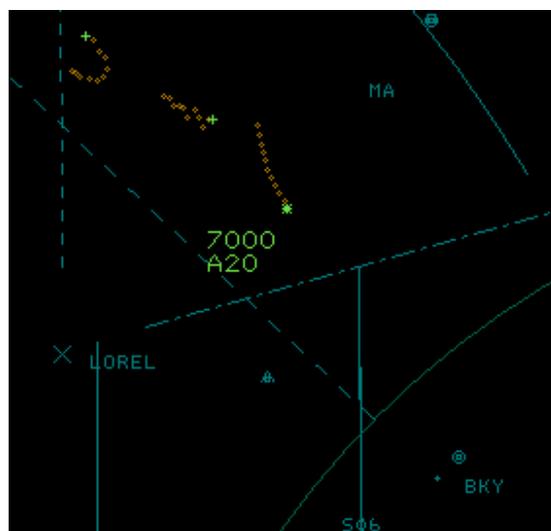
Figure 2: Swanwick MRT at 1008:01 (Prior to the Airprox)

However, there were two unknown primary only contacts observed manoeuvring approximately 5nm northwest of BKY a couple of minutes prior to the Airprox (Figure 2). The C150 was not positively identified on radar but may have seen either of these two unknown aircraft and confused one of these with the PA28 that reported the Airprox, especially as one of these unknown aircraft remained in the vicinity throughout the time and made multiple manoeuvres.

The Board determined, with the use of the radar recordings, that there were three aircraft in the same area at the time of the Airprox: Aircraft 1 – the PA28; Aircraft 2 – the C150; and Aircraft 3 – an unknown manoeuvring aircraft. Taking into account both pilot reports and the radar recordings, it was agreed that, in all probability, the PA28 pilot had seen the C150 crossing left-to-right and had carried out a climbing right turn to avoid, but did not see the unknown manoeuvring aircraft. Meanwhile, the C150 pilot saw the unknown aircraft carrying out manoeuvres and avoided this aircraft to the right (in accordance with the rules of the air) but did not see the PA28.
