**AIRPROX REPORT No 2015220**

Date: 29 Dec 2015 Time: 1129Z Position: 5309N 00236W Location: 1nm SW Ashcroft airfield

**PART A: SUMMARY OF INFORMATION REPORTED TO UKAB**

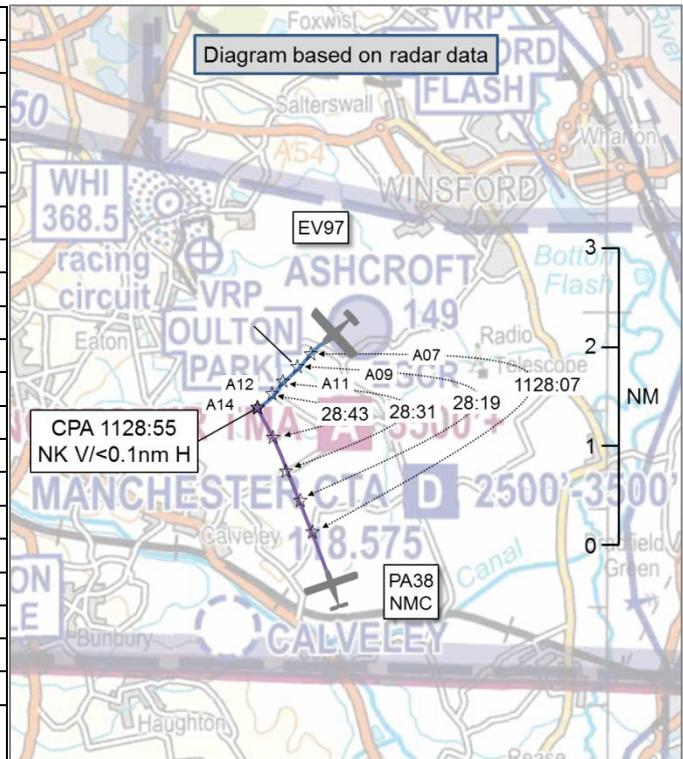
Recorded	Aircraft 1	Aircraft 2
Aircraft	EV97	PA38
Operator	Civ Pte	Civ Club
Airspace	London FIR	London FIR
Class	G	G
Rules	VFR	VFR
Service	None	Basic
Provider	N/A	Liverpool
Altitude/FL	FL013	NMC
Transponder	A, C, S	A only
Reported		
Colours	Silver	White, blue
Lighting	Nil	Wing-tip strobes
Conditions	VMC	VMC
Visibility	>10km	>10km
Altitude/FL	1000ft	1500ft
Altimeter	QFE (1008hPa)	QNH (1014hPa)
Heading	240°	318°
Speed	70kt	90kt
ACAS/TAS	Not fitted	Not fitted
Separation		
Reported	50ft V/20m H	200-300ft V/ 0.5-1nm H
Recorded	NK V/<0.1nm H

**THE EV97 PILOT** reports he had just departed Ashcroft RW27 and was climbing out when an aircraft suddenly appeared at close range, high in his left 10 o'clock. He pushed the nose down and banked sharply left, flew a 360° orbit and saw the other aircraft continue straight and level en-route. He identified the aircraft as a blue and white, low-wing, single-engine piston type. He did not think the other pilot saw him. The EV97 pilot noted that he was just about to change radio frequency when the other aircraft had appeared from a bright low sun, which had been obscuring it previously.

**THE PA38 PILOT** reports conducting a navigation exercise. He had completed all 'zone entry checks' and received clearance to enter the Liverpool CTR at Oulton Park [VRP]. He continued towards Oulton Park, maintaining his lookout. Nothing was seen until approximately 1 minute from Oulton Park, when he became aware of another aircraft to the right, passing below his level and already turning towards the southeast. He assessed that the two aircraft were 'close' when he saw the other aircraft, but by turning, the other pilot had removed any risk which had existed. The PA38 pilot felt it was safe to maintain heading and proceeded on track to Oulton Park.

Cause: A late sighting by the EV97 pilot and effectively a non-sighting by the PA38 pilot.

Degree of Risk: B.
