Analysis and Investigation

CAA ATSI

An Airprox was reported when A319(A) and A319(B) flew into proximity at 1714 on Monday 25th April 2016. Both pilots were under IFR, in receipt of a Radar Control Service from Swanwick. Both aircraft had departed from Gatwick, A319(B) ahead of A319(A). Co-ordination took place with Swanwick for the Aerodrome controller to vertically separate the two flights following a reduced separation take-off

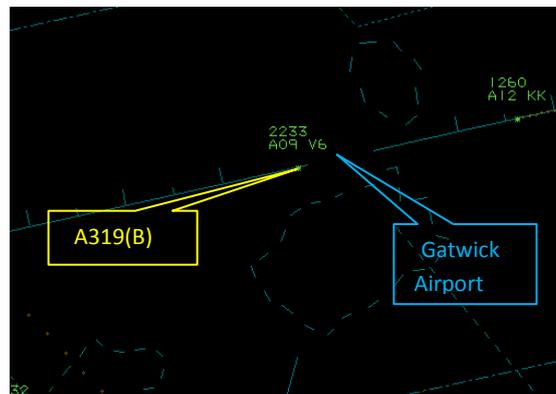
Figure 3 (1711:18).

At 1711:18 (Figure 3) A319(B) (code 2233) first appeared on Radar.

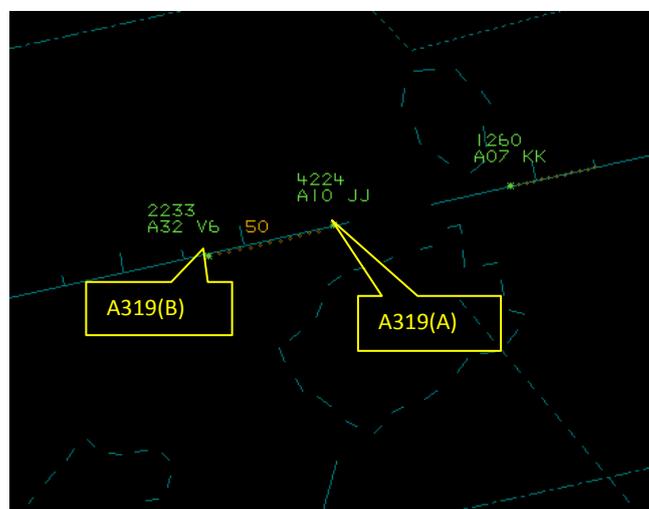
Figure 4 (1712:10).

At 1712:10 (Figure 4) A319(A) first appeared on radar passing 1000ft. A319(B) was passing 3200ft climbing to 5000ft.

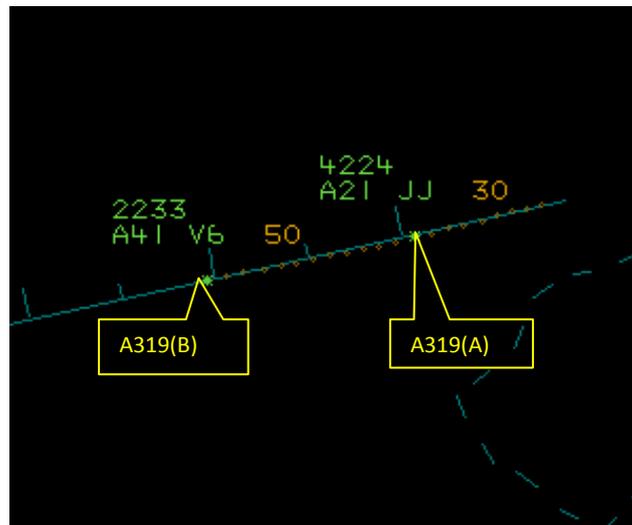
Figure 5 (1712:42).

At 1712:42 (Figure 5), the Gatwick Aerodrome controller transferred the pilot of A319(B) to the TC WILLO Sector and then proceeded to transfer the pilot of A319(A) to TC SW Departures. The A319(B) was at 4100ft and the A319(A) was climbing to 3000ft.

The TC Planner for this sector reports co-ordinating with Gatwick FIN a departure sequence with one aircraft routing via BOGNA and another via SAM. Both of these departures climb to 4000ft but, with the coordination that had been effected, the second aircraft (A319(A)) would stop at 3000ft. This is evidenced by the cleared level of 3000ft indicated in Figure 5.

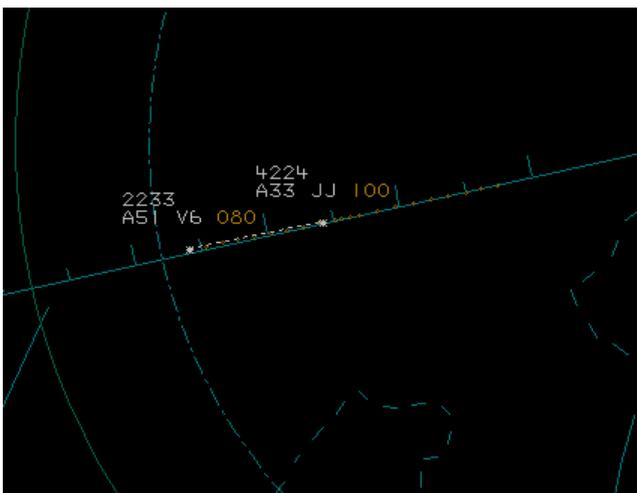
Figure 6 (1735:35).

At 1713:35 (Figure 6) the SW Departures controller issued an 'avoiding action' turn and an instruction to stop the climb at 5000ft to the A319(A) pilot. This instruction was read back immediately. At exactly that second, the Short Term Conflict Alert (STCA) began to warn the controller of the proximity.

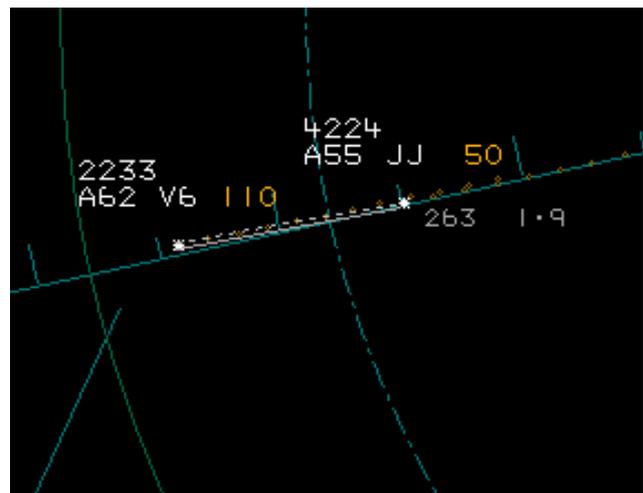
Figure 7 (1714:03).

At 1714:03 (Figure 7) the pilot of A319(A) reported that he was returning to 5000ft. This was also the point of CPA when the aircraft were 1.9nm horizontally and 700ft vertically apart. The aircraft had become this distance from each other approximately 10 seconds earlier and it had remained constant. At the same time, the TC WILLO controller confirmed there was no speed restriction for A319(B).
