AIRPROX REPORT No 2016224

Date: 20 Sep 2016 Time: 1027Z Position: 5104N 00103E Location: 7.7nm NE Lydd airport

PART A: SUMMARY OF INFORMATION REPORTED TO UKAB

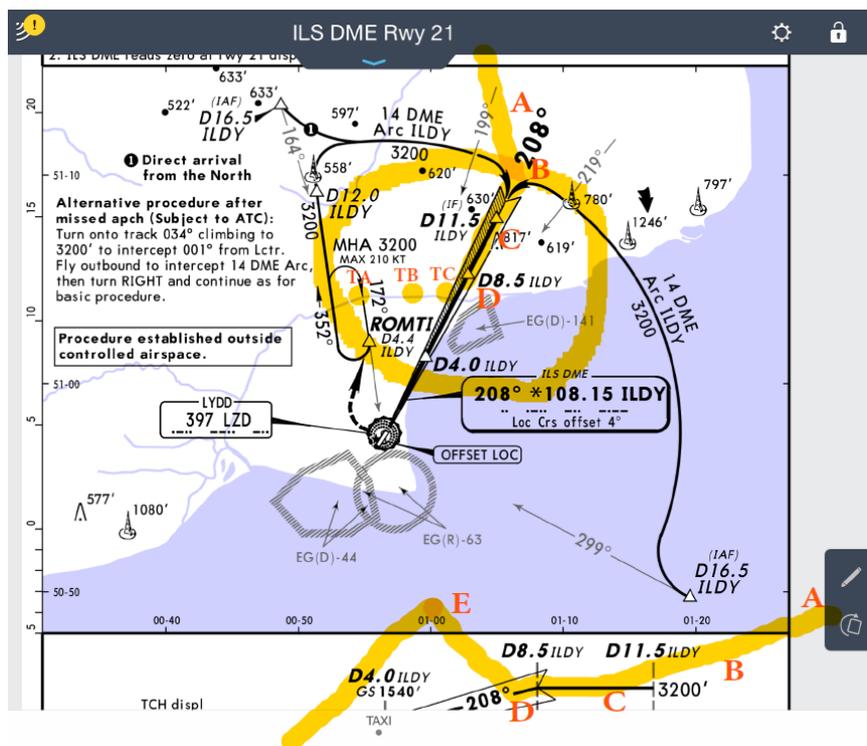
Figure 1 CL30 Reported Flight Path.

THE BOMBARDIER CHALLENGER 300 (CL30) PILOT reports that they had flown east of DVR and had descended on radar vectors towards Lydd. During the descent towards Lydd, and shortly before descending below Controlled Airspace (CAS), London Control released them to contact Lydd Approach. Illustrating his report he provided an annotated diagram of their final approach (Figure 1) that he referenced in his textual comments. He stated that Lydd Approach cleared them to continue descent to 3200ft QNH (the final approach altitude), intercept the Localiser ILS RW21 (Figure 1 - Point A), and to descend on the ILS RW21 to perform a ‘break-off’ for a circling approach to RW03. They captured the localiser RW21 while descending to the final approach altitude at approximately D12.0 ILDY at 3500ft QNH (Point B). At that point, they realised that a ‘target’ on their TCAS at two o’clock was entering the 5nm sector at a vertical distance 400ft below, at approximately 3100ft; the ‘target’ was moving east, probably crossing their glide-slope (GS) at approximately D8.3 ILDY (Figure 1 - Point TA). The ‘target’ went amber, and they received a TCAS TA “Traffic”. They immediately informed ATC about the target. ATC responded that they could not see it, because they do not have radar equipment. At approximately D11.0 ILDY, they levelled at 3200ft (Figure 1 - Point C). The target range was approximately 3nm, with a vertical distance of 100ft (Figure 1 - Point TB). Weather

conditions were still IMC in clouds 6/8 to 8/8 [Broken-Overcast]. He spoke to the Second in command, commenting that if the autopilot captured the GS and commenced descent they might cross the target at the same altitude. At D8.5 ILDY, still IMC, the target range was approximately 1nm, with a vertical distance 100ft (Figure 1 - Point TC). The autopilot captured the GS, and immediately afterwards they received a TCAS RA "Climb" (Figure 1 - Point D). By pitching the aircraft up into the green TCAS reference bar and advancing the thrust levers to climb power, they performed a rapid climb-out. At approximately 3700ft, they received a TCAS "Clear of conflict" (Figure 1 - Point E). They rapidly changed configuration to: flaps 20; gear down to initiate descent again. When descending through approximately 3000ft, they were clear of clouds. Now in VMC and with the airport in sight, they decided to land on RW21, since they had a tailwind component of less than 5kt. After landing, he telephoned the Tower to discuss the conflict situation. ATC told him again that they could not identify the target, because they were not equipped with radar and they learned about the conflicting situation and the TCAS RA only through the CL30 pilot's radio call. ATC further told him that they do have conflicting traffic every now and then. The reason for this is that other pilots flying outside CAS and passing through the Lydd area are not obliged to call Lydd ATC to inform them about their intentions, as long as they do not fly through Lydd's ATZ. The CL30 pilot opined that this may lead to potential conflicting situations with other east or westbound traffic, since pilots on the RW21 approach are flying quite a distance through uncontrolled airspace until they reach the Lydd ATZ. He commented that, in his opinion, the conflicting traffic that caused the TCAS RA did not follow the rules of distances to clouds in the specific airspace because the aircraft was flying at approximately 3000ft or 3100ft QNH, according to their [TCAS] indications. They were clear of clouds only when passing 3000ft or lower, and in his opinion the other pilot was flying at least through broken clouds and not keeping a proper vertical distance to clouds.

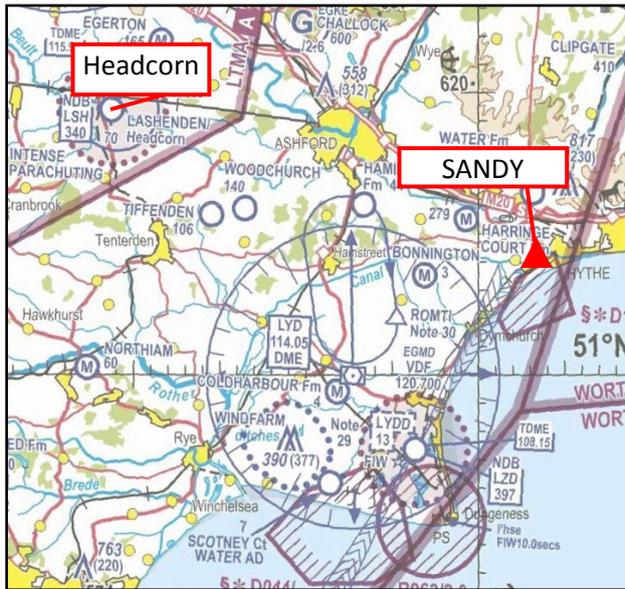
Figure 2.

The SR22 pilot contacted London Information at 1007:55 and was advised to obtain a radar service from Farnborough LARS for his transit to the east of the London TMA. He returned to London Information at 1020:32 and a Basic Service was agreed. At 1021:00 the pilot reported abeam Headcorn at 3400ft, advising the London FISO that they expected to coast-out at (reporting point) SANDY at 1027 (Figure 2).

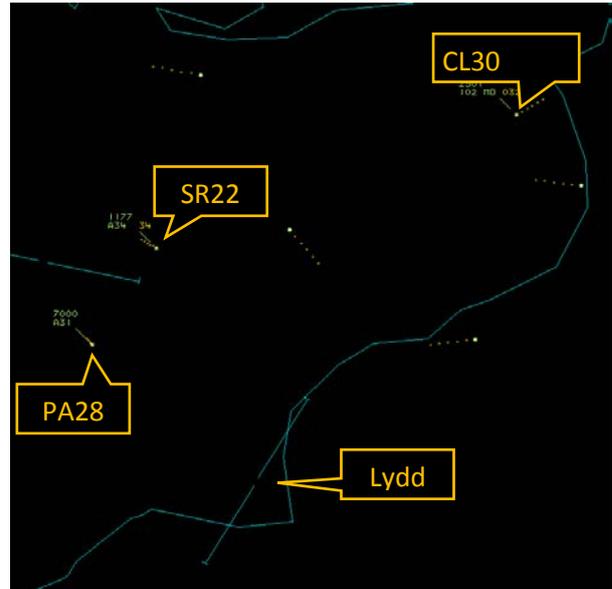
Figure 3 – Swanwick MRT 1023:08.

At 1022:40 the Lydd controller (who was providing both an Aerodrome and non-surveillance Procedural Approach service), passed Traffic Information on the inbound CL30 to a PA28 pilot, who was 6nm south-west of the SR22, on a similar south-easterly track, and which was routing via the LYD VOR. At 1023:08 the CL30 pilot, (approaching 24nm north-east of Lydd), contacted Lydd Approach advising that they were in the descent to 3200ft (Figure 3).

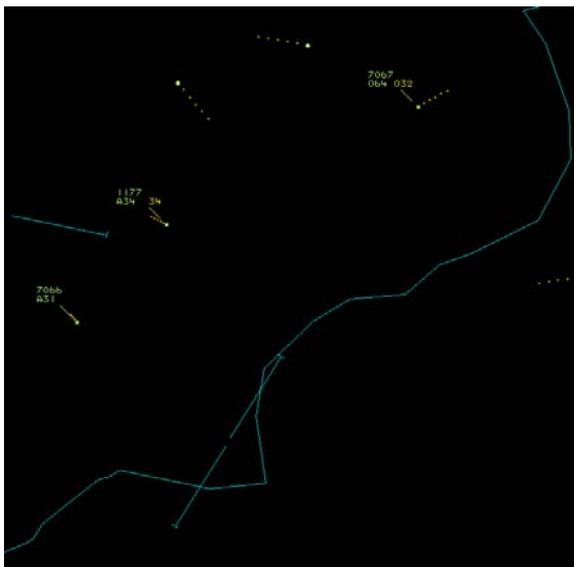
Figure 4 – Swanwick MRT 1024:05.

At 1024:05 the Lydd controller requested a range-check from the CL30 pilot, who reported at 20nm and, shortly afterwards, confirmed that they were established on the localiser. The controller again requested that the pilot call at 12nm which was acknowledged by the pilot (see Figure 4).

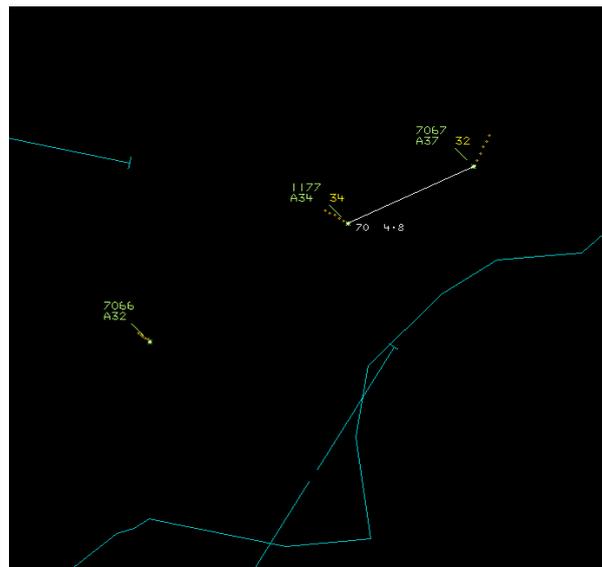
Figure 5 – Swanwick MRT 1025:55.

At 1025:55 the CL30 pilot reported at 12nm. The Lydd controller requested a further check at 4nm, advising the pilot to expect a break to the right to visually manoeuvre for landing on RW03 (Figure 5).

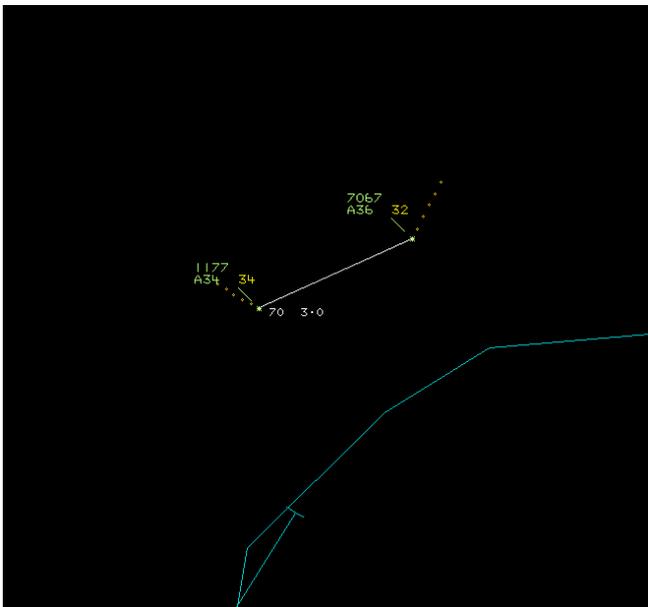
Figure 6 – Swanwick MRT 1026:22.

At 1026:22 the CL30 pilot reported a target in their 1 o'clock position, 200ft below. The Lydd controller acknowledged this and advised that they had a PA28 routing to the 'LYD' (VOR) at 3000ft but the pilot had not reported there yet. The CL30 pilot reported that the traffic was now 100ft below them and the Lydd controller confirmed that they were not working any other traffic (Figure 6).

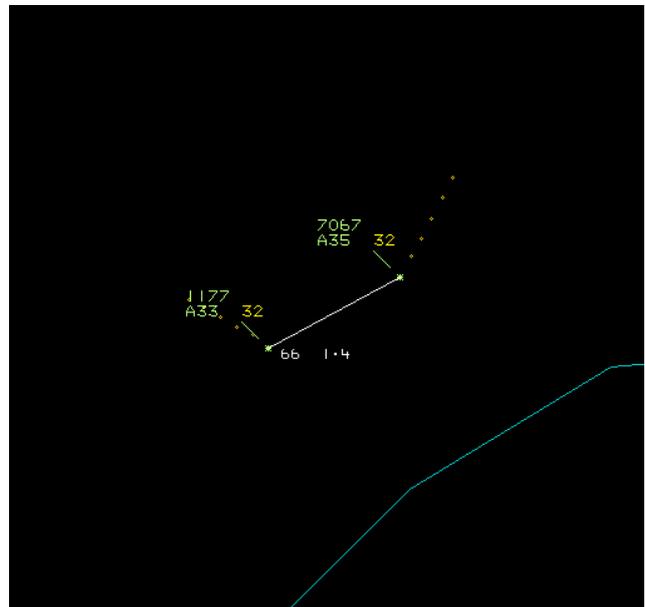
Figure 7 – Swanwick MRT 1026:45.

At 1026:45 the CL30 pilot reported a TCAS TA. The Lydd controller asked if they were visual with the traffic, to which the CL30 pilot reported that they were not (Figure 7).

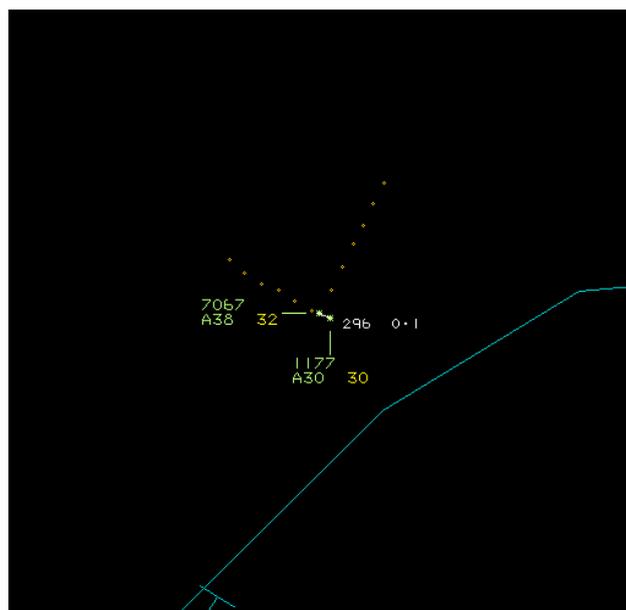
Figure 8 – Swanwick MRT 1027:03.

The CPA took place at 1027:03. The CL30 was observed to already be in a climb, with a separation of 800ft vertically and less than 0.1nm laterally (Figure 8).

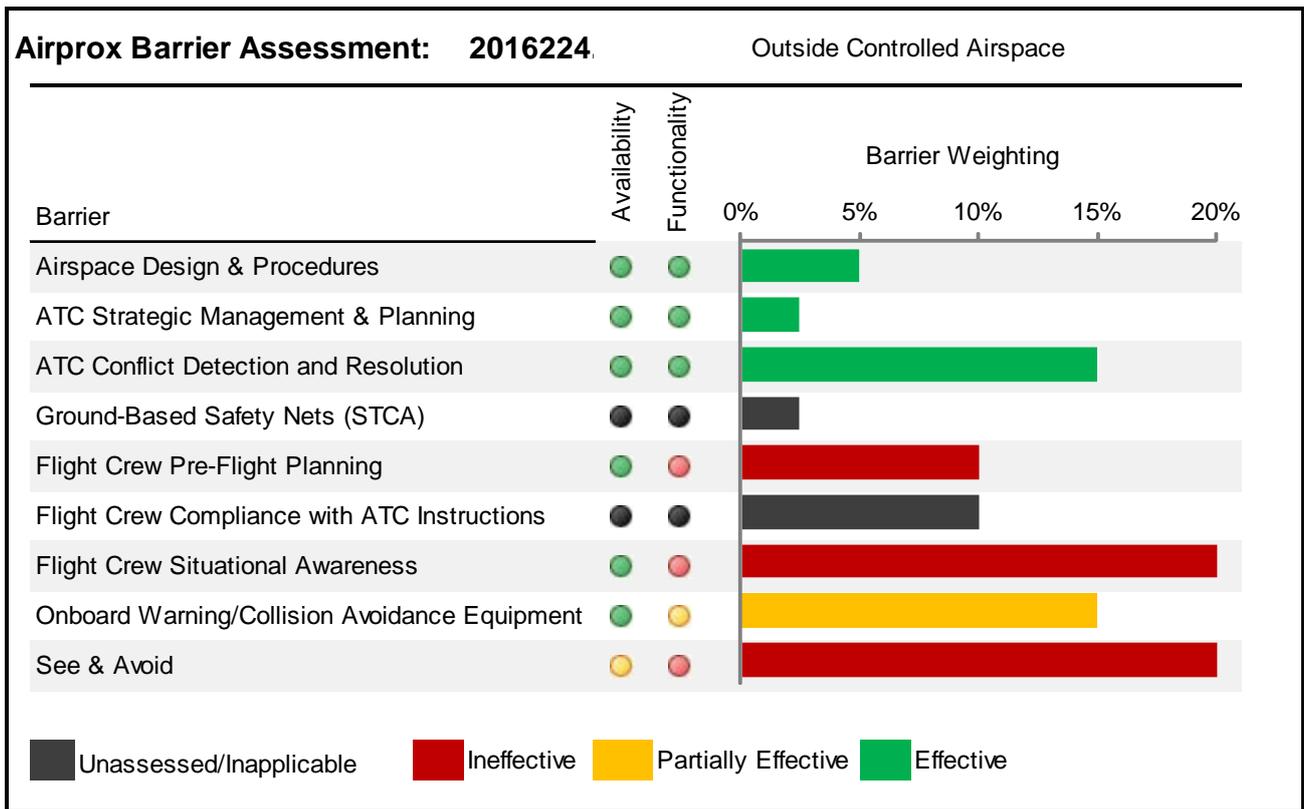
- **Flight Crew Pre-Flight Planning** was considered to be **ineffective** because the CL30 pilot seemed to have an apparent lack of understanding of the UK FIS and Lydd's ATS capabilities - the Board believed that although he was in receipt of a Procedural Service he still believed that Lydd was equipped with radar surveillance and would keep him advised of, or separated from, traffic not on the Lydd frequency

- **Flight Crew Situational Awareness** was considered to be **ineffective** because the CL30 pilot did not expect aircraft to be in his vicinity without being in contact with Lydd, and neither pilot was aware of the other because the SR22 pilot was not on the Lydd frequency.

- **Onboard Warning/Collision Avoidance Equipment** was assessed as only **partially effective** because the CL30 pilot continued his approach despite being aware of unknown traffic ahead on his TCAS display.

- **See and Avoid** was only **partially available** because only the SR22 pilot was clear of cloud. Accordingly, it was assessed as being **ineffective** overall because neither pilot was able to see the other aircraft.

Modern safety management processes employ the concept of safety barriers that prevent contributory factors or human errors from developing into accidents. Based on work by EASA, CAA, MAA and UKAB, the following table depicts the barriers associated with preventing mid-air-collisions. The length of each bar represents the barrier's weighting or importance (out of a total of 100%) for the type of airspace in which the Airprox occurred (i.e. Controlled Airspace or Uncontrolled Airspace).¹¹ The colour of each bar represents the Board's assessment of the effectiveness of the associated barrier in this incident (either Fully Effective, Partially Effective, Ineffective, or Unassessed/Inapplicable). The chart thus illustrates which barriers were effective and how important they were in contributing to collision avoidance in this incident.
