**AIRPROX REPORT No 2016256**

Date: 29 Nov 2016 Time: 1400Z Position: 5146N 00109W Location: 7nm NW Benson

**PART A: SUMMARY OF INFORMATION REPORTED TO UKAB**

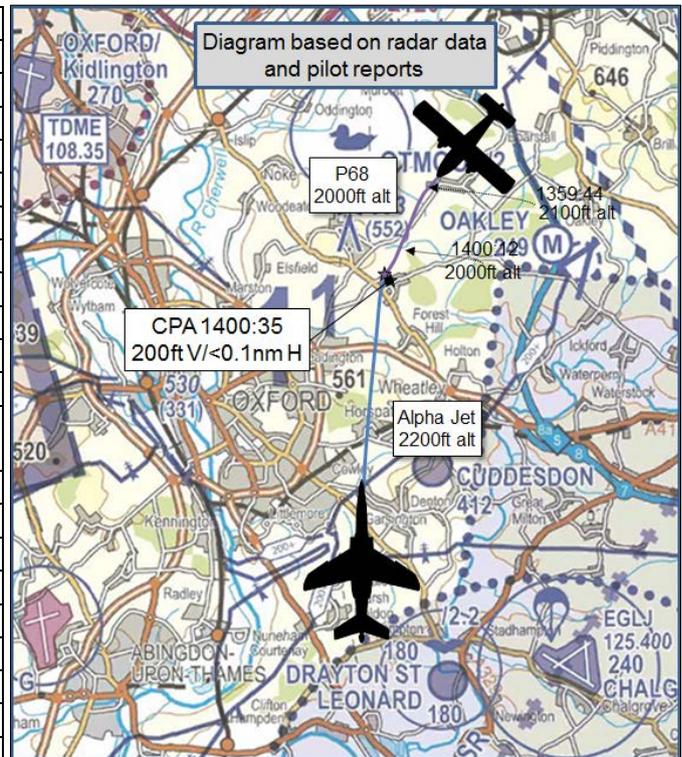
Recorded	Aircraft 1	Aircraft 2
Aircraft	Alpha Jet	P68
Operator	MoD ATEC	Civ Comm
Airspace	London FIR	London FIR
Class	G	G
Rules	VFR	VFR
Service	Traffic	Basic
Provider	Benson	Oxford
Altitude/FL	2200ft	2000ft
Transponder	On/C, S	On/C
Reported		
Colours	Black, White	White, Blue
Lighting	HISL	Strobe, Taxi, Landing
Conditions	VMC	VMC
Visibility	>10km	9km
Altitude/FL	1900ft	2000ft
Altimeter	QFE (1026hPa)	QNH (1033hPa)
Heading	340°	200°
Speed	160kt	120kt
ACAS/TAS	TAS	Not fitted
Alert	None	N/A
Separation		
Reported	200ft V/NK H	0-100ft V/1nm H
Recorded	200ft V/<0.1nm H

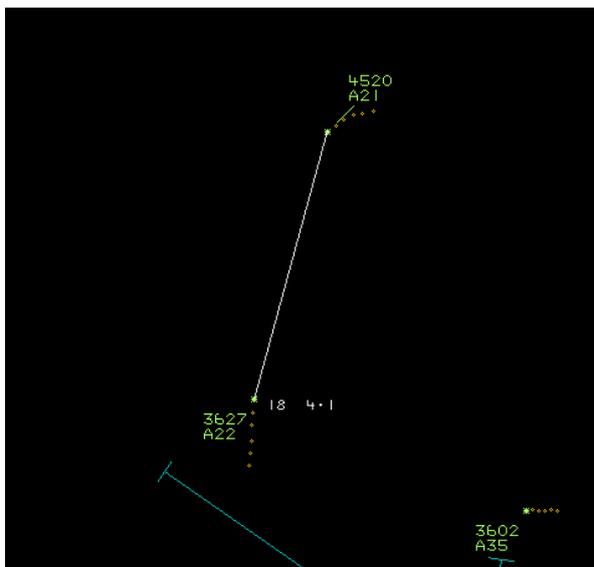
Figure 1 – 1359:45

According to the report from Benson ATC, Traffic Information (on the P68) was passed to the Alpha Jet when the P68 was in the Alpha Jet's 12 o'clock at 4nm, advising that the P68 was indicating 200ft below (Figure 1).

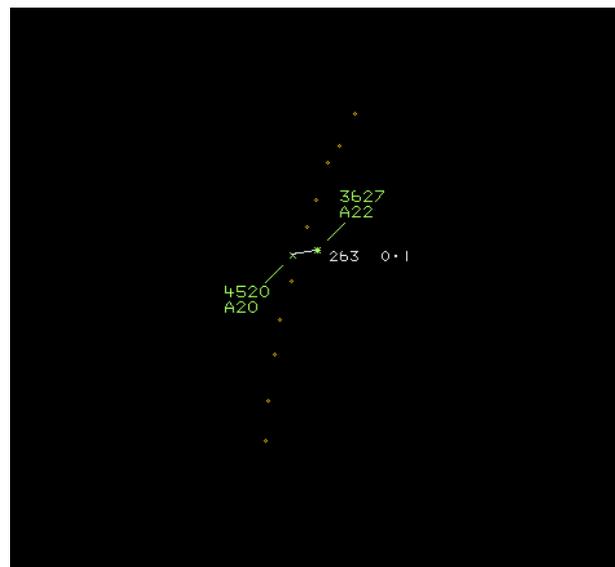
Figure 2 – 1400:36

A turn onto 090° was offered and subsequently accepted by the Alpha Jet. CPA took place at 1400:36 (Figure 2), with the aircraft separated by 0.1nm laterally and 200ft vertically.

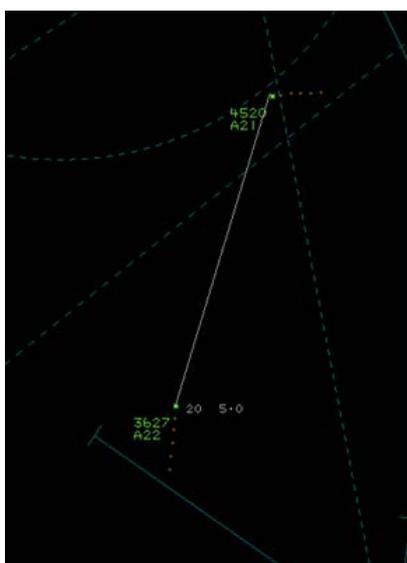
Figure 3: Geometry at 13:59:32    Figure 4: Geometry at 13:59:59    Figure 5: Geometry at 14:00:17 (Alpha Jet (3627); P68 (4620))

At 13:59:32 (Figure 3), the Benson Approach controller passed TI to the Alpha Jet on traffic in its right, 1 o'clock, range 3nm, opposite direction, indicating 100ft below. The Alpha Jet reported that he was looking but did not call visual with the traffic. The Benson Approach controller then asked if the pilot was happy to turn against that traffic (onto base leg) for checks, to which the Alpha Jet responded that checks were complete and they would take a turn.

The radar analysis in Figures 3-6 shows the position of the Alpha Jet and P68 at times when pertinent instructions were issued. The replays are taken from the 'All Swanwick' radar feed, which was not the feed available to the controller and therefore does not necessarily depict what was on their screen at the time.

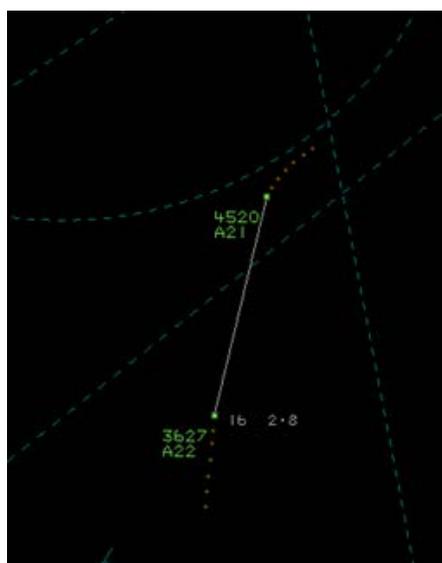
At 13:59:59 (Figure 4), the Alpha Jet was instructed to turn right onto heading 090 degree degrees for base leg.

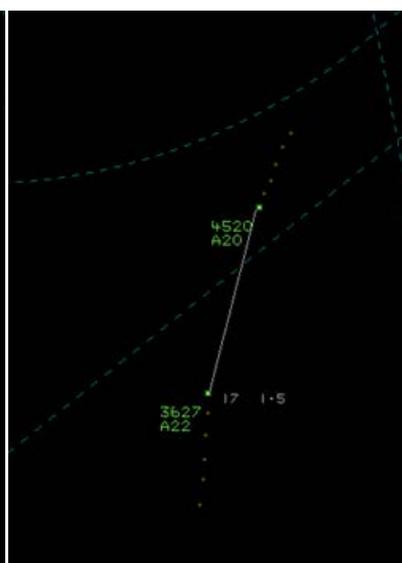
At 14:00:17 (Figure 5), the Alpha Jet reported visual with the previously called traffic.

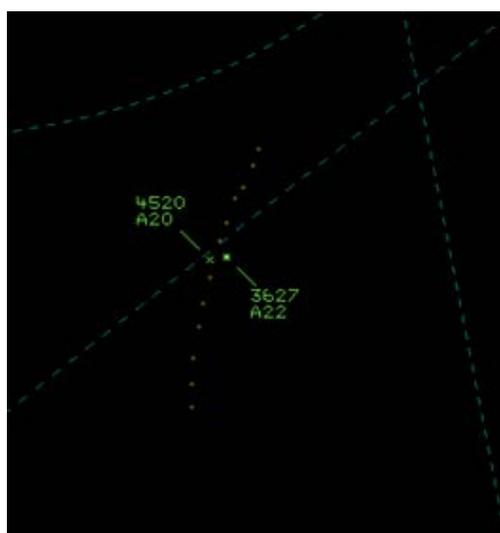
Figure 6: Geometry at 14:00:35 (Alpha Jet (3627); P68 (4620))

At 14:00:35 (Figure 6), the Alpha Jet and P68 passed at their CPA, which was 0.1nm and indicated 200ft separation.

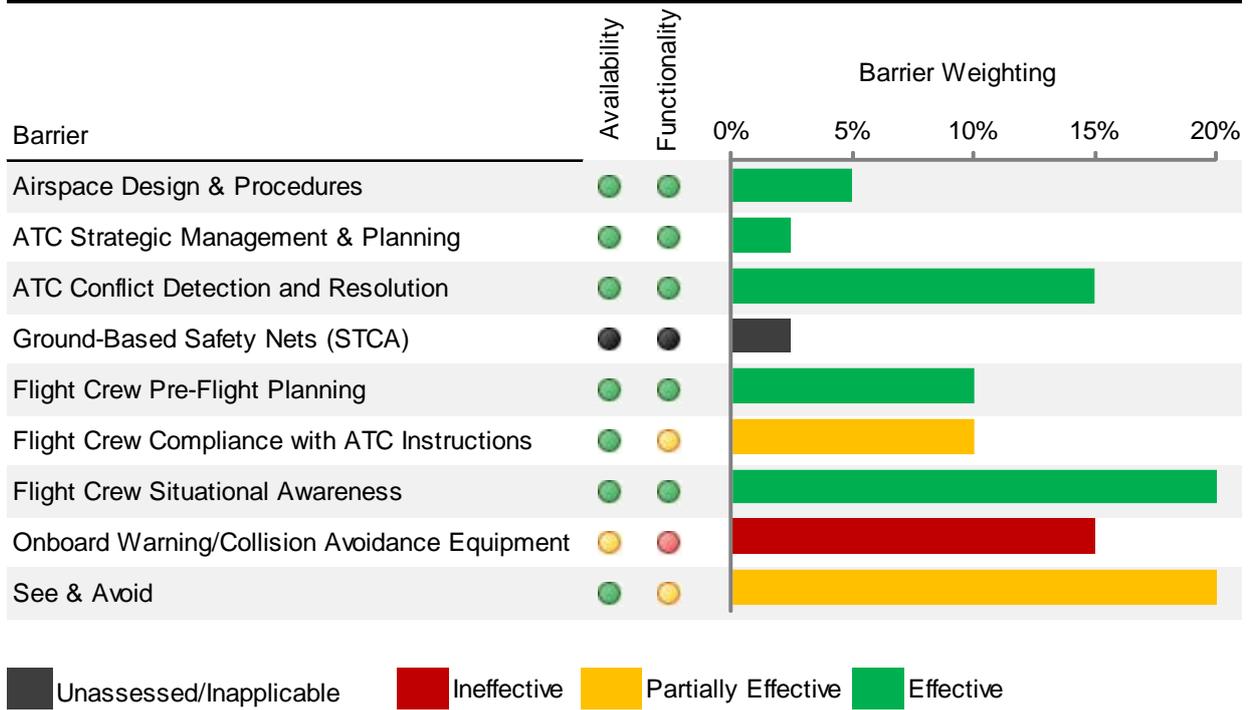
**Airprox Barrier Assessment: 2016256**

**Flight Crew Compliance with ATC Instructions** was considered to be **partially effective** because although the Alpha Jet was passed TI on the P68 he did not utilise the information sufficiently to deconflict himself from the P68.

**Onboard Warning/ Collision Avoidance Equipment** was considered to be **ineffective** because although the Alpha Jet had a TAS that had been functioning previously, on this occasion it failed to alert the Alpha Jet pilot to the conflicting traffic.

**See and Avoid** was considered to be only **partially effective** because neither pilot effectively saw the other aircraft until the Alpha Jet had turned onto base leg, away from the conflict.

<sup>4</sup> Modern safety management processes employ the concept of safety barriers that prevent contributory factors or human errors from developing into accidents. Based on work by EASA, CAA, MAA and UKAB, the table depicts the barriers associated with preventing mid-air-collisions. The length of each bar represents the barrier's weighting or importance (out of a total of 100%) for the type of airspace in which the Airprox occurred (i.e. Controlled Airspace or Uncontrolled Airspace). The colour of each bar represents the Board's assessment of the effectiveness of the associated barrier in this incident (either Fully Effective, Partially Effective, Ineffective, or Unassessable/Inapplicable). The chart thus illustrates which barriers were effective and how important they were in contributing to collision avoidance in this incident. The UK Airprox Board scheme for assessing the Availability, Functionality and Effectiveness of safety barriers can be found on the [UKAB Website](#).
