AIRPROX REPORT No 2016209

Date: 23 Sep 2016 Time: 1205Z Position: 5157N 00109W Location: NW of Bicester Airfield

PART A: SUMMARY OF INFORMATION REPORTED TO UKAB

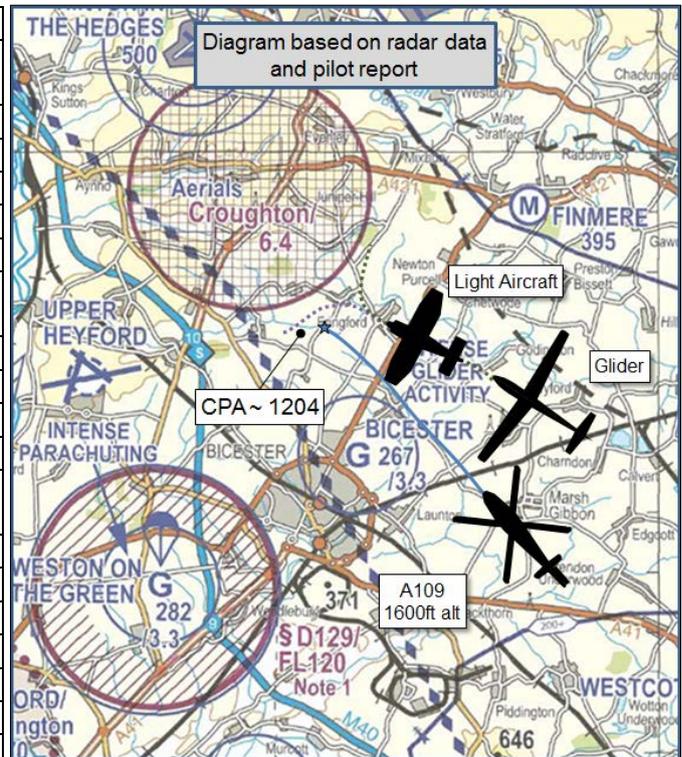
Recorded	Aircraft 1	Aircraft 2
Aircraft	A109	Light aircraft (glider tug)
Operator	Civ Comm	Unknown
Airspace	London FIR	London FIR
Class	G	G
Rules	VFR	NK
Service	Basic	
Provider	London Information	
Altitude/FL	1600ft	
Transponder	On/C, S	
Reported		
Colours	Beige, Green	Red, White
Lighting	NAV, HISL, Strobe	NK
Conditions	VMC	
Visibility	>10km	
Altitude/FL	1600ft	
Altimeter	NK (1019hPa)	
Heading	300°	
Speed	150kt	
ACAS/TAS	Unknown	
Alert	None	
Separation		
Reported	200ft V/100m H	NK
Recorded	NK

THE A109 PILOT reports that as he was remaining clear of Bicester Glider site he was monitoring a Tug/Glider depart. He chose a path between the Tug/Glider combination and Bicester, with him behind and to the Port of the combination. He observed the Tug release from the Glider, roll left and enter a rapid descent across his path. He manoeuvred his aircraft right and up to remain clear of the Tug but was also cognisant of the Glider to his right. He then continued on task and reported the Airprox to London Information.

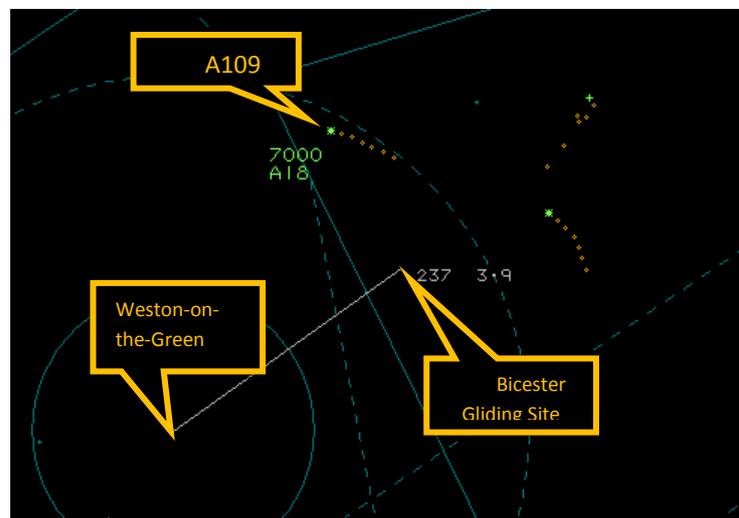
Figure 1 – 1204:55 UTC

At 1204:55 (Figure 1), the A109 pilot reported having just seen a glider released from the towing aircraft. [Note that in Figure 1 the A109 is still squawking 7000 and has yet to change to 1177 as just agreed with the London FISO]. In his later written report, the A109 pilot described having remained clear of Bicester Airfield and that he viewed a tug and glider combination depart and chose to route between them and Bicester. He went on to state that the *"...tug released from glider and rolled left and entered rapid descent across my path. I manoeuvred my aircraft right and up to remain clear of the tug but was cogniscent (sic) of the glider to my right"*.

Prior to the Airprox, the A109 was transponding the general conspicuity code 7000, and contacted London Information at 1204:15. At this time the A109 was approximately 1nm north of Bicester Airfield. The London Flight Information Service Officer instructed the A109 pilot to select SSR code 1177, which is a conspicuity code allocated to aircraft in receipt of a Basic Service from London Information, a Basic Service was then agreed. The A109 pilot reported his altitude as being 1700ft on QNH 1025.

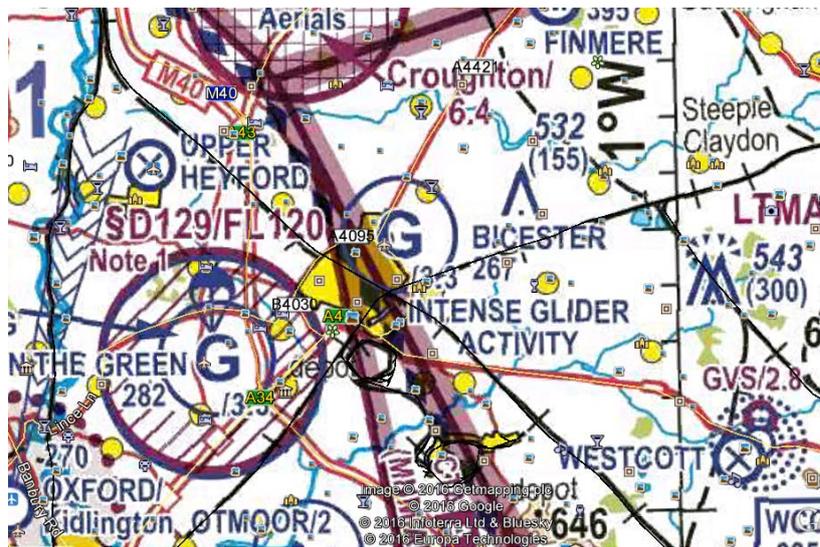
Figure 2 – Southern England and Wales 1:500,000 Aeronautical Chart

Bicester Airfield is notified in the UK AIP as being a gliding site with an upper limit of 3300ft and is marked on the Southern England 1:500:000 aeronautical chart as being an area of intense glider activity. For illustrative purposes the area around Bicester Airfield is reproduced in Figure 2.

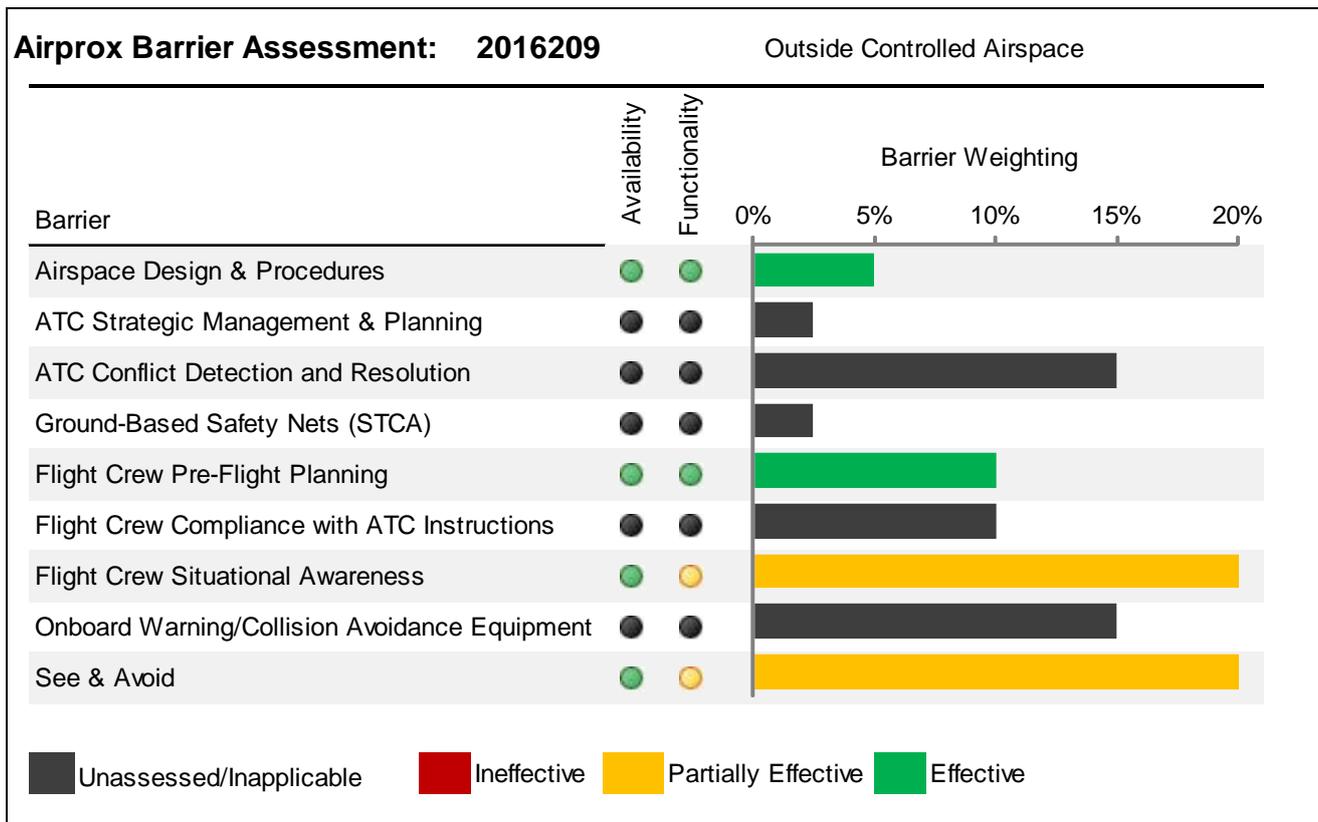
Modern safety management processes employ the concept of safety barriers that prevent contributory factors or human errors from developing into accidents. Based on work by EASA, CAA, MAA and UKAB, the following table depicts the barriers associated with preventing mid-air-collisions. The length of each bar represents the barrier's weighting or importance (out of a total of 100%) for the type of airspace in which the Airprox occurred (i.e. Controlled Airspace or Uncontrolled Airspace).⁷ The colour of each bar represents the Board's assessment of the effectiveness of the associated

barrier in this incident (either Fully Effective, Partially Effective, Ineffective, or Unassessable/Absent). The chart thus illustrates which barriers were effective and how important they were in contributing to collision avoidance in this incident.

- **Flight Crew Situational Awareness** was considered to be only **partially effective** because the A109 pilot did not appear to be aware of the potential for the tug and glider to separate, he had flown too close to the combination, and he was on the wrong side for overtaking. That the tug pilot did not sufficiently clear his flight path before turning, and was therefore not aware of the A109, was also considered contributory to the degradation of this barrier.
- **See and Avoid** was also considered to be only **partially effective** because although the A109 pilot was visual with the tug and glider at all times, he did not avoid them by a sufficient margin.
