AIRPROX REPORT No 2017029

Date: 01 Mar 2017 Time: 1308Z Position: 5144N 00140W Location: 2nm W Brize Norton airfield

PART A: SUMMARY OF INFORMATION REPORTED TO UKAB

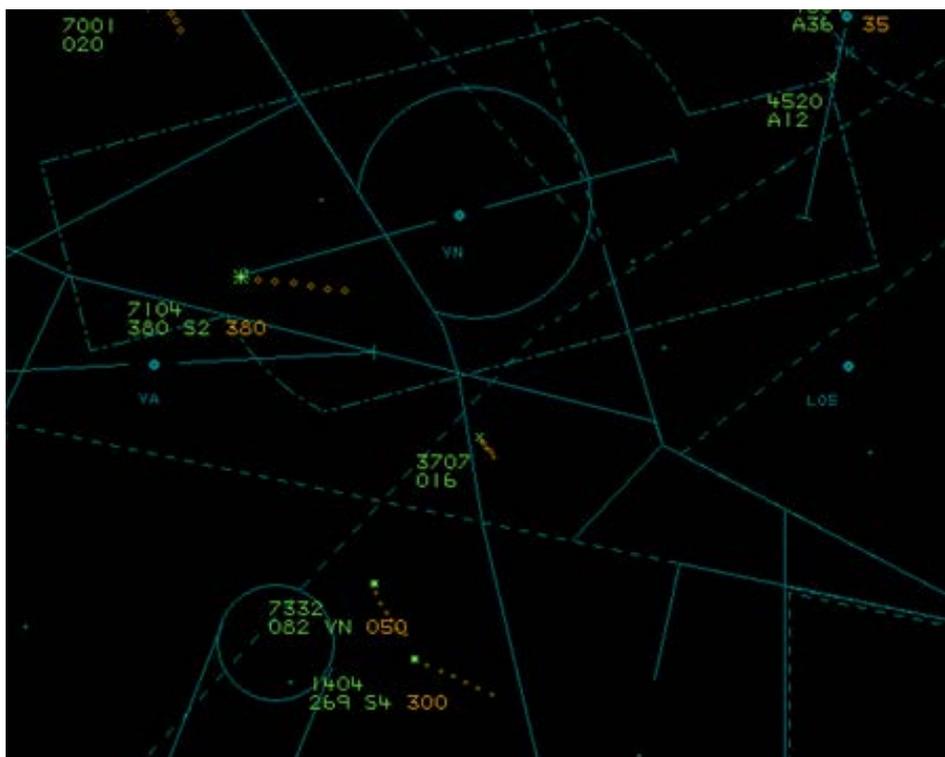
Figure 1: Geometry at 13:06:04 (A400(A) not on screen; A400(B) 7332).

At 13:06:04 (Figure 1), the Brize Director instructed the inbound A400(B) pilot to descend to 2800ft before calling the appropriate civil sector to pass departure details.

Figures 1-6 show the positions of the A400(B) and the A400(A) in the lead up to and during the Airprox. The screen shots were taken from a replay of the All Swanwick Radar feed, which is not the feed the controllers were using.

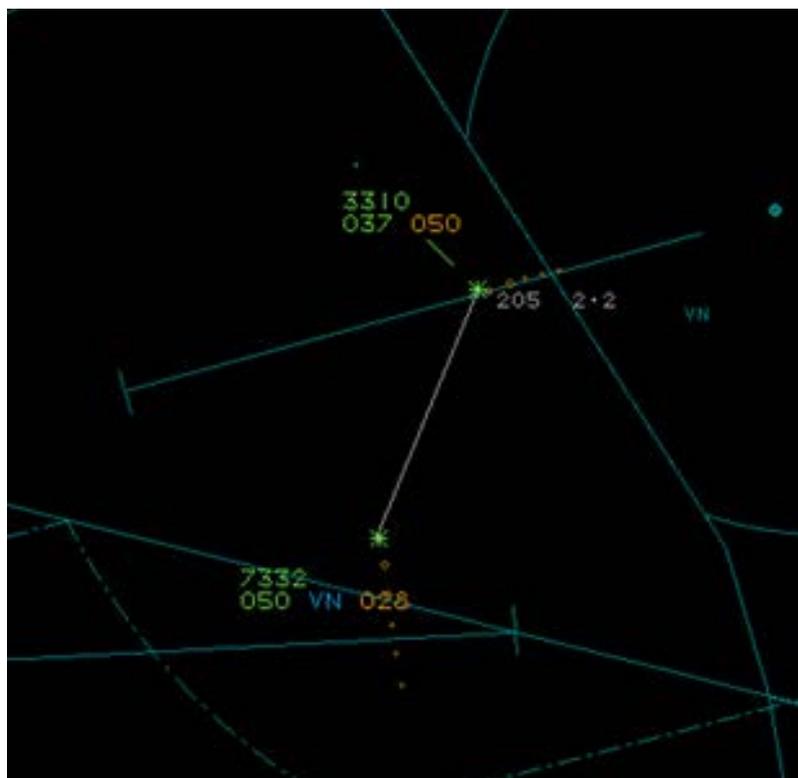
Figure 4: Geometry at 13:07:56 (A400(A) 3310; A400(B) 7332).

At 13:07:56 (Figure 4), the A400(A) pilot told the Brize Approach controller that he was following a TCAS RA. The Brize Approach controller instructed the A400(A) to stop climb at FL40. The A400(A) pilot stated that they were recovering from the TCAS RA, stopping climb FL40.

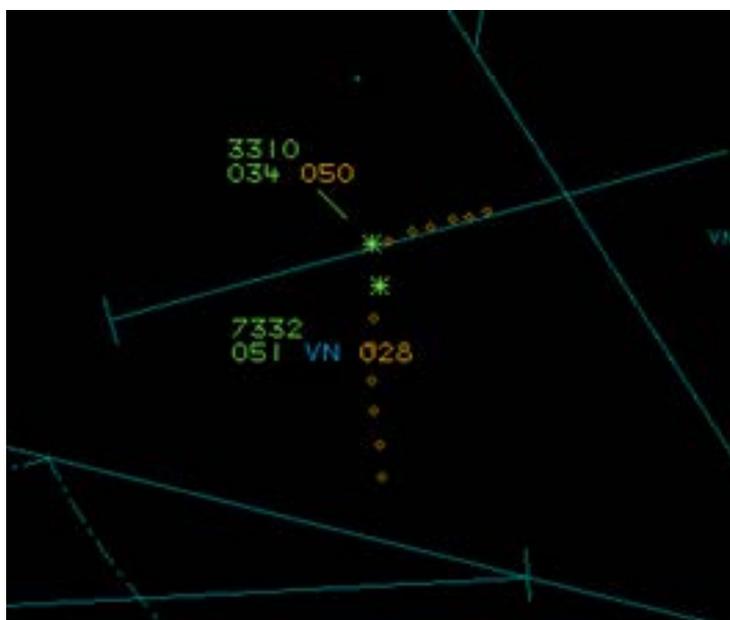
Figure 6: Geometry at 13:08:18 (A400(A) 3310; A400(B) 7332).

At 13:08:18 (Figure 6), the 2 aircraft passed at their CPA at 0.3nm horizontally and 1700ft vertically.
