AIRPROX REPORT No 2017031

Date: 21 Feb 2017 Time: 1816Z (Night) Position: 5339N 00102E Location: West corner EG D323D

PART A: SUMMARY OF INFORMATION REPORTED TO UKAB

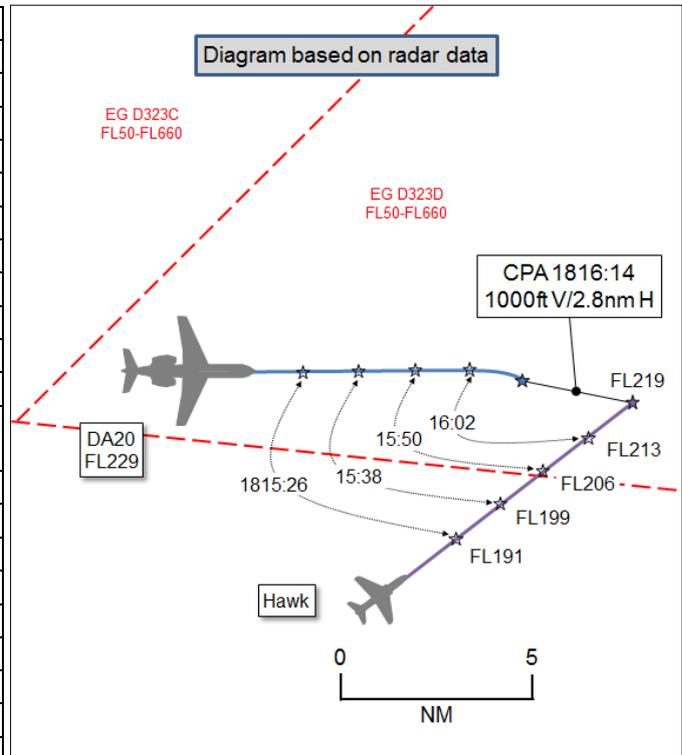
Recorded	Aircraft 1	Aircraft 2
Aircraft	DA20	Hawk
Operator	Civ Comm	HQ Air (Ops)
Airspace	London FIR	London FIR
Class	C	C
Rules	IFR	IFR
Service	Traffic	Radar Control
Provider	Hotspur (GCI)	Hotspur (GCI)
Altitude/FL	FL229	FL219
Transponder	A, C, S	A, C, S
Reported		
Colours	Blue, white	Black
Lighting	HISLs, nav	Nav, strobes, nose light
Conditions	VMC	VMC
Visibility	NK	40km
Altitude/FL	23000ft	FL230
Altimeter	RPS (990hPa)	SPS
Heading	160°	070°
Speed	250kt	NK
ACAS/TAS	TCAS II	Not fitted
Alert	TA	N/A
Separation		
Reported	0ft V/3nm H	NK
Recorded	1000ft V/2.8nm H

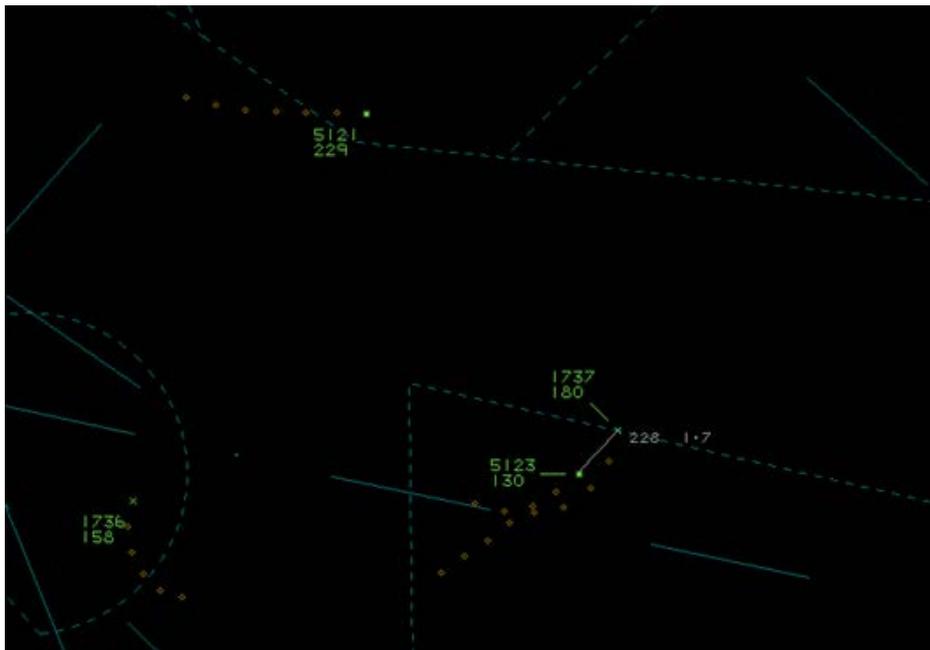
Figure 1

At 18:13:46 (Figure 1), the Hotspur controller passed Traffic Information to the Hawk pilot, squawking 5123, of traffic on the nose at FL180, crossing left to right.

The pilot had previously reported clear of said traffic and requested a climb to FL380. The Hotspur controller instructed the Hawk pilot to climb to FL280. After discussion to clarify the requested level, the pilot was instructed to climb to FL380 and reminded to remain visual with the previously called traffic.

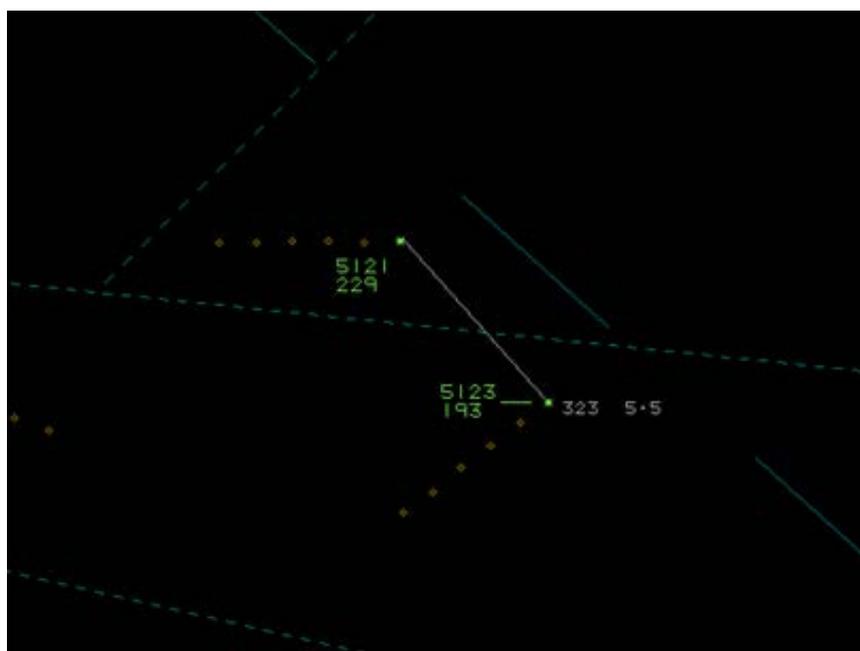
Figure 2

At 18:15:33 (Figure 2), the Hotspur controller agreed a Traffic Service with the DA20 pilot who by then was within D323D, but did not pass Traffic Information on the Hawk nor to the Hawk pilot, who was outside D323D, in Class C airspace, under a Radar Control Service.

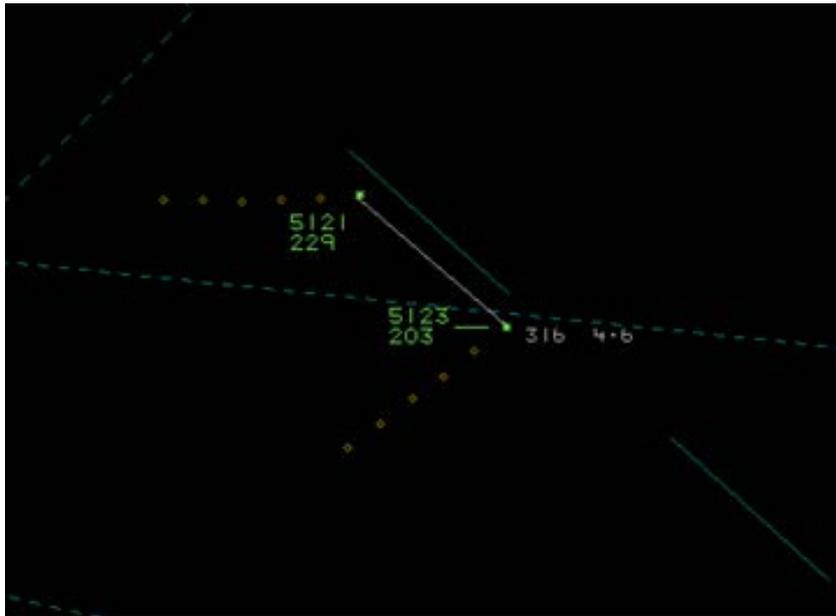
Figure 3

At 18:15:48 (Figure 3), the DA20 pilot requested to climb and possibly suggested that the Hawk was in his 12 o'clock at range 4nm. The Hotspur controller asked the DA20 pilot to say again, to

which the DA20 pilot asked what the traffic was on his nose at 3nm. The Hotspur controller stated their call sign but did not pass Traffic Information to either aircraft.

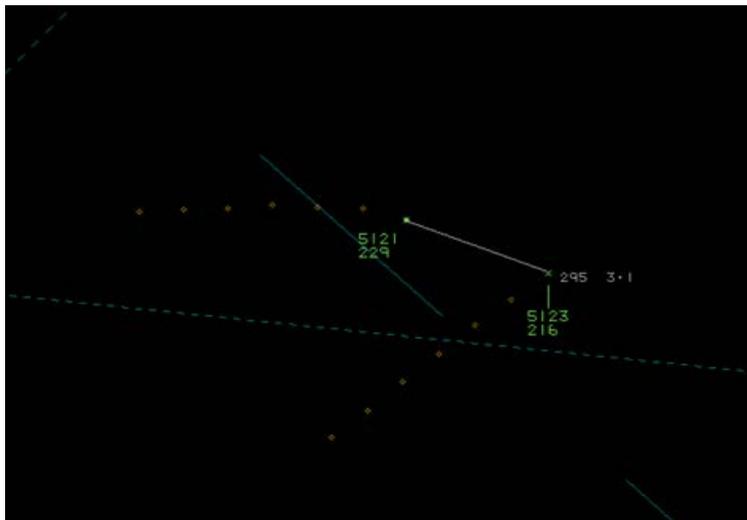
Figure 4

At 18:16:08 (Figure 4), the DA20 pilot asked the Hotspur controller to clarify what the traffic was on his nose, 3nm, climbing 23,000ft. The Hotspur controller responded that it was the Hawk.

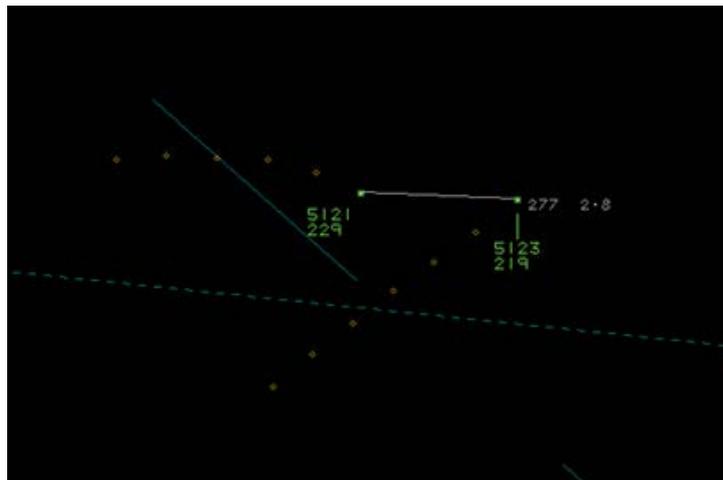
Figure 5

At 18:16:16 (Figure 5), the 2 aircraft were at their CPA of 2.8nm. The DA20 pilot asked the Hotspur controller if the Hawk pilot was aware of the DA20 traffic. The Hawk pilot, who was on the same frequency, responded that he had the DA20 '5'. A short conversation between the Hawk and DA20 pilots followed in order to clarify each other's intentions.
