AIRPROX REPORT No 2017043

Date: 24 Mar 2017 Time: 1738Z Position: 5248N 00115E Location: 7.5nm N Norwich airport

PART A: SUMMARY OF INFORMATION REPORTED TO UKAB

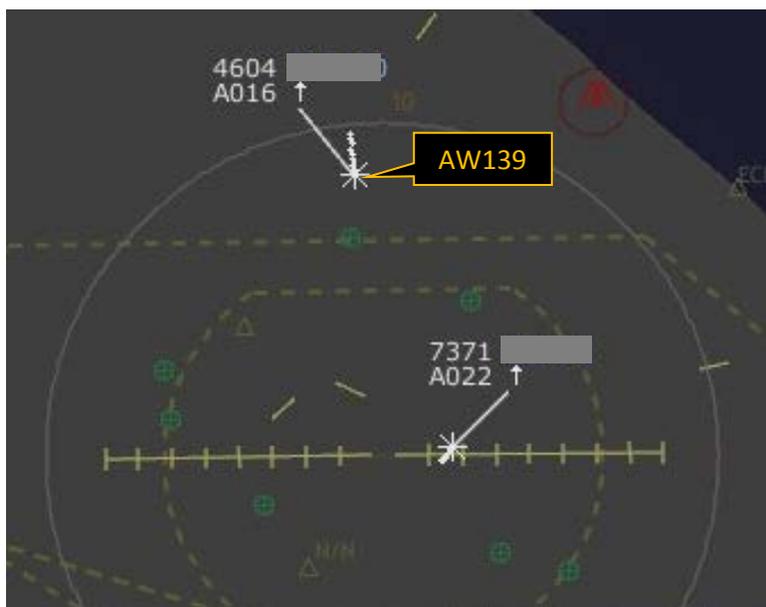
Figure 2 – Norwich Radar (callsigns removed) – 1737:58.

At 1737:58 the AW139 pilot reported descending to avoid a light aircraft (Figure 2).

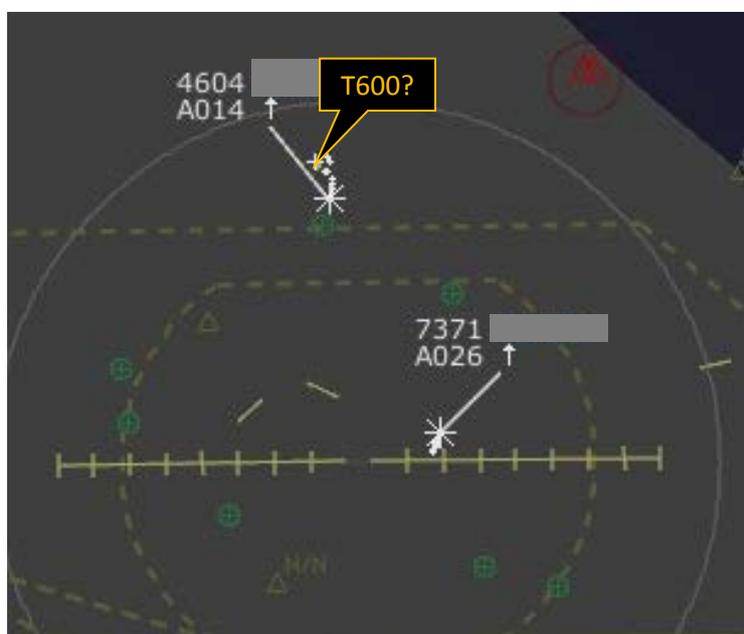
Figure 3 – Norwich Radar – 1738:29.

CPA could not be determined as no contact identifiable as the T600 was visible on either the area or the Norwich radar replay. A primary contact was observed on the Norwich radar replay subsequent to the report by the AW139 crew of their having turned for avoidance (Figure 3).

Although the Norwich controller was aware of the presence of the T600 as its pilot had called them earlier, the controller had not identified it on radar, and radar contact was subsequently lost whilst it was still 4-5nm to the west of the Airprox.
