AIRPROX REPORT No 2017053

Date: 06 Apr 2017 Time: 1419Z Position: 5355N 00022W Location: Beverley Airfield

PART A: SUMMARY OF INFORMATION REPORTED TO UKAB

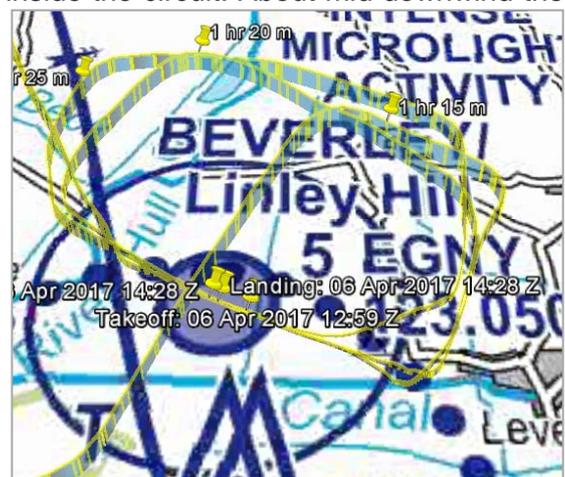
Figure 1: C150 SkyDemon track

THE C150 PILOT reports that the student was the pilot flying; the reporter was the commander/examiner assessing the student for circuit competence at the time of the incident. The student had already performed two touch-and-go landings and was on the downwind leg preparing for another approach. He was 1000ft at circuit height and inside the circuit. About mid downwind the aircraft hit "turbulence" which was completely unexpected in the smooth flying conditions of the test. The starboard wing dropped rapidly to 30 degrees from the horizontal and the airframe shuddered. The commander took control and restored the aircraft to level flight. They looked at each other and said "what was that?" immediately the Typhoon was visible having completed his turn away. The commander notified the AGCS of military traffic in the circuit in the proximity of flight. The time was recorded at 1420 UTC by the ground station. The commander considers that if the pilot flying had been an inexperienced solo student with the upset recovery action required the incident could have been beyond the flight envelope of that low hours individual.

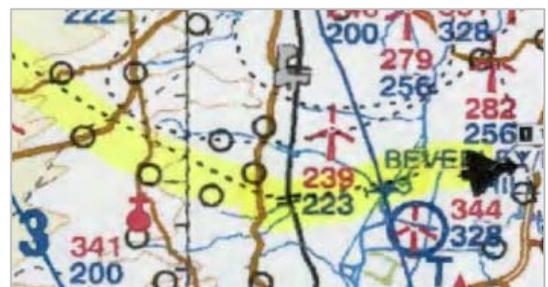
Figure 1: Unit Investigation Snapshot

A unit investigation was carried out by the Typhoon operating authority. Figure 1 is a snapshot from planning data which highlights the Typhoon's track and shows that the closest it planned to come to the airfield boundary was not less than 1nm. HUD data shows the Typhoon at 700ft AGL when the Cessna comes into view, high in the left 10.30. Immediately after the Cessna appears in the HUD field of view, the Typhoon is manoeuvred through a left-hand turn.
