AIRPROX REPORT No 2017081

Date: 07 Apr 2017 Time: 1149Z Position: 5113N 00226W Location: W Frome

PART A: SUMMARY OF INFORMATION REPORTED TO UKAB

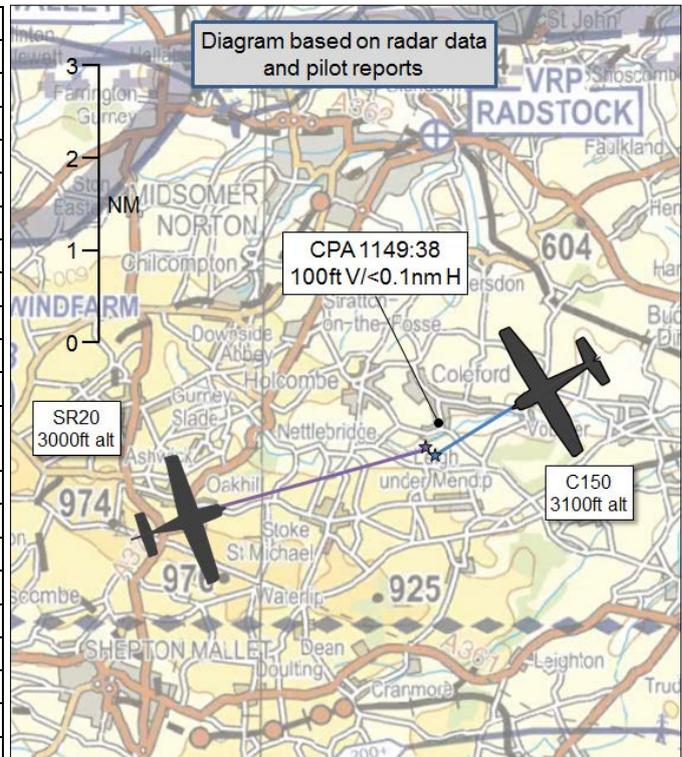
Recorded	Aircraft 1	Aircraft 2
Aircraft	C150	Cirrus SR20
Operator	Civ Pte	Civ Pte
Airspace	London FIR	London FIR
Class	G	G
Rules	VFR	VFR
Service	Basic	None
Provider	Yeovilton	
Altitude/FL	FL027	FL026
Transponder	A, C, S	A, C, S
Reported		
Colours	Red, White	White
Lighting	Nav	Strobe, Landing, Wing-tip, Nav
Conditions	VMC	VMC
Visibility	>10km	'Good'
Altitude/FL	3500ft	~3000ft
Altimeter	QNH (1026hPa)	NK
Heading	248°	NK
Speed	70kt	135kt
ACAS/TAS	Unknown	Not fitted
Alert	Unknown	N/A
Separation		
Reported	2-300ft V	1-300ft V/150-300m H
Recorded	100ft V/0.1nm H

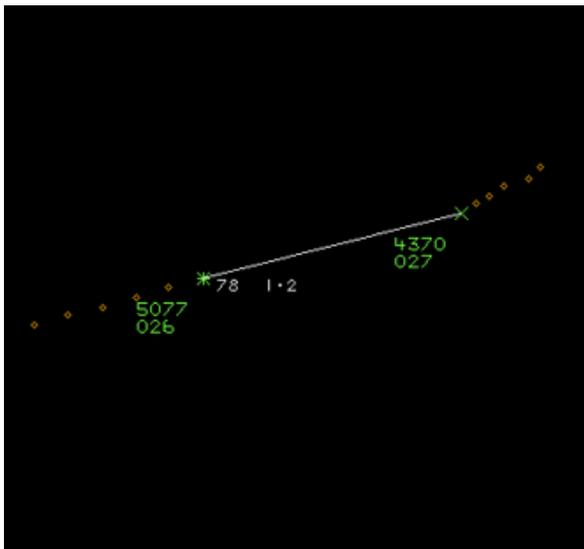
Figure 1 1149:19 (C150 Squawking 4370, SR20 5077)

Due to an initial reporting of the wrong time of Airprox, Yeovilton ATC initially believed that they were not providing a service to the C150 pilot. However, it was subsequently discovered that the Airprox took place earlier in the day. Although a report from the Yeovilton controller was not available, the RT transcript revealed that the C150 had indeed been receiving a Basic Service from Yeovilton, but had not mentioned the incident on the RT. NATS radar screen shots show the relative position of the C150 and the SR20 at 1149:19 (Figure 1). This was not the same radar as the one seen by the Yeovilton controller, although screenshots from the Yeovilton radar indicate that both aircraft were showing on their radar. CPA is at 1149:39, Figure 2; the SR20 is indicating FL028 and the C150 FL027 and the lateral distance is 0.1nm.

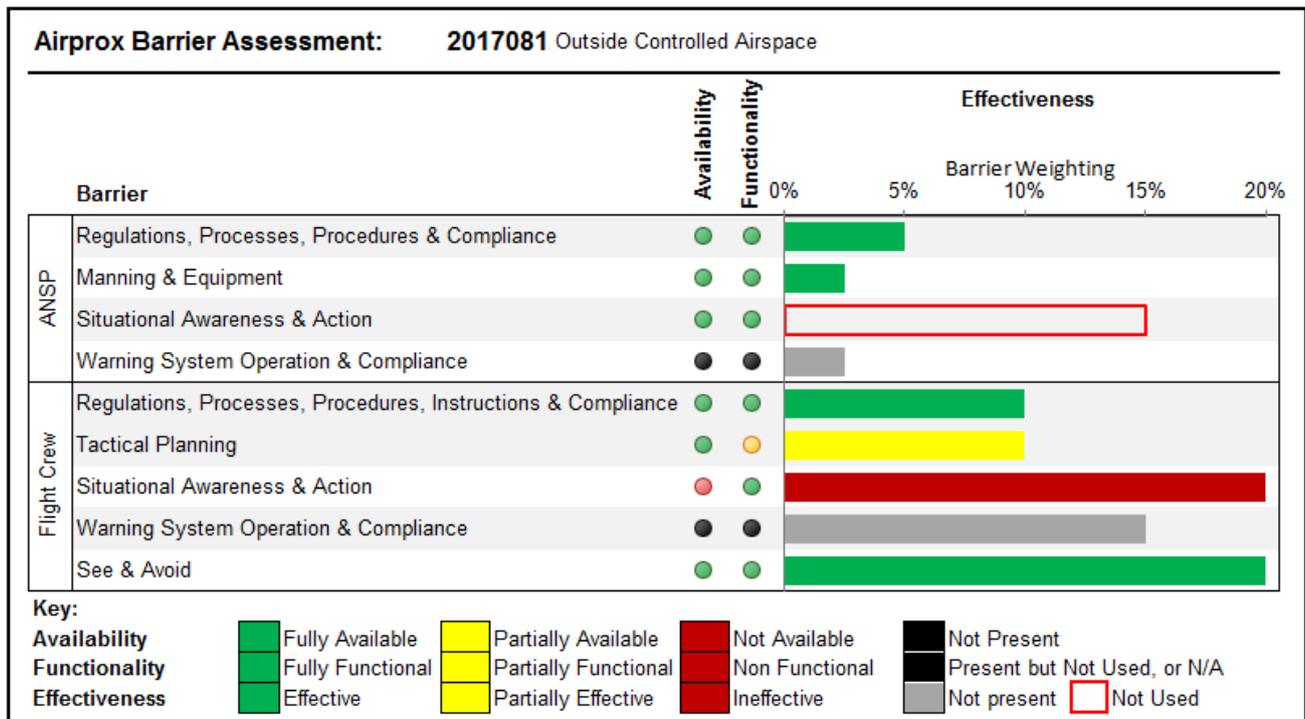
Situational Awareness & Action was assessed as **not used** because neither pilot had asked for a Traffic Service that could have provided Traffic Information.

Tactical Planning was assessed as **partially effective** because neither pilot had planned to receive a radar service.

Situational Awareness & Action was assessed as **ineffective**, neither pilot had situational awareness of the other, either from ATC or from a CWS.

Warning System Operation and Compliance was assessed as **not present**.

See and Avoid was assessed as **fully effective**, both pilots saw the other and took appropriate action.
