AIRPROX REPORT No 2017182

Date: 31 Jul 2017 Time: 1639Z Position: 5245N 00445W Location: 3nm south Aberdaron

PART A: SUMMARY OF INFORMATION REPORTED TO UKAB

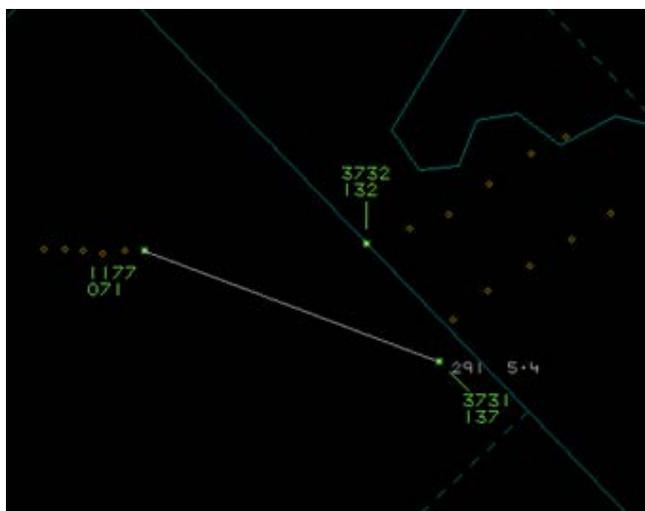
Figure 5: Geometry at 16:37:52

At 16:37:52 (Figure 5), the Valley Approach Controller passed Traffic Information (TI) to the pair of Hawks as "west, 2nm, eastbound, slow moving, indicating 7000ft". Hawk 1 was 5.4nm and Hawk 2 was 3.8nm from the PA28.

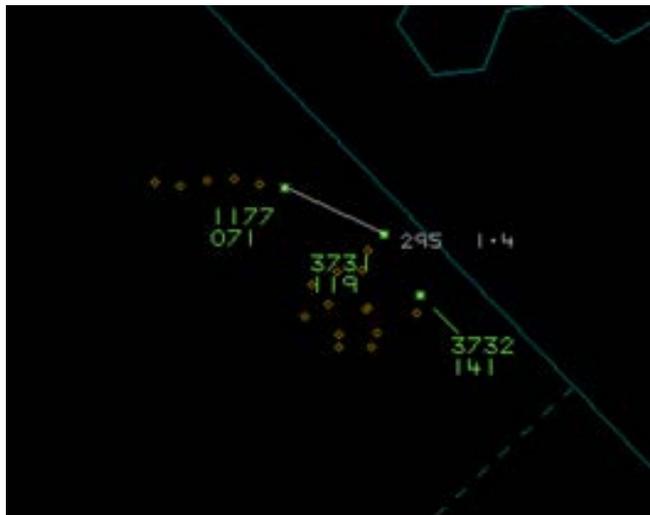
Figure 7: Geometry at 16:38:56
(PA28 1177; Hawks 3731/2)

At 16:38:56 (Figure 7), the Hawks were both still operating above 11,000ft, with the PA28 maintaining course and altitude.

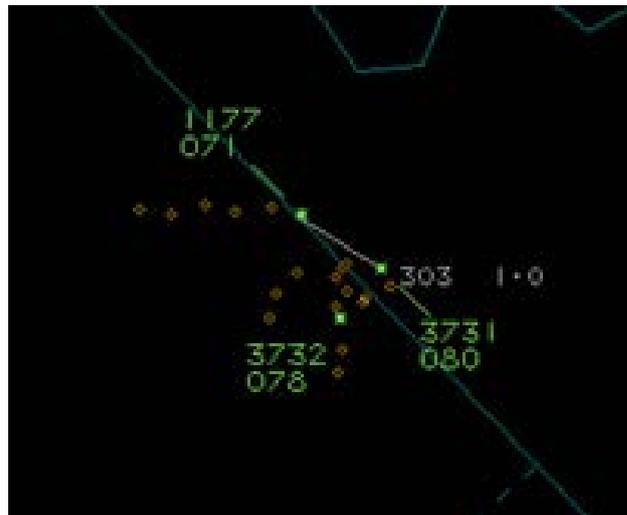
Figure 8: Geometry at 16:39:23

At 16:39:23 (Figure 8), after their mode C readout had dropped out for several seconds, the Hawks reappeared having made a rapid descent.

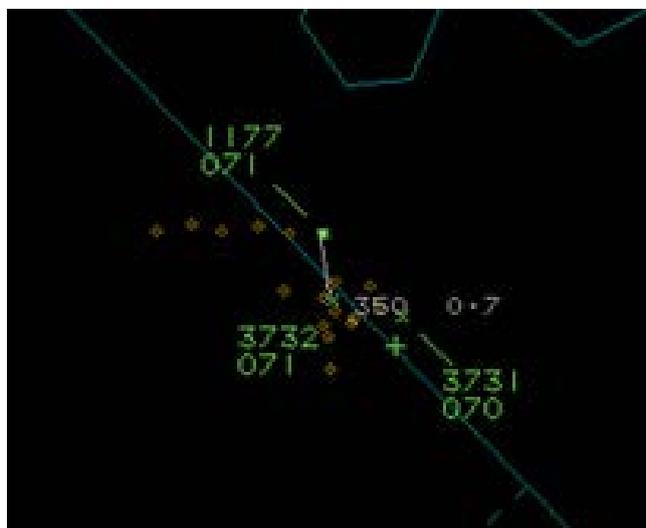
Figure 9: Geometry at 16:39:33
(PA28 1177; Hawks 3731/2)

At 16:39:33 (Figure 9), the Hawks and PA28 were co-altitude with 0.7nm lateral separation.

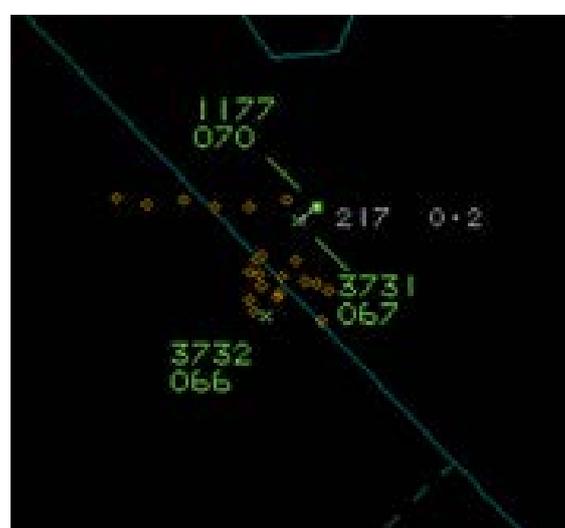
Figure 10: Geometry at 16:39:47

At 16:39:47 (Figure 10), the PA28 and Hawks were at their closest proximity, approximately 0.2nm lateral separation and 300ft vertical separation.
