AIRPROX REPORT No 2017183

Date: 02 Aug 2017 Time: 1041Z Position: 5404N 00051W Location: Malton, North Yorkshire

PART A: SUMMARY OF INFORMATION REPORTED TO UKAB

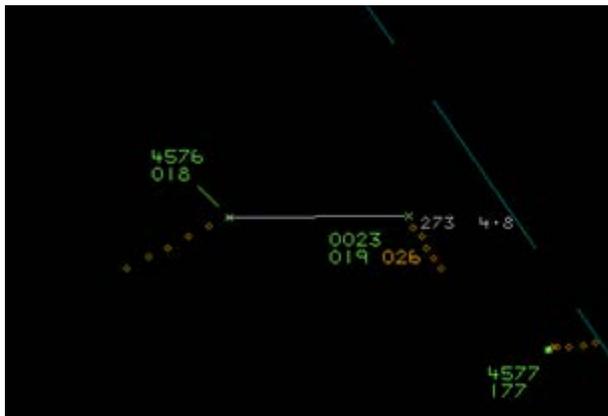
Figure 3: Geometry at 1041:12

Figures 3-6 show the S92 and Tucano as they closed, with neither receiving Traffic Information (TI) on the other. Figure 6 shows the closest point of approach, with 200ft vertical and 1.5nm lateral separation.
