AIRPROX REPORT No 2017256

Date: 29 Oct 2017 Time: 1434Z Position: 5216N 00007W Location: 1nm north Papworth Everard

PART A: SUMMARY OF INFORMATION REPORTED TO UKAB

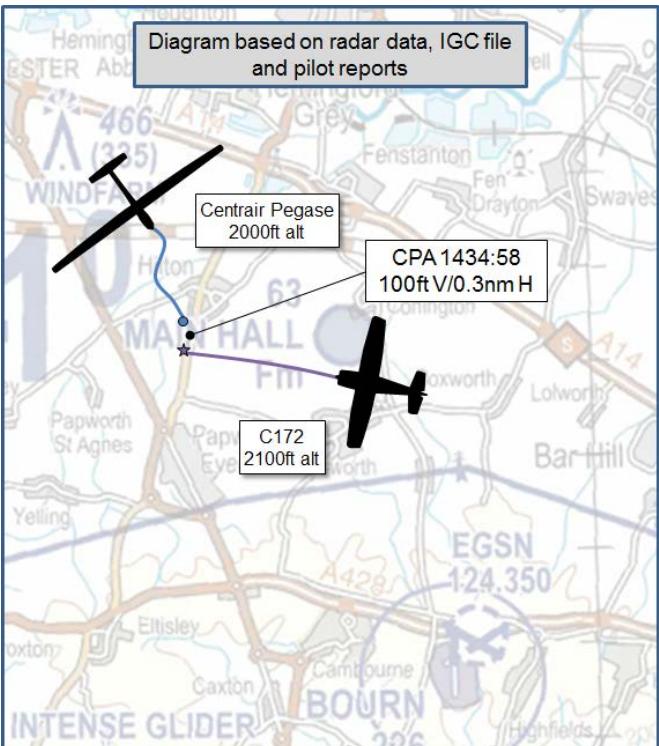
Recorded	Aircraft 1	Aircraft 2
Aircraft	Centrair Pegase	C172
Operator	Civ Club	Civ Trg
Airspace	London FIR	London FIR
Class	G	G
Rules	VFR	VFR
Service	Listening Out	Basic
Provider	Gransden Lodge	Cambridge
Altitude/FL	2000ft	2100ft
Transponder	Not Fitted	A, C
Reported		
Colours	White	White, Navy
Lighting	None	Landing, Strobe, Nav
Conditions	VMC	Choose an item.
Visibility	>10km	10km
Altitude/FL	1900ft	2500ft
Altimeter	QNH	QNH
Heading	175°	300°
Speed	60kt	110kt
ACAS/TAS	FLARM	Not fitted
Alert	None	N/A
Separation		
Reported	50ft V/80m H	500-1000ft V/200m H
Recorded	100ft V/0.3nm H

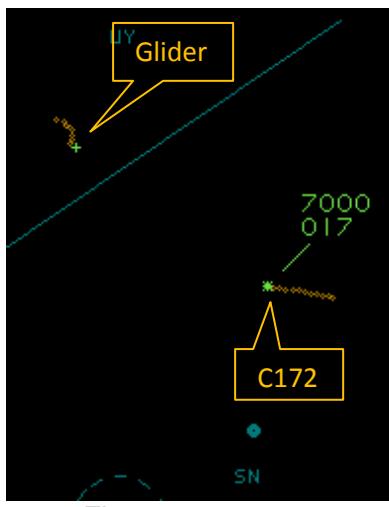
Figure 1 – 1433:10

At 1433:10, the glider and the C172 were first observed on the area radar replay. The identity of the C172 was established from the radar replay but the glider was a primary radar only contact whose identity could not be established. However, the primary track displayed was consistent with the report received from the glider pilot (Figure 1).

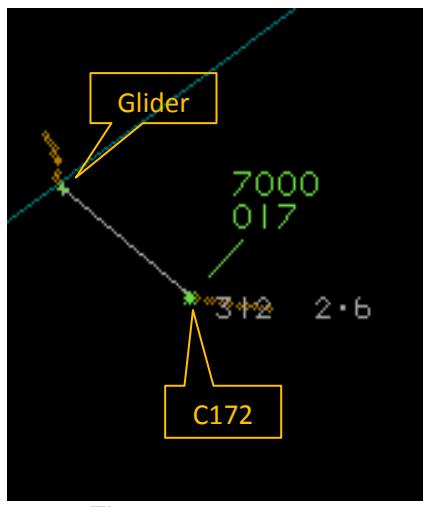
Figure 2 - 1434:00

At 1434:00, the aircraft were displayed as being 2.6nm apart with the C172 displaying FL017 (altitude 2030ft) and the glider reported at altitude 1900ft (Figure 2).

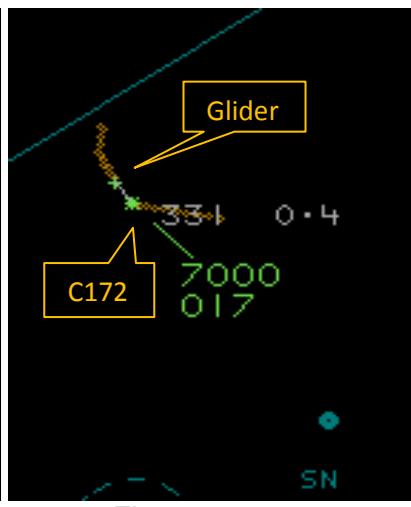
Figure 3 - 1434:51

CPA could only be measured at 1434:51 due to the glider primary radar contact fading from radar cover [UKAB note: using a different radar replay the CPA was determined as 0.3nm laterally at 1434:58]. The vertical distance as reported by the glider pilot was thought to be around 50ft (Figure 3).

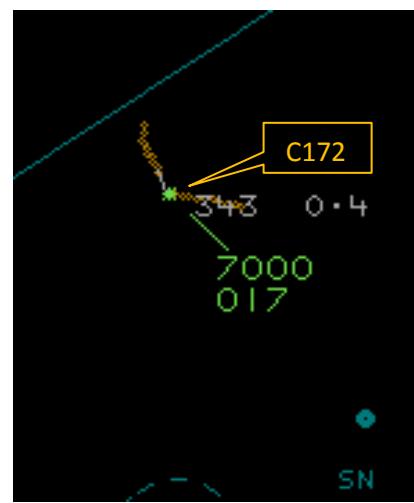
Figure 4 - 1435:56

At 1435:56, the primary contact associated with the glider faded from radar cover. Of note is that the report from the pilot of the C172 states that the aircraft was at altitude 2500ft at the time of the reported sighting of the glider. The altitude as calculated from the radar replay Flight Level was 2030ft. The glider pilot reported as being at altitude 1900 feet, which was calculated as 2000ft from the IGC logger file. This would suggest that the vertical distance between the two aircraft may have been around 130ft (Figure 4).

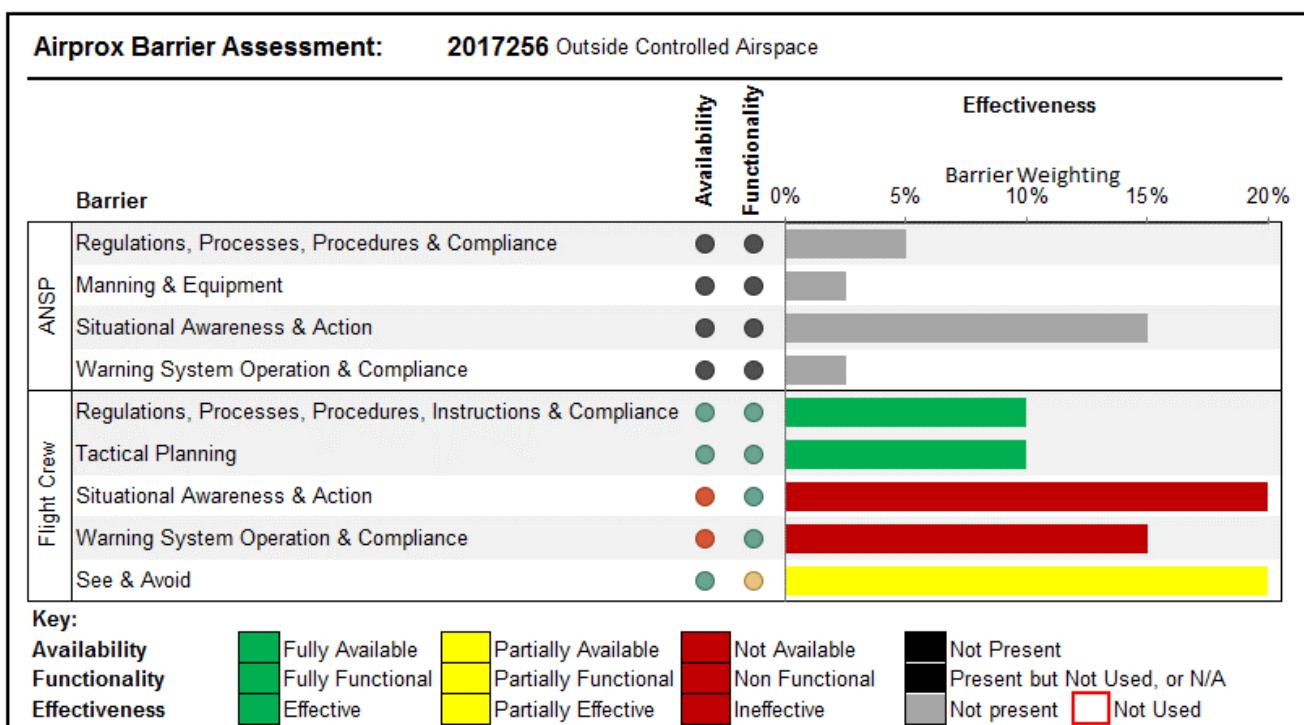
In assessing the effectiveness of the safety barriers associated with this incident, the Board concluded that the key factors had been that:

Flight Crew:

Situational Awareness and Action were assessed as **ineffective** because neither pilot had situational awareness about the other aircraft.

Warning System Operation and Compliance were assessed as **ineffective** because the C172 was not fitted with an electronic warning system. The Centrair Pegase had FLARM fitted, but the system is not designed to detect the C172's transponder.

See and Avoid were assessed as **partially effective** because the Centrair Pegase pilot saw the C172 late and the C172 probably did not see the Centrair Pegase.
