AIRPROX REPORT No 2017012

Date: 19 Jan 2017 Time: 1610Z Position: 5138N 00048W Location: Wycombe Air Park

PART A: SUMMARY OF INFORMATION REPORTED TO UKAB

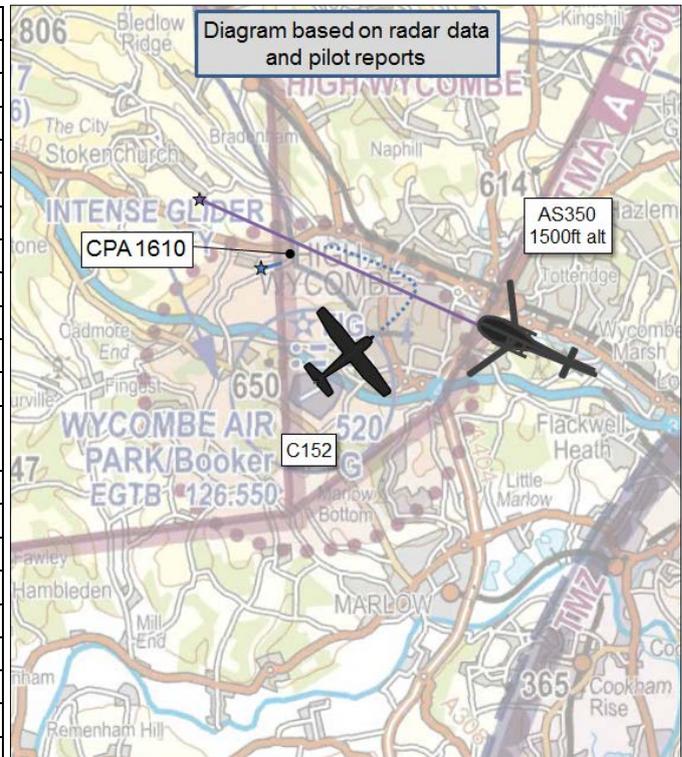
THE C152 PILOT reports that he was in the visual circuit at Wycombe; he had just taken-off from RW06 following a touch and go. He was following the noise abatement procedure precisely and was in a level turn left at 1000ft to turn from crosswind to downwind. Lookout was undertaken before turning, but nothing was seen. However, as he was rolling wings level, Wycombe tower informed him there was a helicopter, not in contact with them, crossing left to right (south to north). The instructor took control to roll the wings level and the helicopter crossed 200ft in front at the same level, it was moving fast enough for the instructor to assess that avoiding action was not necessary at this time. The helicopter continued northbound.

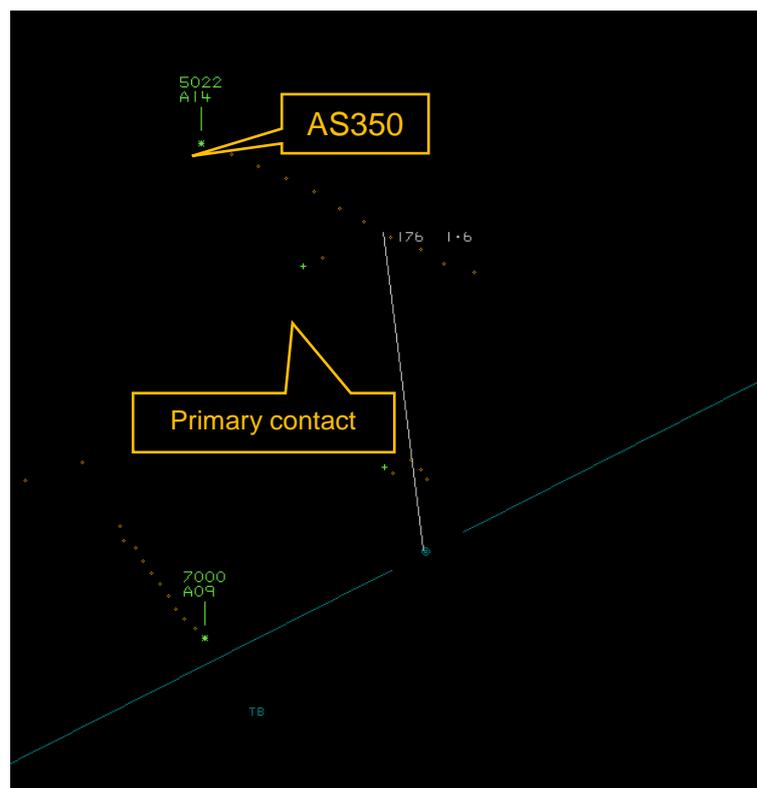
Figure 1 - 1610:57

At 1610:57 a primary contact was observed for 12 seconds tracking in a manner consistent with the report from the C152 pilot. The tracks of both aircraft can be seen to have crossed at a period of time before the primary contact became visible (Figure 1).

Following a review of the Swanwick MRT it was not possible to positively identify either the C152 or the second aircraft involved in the Airprox, nor the point of CPA. However an aircraft subsequently identified as an AS350 was seen to transit the Wycombe ATZ at this time, (Wycombe ATZ has a notified radius of 2nm, extending from surface to 2000ft), the aircraft was maintaining a north-westerly track and indicating an altitude of 1400ft. The callsign associated with this helicopter did not contact Wycombe ATC and had been transponding code 7000 until 1610:09.

The Wycombe Tower controller had passed traffic information to the C152 at 1610:28, advising that a helicopter appeared to be passing ahead (of the C152), and that it wasn't speaking to them. The pilot of the C152 reported having been visual with the helicopter, and that it had crossed approximately 150ft ahead of them. The C152 reported being at 1000ft on the Wycombe QFE in their written report (approximately 1520ft altitude), the helicopter observed on radar was indicating between 1400ft and 1500ft altitude.

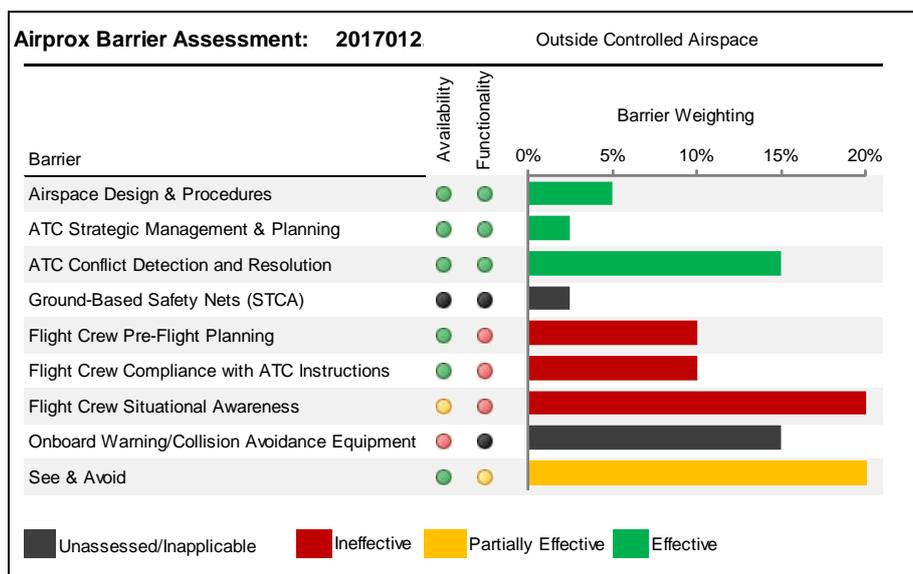
- **Flight Crew Pre-Flight Planning** was **ineffective** because the AS350 had flown through the ATZ without calling Wycombe ATC.
- **Flight Crew Compliance with ATC instructions** was **ineffective** because the AS350 had not complied with ATC procedures.
- **Flight Crew Situational Awareness** was **ineffective** because neither pilot was aware of each other in time to affect the outcome.
- **Onboard Warning/ Collision Avoidance Equipment** was **inapplicable** because the C152's transponder was not visible to the AS350's TCAS.

³ Modern safety management processes employ the concept of safety barriers that prevent contributory factors or human errors from developing into accidents. Based on work by EASA, CAA, MAA and UKAB, the table depicts the barriers associated with preventing mid-air-collisions. The length of each bar represents the barrier's weighting or importance (out of a total of 100%) for the type of airspace in which the Airprox occurred (i.e. Controlled Airspace or Uncontrolled Airspace). The colour of each bar represents the Board's assessment of the effectiveness of the associated barrier in this incident (either Fully Effective, Partially Effective, Ineffective, or Unassessable/Inapplicable). The chart thus illustrates which barriers were effective and how important they were in contributing to collision avoidance in this incident. The UK Airprox Board scheme for assessing the Availability, Functionality and Effectiveness of safety barriers can be found on the [UKAB Website](#).

Safety Barrier Assessment³:

The Board decided that the following key safety barriers were contributory in this Airprox:
