AIRPROX REPORT No 2017015

Date: 07 Feb 2017 Time: 1114Z Position: 5319N 00355W Location: West of Llandudno

PART A: SUMMARY OF INFORMATION REPORTED TO UKAB

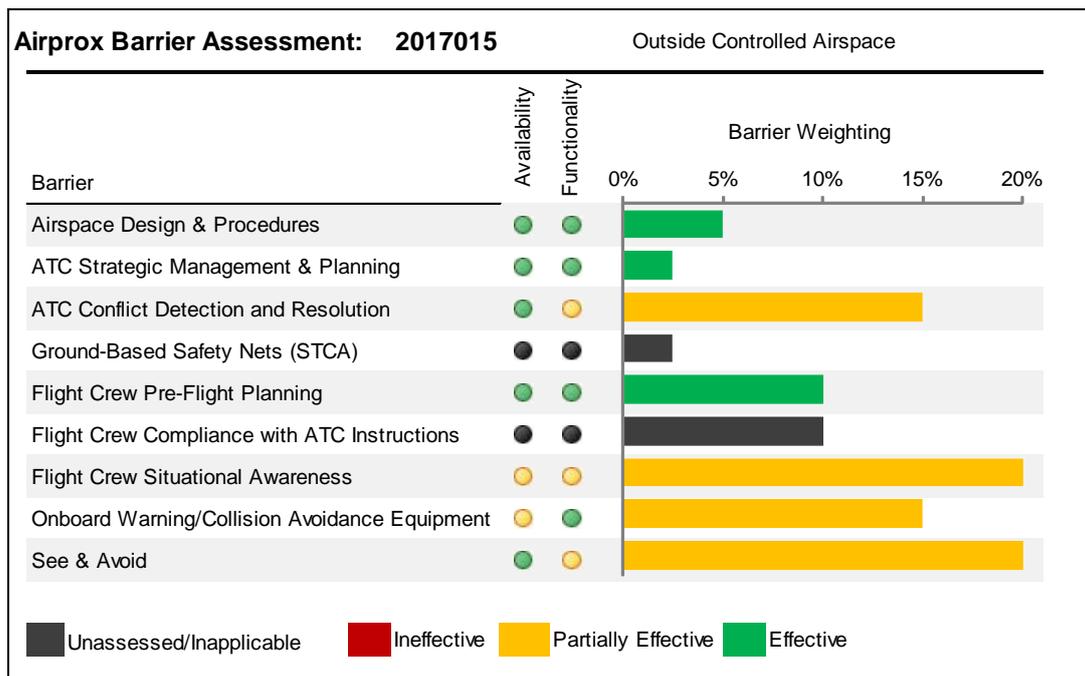
The Board decided that the following key safety barriers were contributory in this Airprox:

ATC Conflict Detection and Resolution was considered to be **partially effective** because although the S92 was under a Basic Service, ATC had detected a potential conflict but did not pass on that information because they assumed that the Hawk would turn. Given that they did not know the Hawk pilot's intentions, and with the aircraft at the same altitude, it would have been pertinent for ATC to have passed Traffic Information to the S92 pilot.

Flight Crew Situational Awareness was also considered to be **partially effective** because the Hawk was not in communication with Valley ATC and neither aircraft was specifically aware of the other until just before CPA.

Onboard Warning/Collision Avoidance Equipment was also considered to be **partially effective** because the Hawk was not fitted with any collision warning equipment. Notwithstanding, the barrier did provide functionality because the S92 had TCAS II, and the Hawk was transponding, which alerted the S92 pilot to the presence of the Hawk.

See and Avoid was considered to be only **partially effective** because the Hawk pilot did not see the S92.
