AIRPROX REPORT No 2017024

Date: 24 Feb 2017 Time: 1021Z Position: 5118N 00001W Location: 2nm WSW Biggin Hill

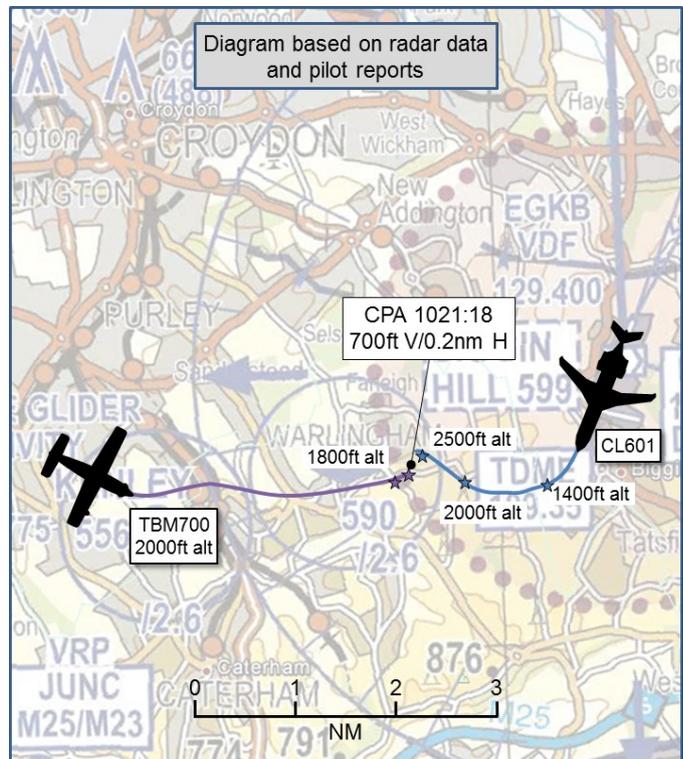
Recorded	Aircraft 1	Aircraft 2
Aircraft	CL601	TBM700
Operator	Civ Exec	Civ Pte
Airspace	London FIR	London FIR
Class	G	G
Rules	IFR	VFR
Service	Aerodrome	Aerodrome
Provider	Biggin Hill	Biggin Hill
Altitude/FL	↑2500ft	1800ft
Transponder	On/C, S	On/C, S
Reported		
Colours	White, Blue	White, Black, Grey
Lighting	Nav, Strobe, Taxi, Beacon	Strobe, Nav
Conditions	VMC	VMC
Visibility	10km	10km
Altitude/FL	1900ft	2000ft
Altimeter	QNH (1016hPa)	NK
Heading	250°	Not reported
Speed	160kt	165kt
ACAS/TAS	TCAS II	TCAS I
Alert	RA	TA
Separation		
Reported	0ft V/500m H	NK
Recorded	700ft V/0.2nm H

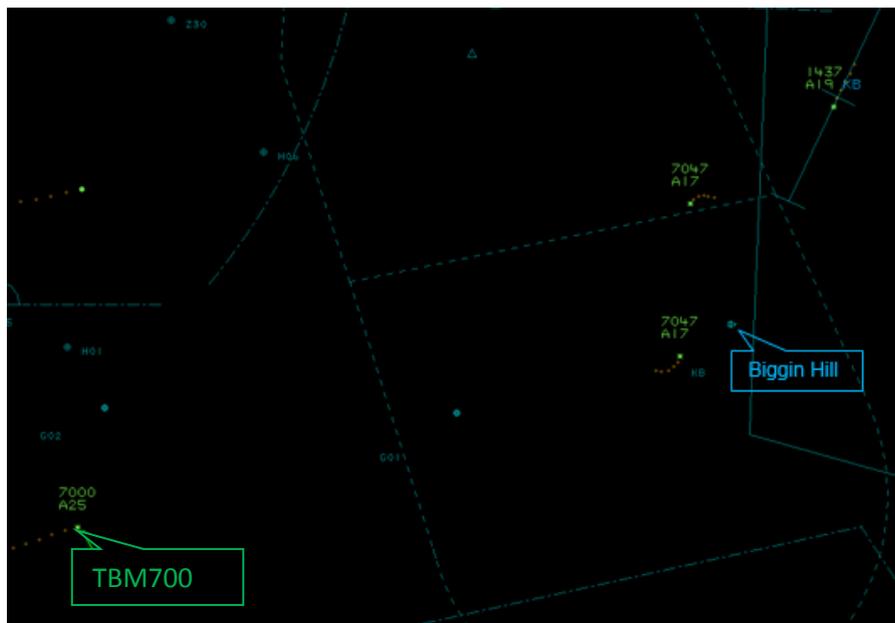
Figure 1 – 1016:02

At 1016:02 (Figure 1) the TBM700 called Biggin Hill Tower and Approach (the two ATC services were combined). The TBM700 was approximately 12nm west of Biggin Hill. The controller asked the TBM700 to standby for joining clearance and then continued with other tasks, including the issue of a conditional line-up clearance to the CL601.

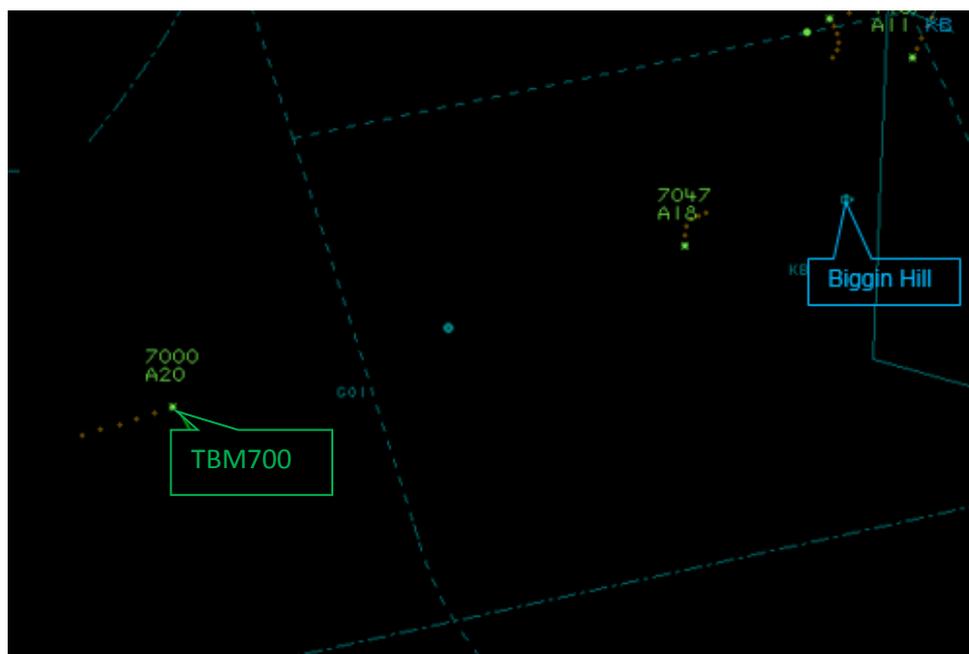
Figure 2 - 1017:08

At 1017:08 (Figure 2) the controller returned to the TBM700 who reported at 7nm and 2000ft to request joining instructions.

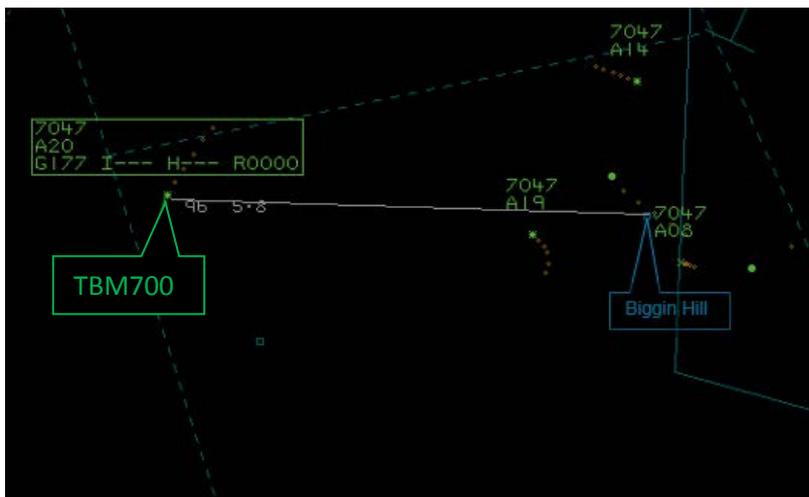
Figure 3 – 1019:42

At 1019:42 (Figure 3) the controller instructed the TBM700 to join downwind right-hand for runway 21, and to report downwind. The TBM700 was in a left hand orbit 5.8nm west of Biggin Hill at this time. Information was issued concerning the traffic ahead, and that the TBM700 was number 3 in the traffic sequence.

The TBM700 request for joining clearance at 7nm was timely and consistent with the range most inbound VFR aircraft request such a clearance. At interview the controllers did observe that they were surprised by the speed of the TBM700, which the radar recordings endorse. In Figure 3 and Figure 6, the ground speed of the TBM700 can be seen to be 177kts and 185kts respectively, somewhat higher than the speed most light aircraft join the circuit at.

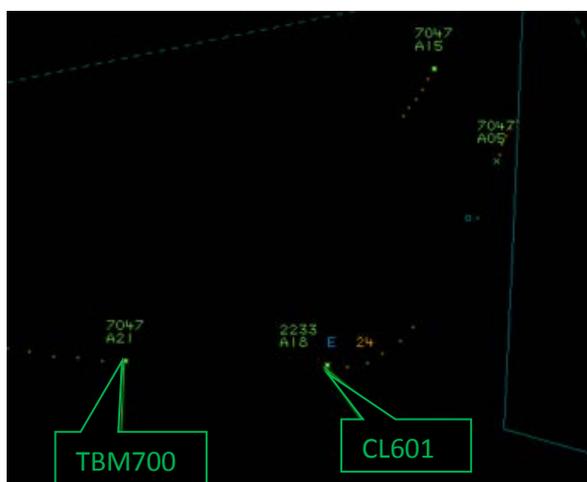
Figure 4 - 1020:55

At 1020:55 (Figure 4) the CL601 was airborne and passing an indicated 1800ft having made a right turn after departure as required by local procedures.

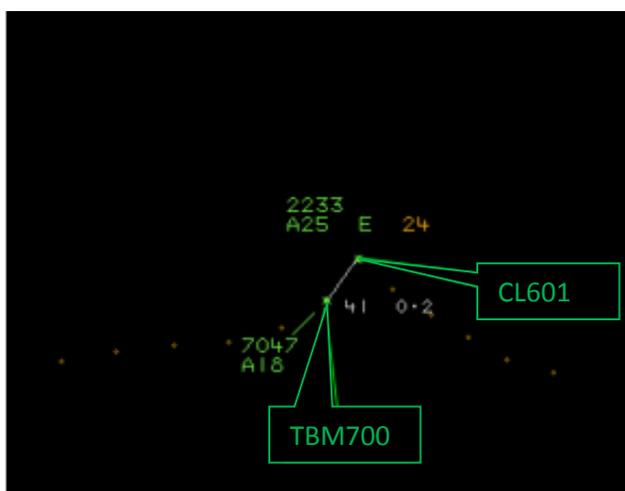
Figure 5 1021:12

CPA occurred between 1021:12 (Figure 5) and 1021:18 (Figure 6) with the minimum distance indicating 0.2nm and 700ft in both screenshots.

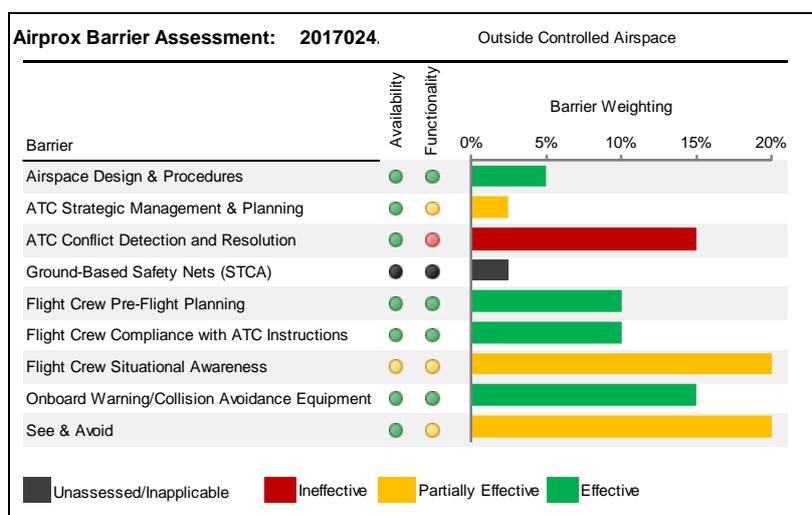
The Board decided that the following key safety barriers were contributory in this Airprox:

ATC Strategic Management and Planning was considered to be **partially effective** because the traffic situation was busy and this should have prompted the Approach and Tower positions being spilt rather than them being banded, which resulted in only one control position that unnecessarily increased controller workload.

ATC Conflict Detection and Resolution was considered to be **ineffective** because the Biggin Hill controllers did not pass Traffic Information to either aircraft on the other, or provide adequate separation between the departing IFR aircraft and the inbound VFR aircraft.

Flight Crew Situational Awareness was also considered to be **partially effective** because neither pilot was passed Traffic Information by the Biggin Hill controllers, therefore neither aircraft was specifically aware of the other (although the TBM700 pilot was generically aware that the CL601 was departing Biggin).

See and Avoid was considered to be **partially effective** because the CL601 pilot only saw the TBM700 as he received a TCAS RA, and the TBM700 pilot did not see the CL601 until after CPA.
