AIRPROX REPORT No 2017030

Date: 01 Mar 2017 Time: 1505Z Position: 5319N 00042W Location: 5 nm W Scampton

PART A: SUMMARY OF INFORMATION REPORTED TO UKAB

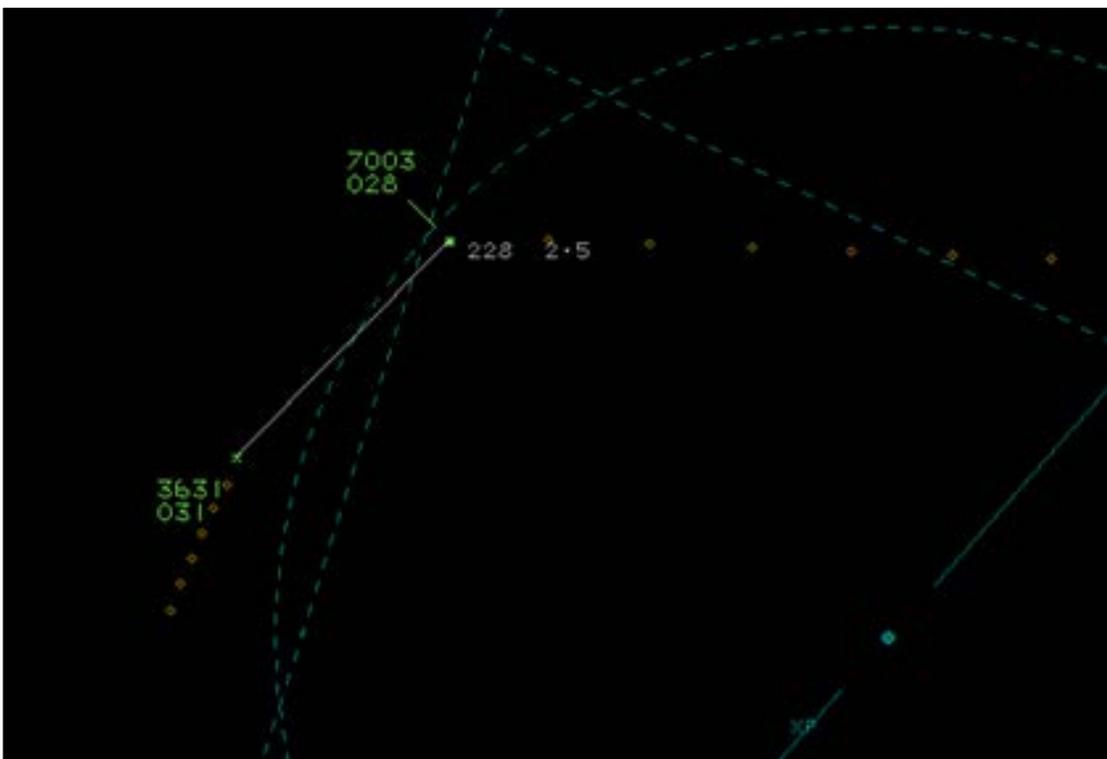
Figure 1: Geometry at 15:04:41 (Hawk 7003; Tecnam 3631)

At 15:04:41 (Figure 1), the Waddington LARS controller passed Traffic Information (TI) to the Tecnam on traffic 12 o'clock, 2nm, crossing right to left ahead, fast moving, indicating 300ft below.

Figures 1-3 depict the positions of the Hawk and Tecnam at pertinent times in the lead up to and during the Airprox. The screen shots are taken from a replay of the Claxby radar feed, which is not the feed utilised by Waddington ATC therefore not the picture seen by the controllers involved.

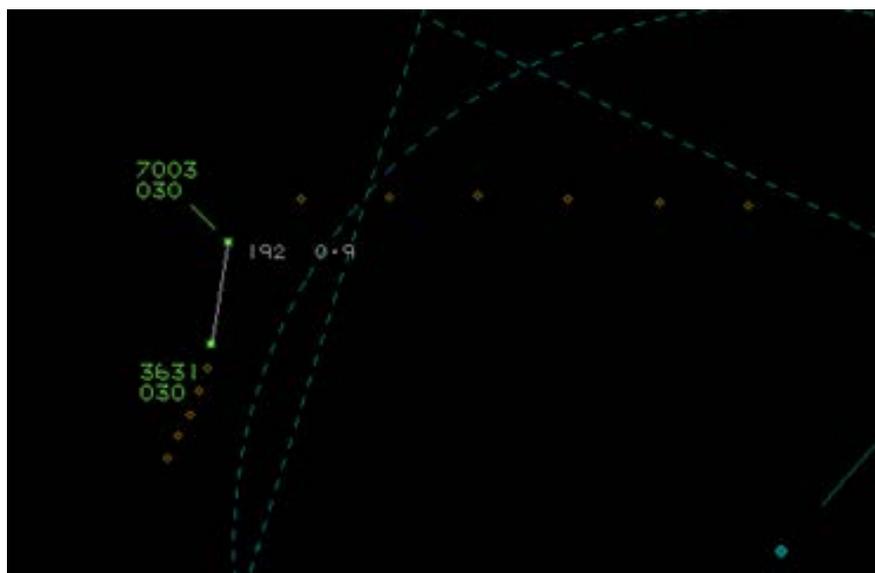
Figure 2: Geometry at 15:04:57 (Hawk 7003; Tecnam 3631)

At 15:04:57 (Figure 2), the Waddington RA controller passed TI to the Hawk on traffic south, 1nm, tracking north, similar altitude.

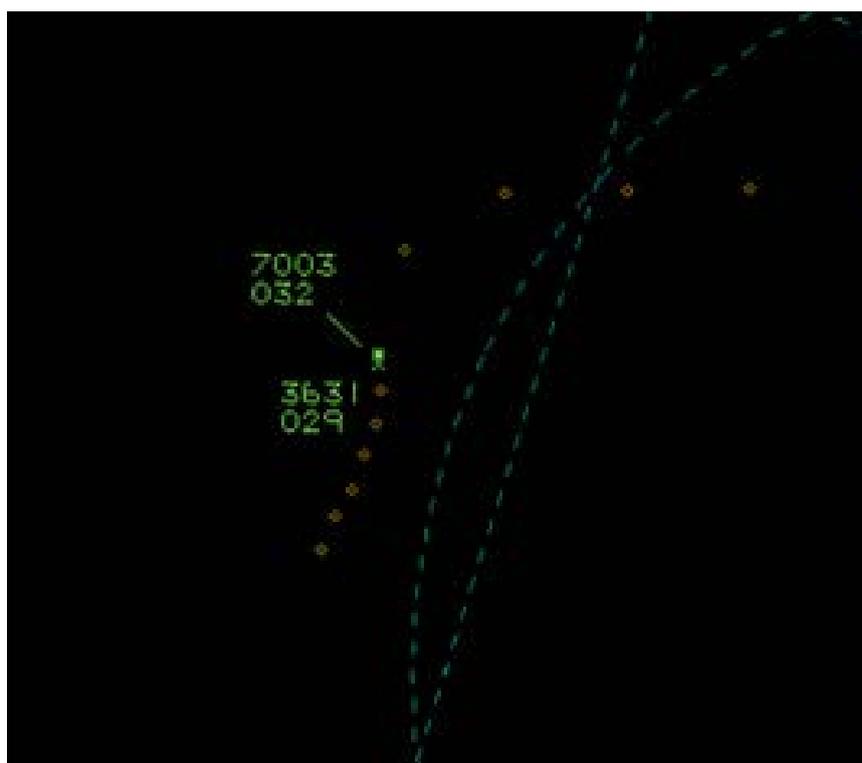
Figure 3: Geometry at 15:05:57 (Hawk 7003; Tecnam 3631)

At 15:05:05 (Figure 3), the two aircraft passed at their CPA.
