AIRPROX REPORT No 2017072

Date: 22 Apr 2017 Time: 0621Z Position: 5130N 00001E Location: 1nm W London City airport

PART A: SUMMARY OF INFORMATION REPORTED TO UKAB

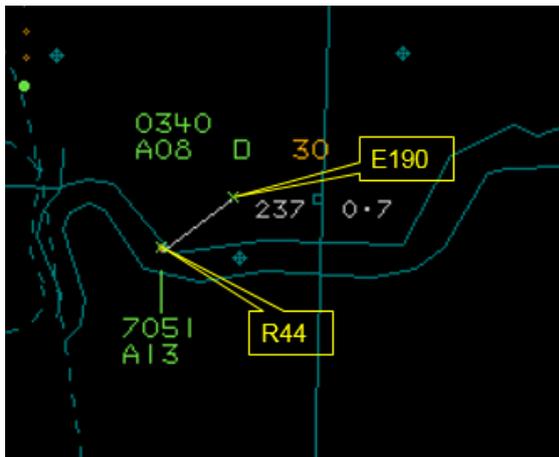
Figure 1 – 0620:25.

At 0620:25 the E190 first appeared on the radar (Figure1). CPA occurred at 0620:47 (Figure 2), when there was 0.4nm laterally and 400ft vertically between the two aircraft.

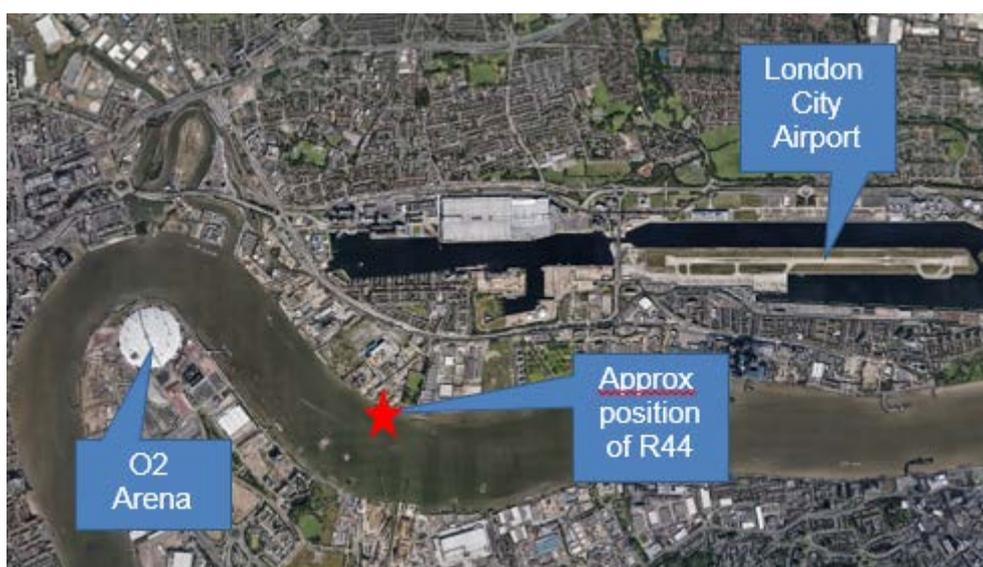
Figure 3.

Figure 3 depicts London City Airport and the O2 arena (or ‘Dome’) and the approximate position of the R44 when the E190 departed.
