AIRPROX REPORT No 2017074

Date: 02 May 2017 Time: 0941Z Position: 5302N 00028W Location: RAF Cranwell (elev 218ft)

PART A: SUMMARY OF INFORMATION REPORTED TO UKAB

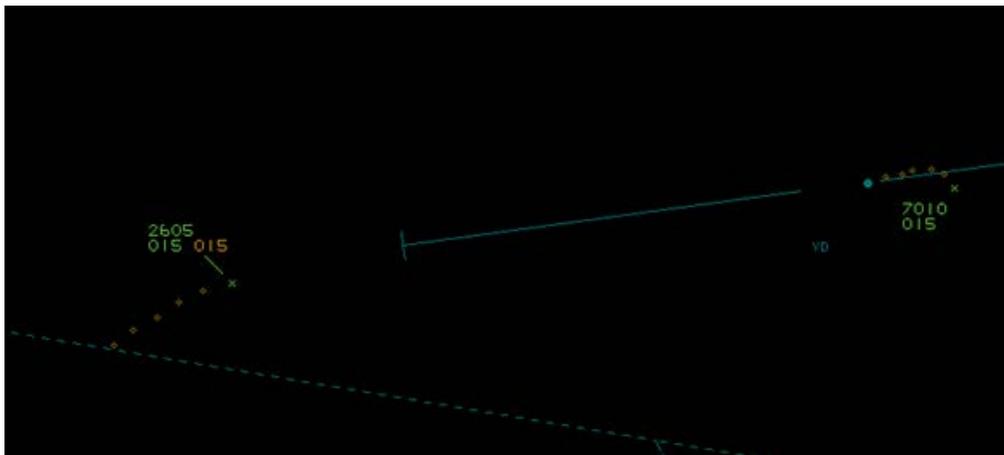
Figure 1: Geometry at 09:37:22 (King Air 2605; Tutor 7010)

At 09:37:22 (Figure 1), the Cranwell Tower controller broadcast to all aircraft on frequency that the King Air was at 7nm, to low approach and depart, simulated asymmetric.

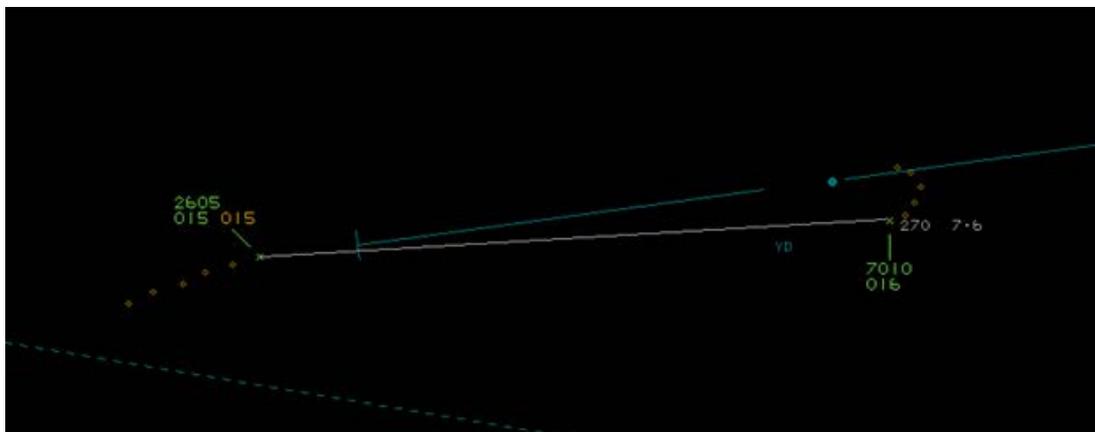
Figure 2: Geometry at 09:37:41 (King Air 2605; Tutor 7010)

At 09:37:41 (Figure 2), the Cranwell Tower controller informed the Tutor pilot, who had reported downwind for glide circuit touch and go, that there was King Air radar traffic at 6nm.

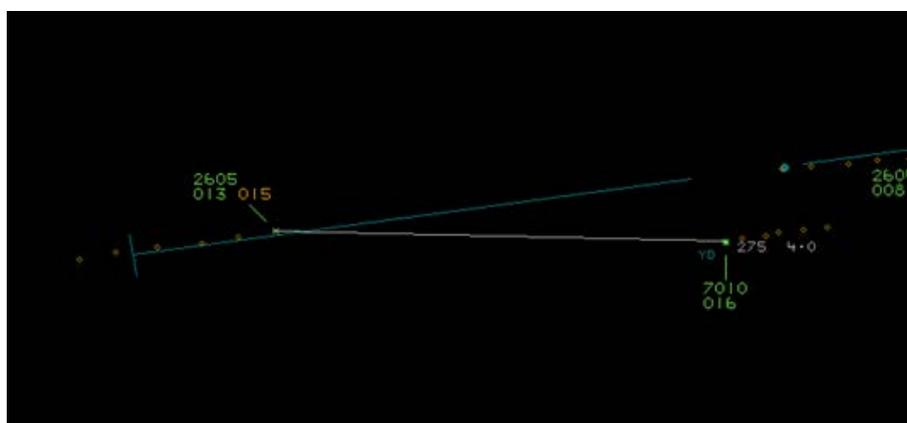
Figure 3: Geometry at 09:38:40 (King Air 2605; Tutor 7010)

At 09:38:40 (Figure 3), the Cranwell Tower controller advised the Tutor that the priority radar traffic was at 3nm and would be number one. The Talkdown controller then came through on the radar clearance line to seek a clearance for the King Air to low approach. The Cranwell Tower controller gave clearance for the King Air to low approach, with information that there was one going around circuit height, quickly corrected to glide height. The clearance was being relayed to the King Air by the Talkdown controller.

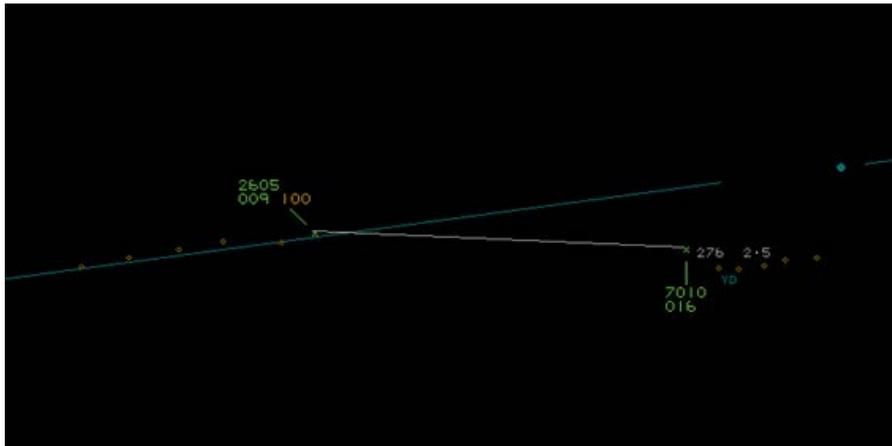
Figure 4: Geometry at 09:39:05 (King Air 2605; Tutor 7010)

At 09:39:05 (Figure 4), the Cranwell Tower controller broadcast to all aircraft on frequency that the King Air was at a range of 2.5nm to low approach.

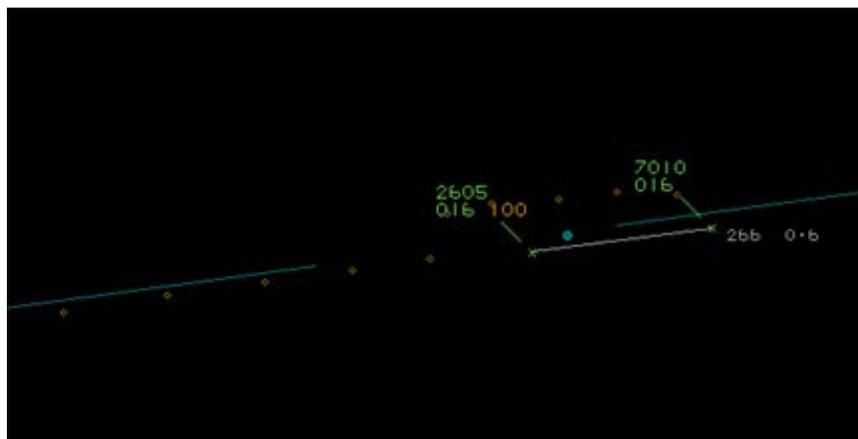
Figure 5: Geometry at 09:40:26 (King Air 2605; Tutor 7010)

At 09:39:32, the King Air pilot informed the Talkdown controller that he was going around, and then changed to Cranwell Departures. At 09:40:26 (Figure 5), the Cranwell Departures controller identified the departing King Air, agreed a Traffic Service and passed Traffic Information on traffic 12 o'clock, 1nm, similar heading, believed to be in the circuit at the same height. The King Air pilot responded that he was visual with the traffic and had just had a TCAS RA.

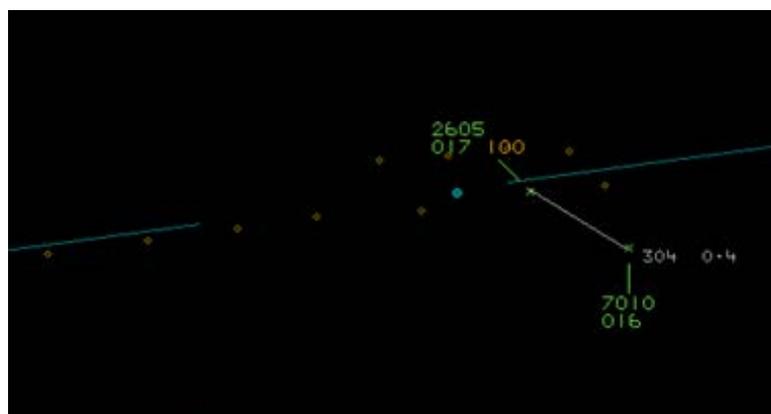
Figure 6: Geometry at 09:40:33 (King Air 2605; Tutor 7010)

At 09:40:33 (Figure 6), the King Air and Tutor passed at a CPA of 0.4nm and similar height.
