AIRPROX REPORT No 2017201

Date: 21 Aug 2017 Time: 1514Z Position: 5145N 00135W Location: Brize Norton airfield

PART A: SUMMARY OF INFORMATION REPORTED TO UKAB

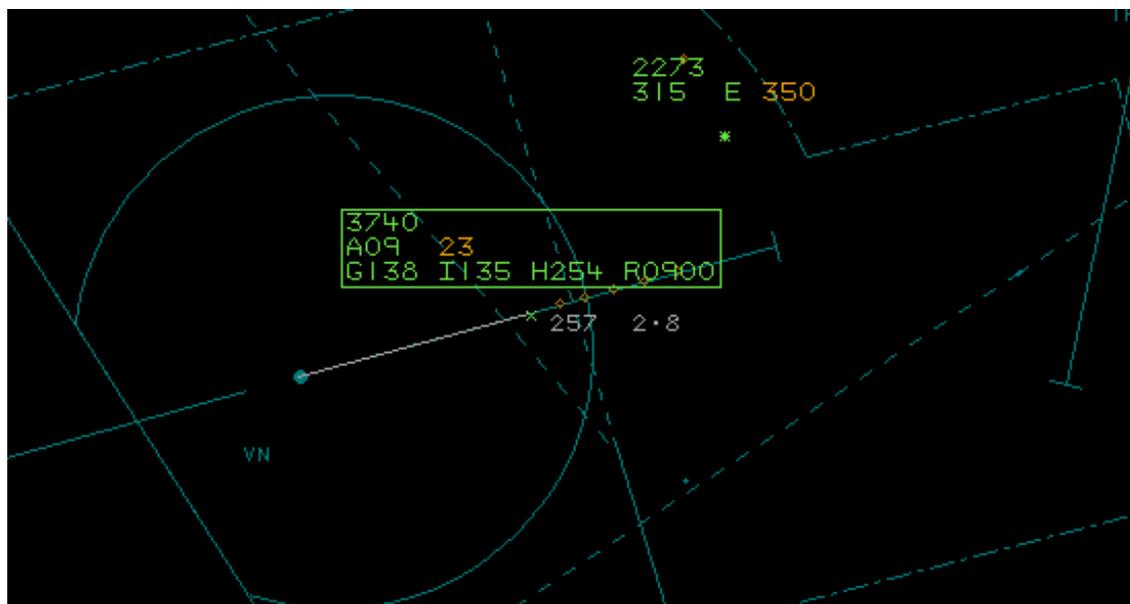
Figure 1 1512:38 A400M(A)-3740.
(A400M(A) pilot instructed to break off approach, based on R/T transcript.)

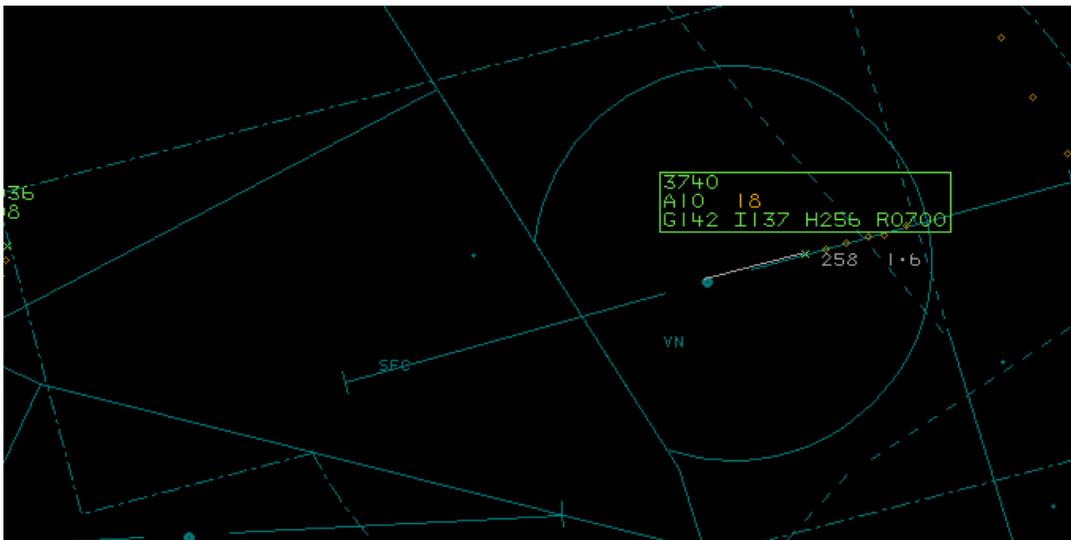
Figure 2 1513:09.
(A400M(A) climbing.)

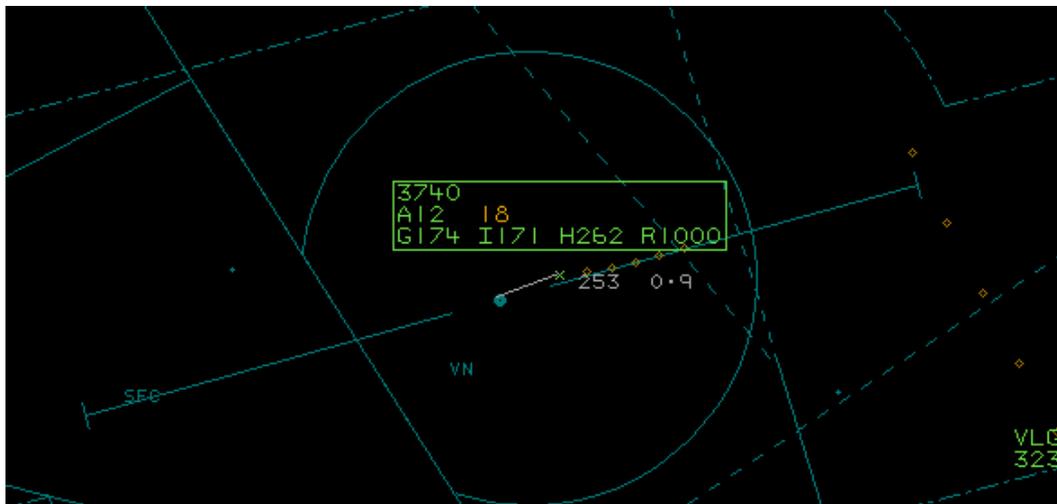
Figure 3 1513:28.
(A400M(A) pilot reports turning left.)

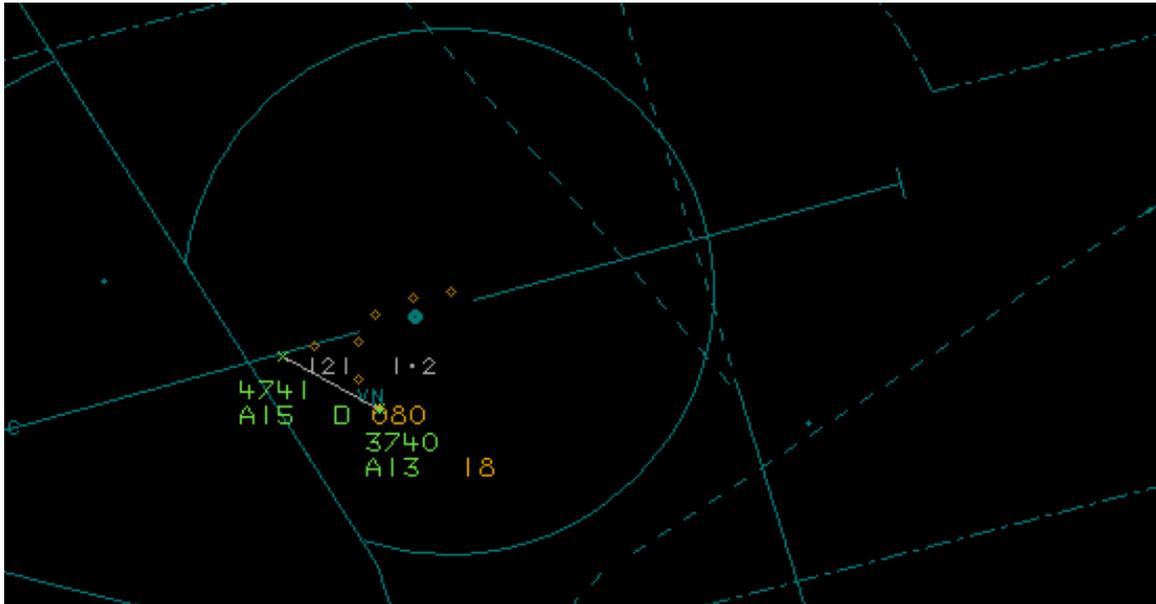
Figure 5 1514:16 A400M(B)-4741.
(A400M(B) first appears.)
