AIRPROX REPORT No 2017206

Date: 25 Aug 2017 Time: 1340Z Position: 5136N 00009W Location: Finchley

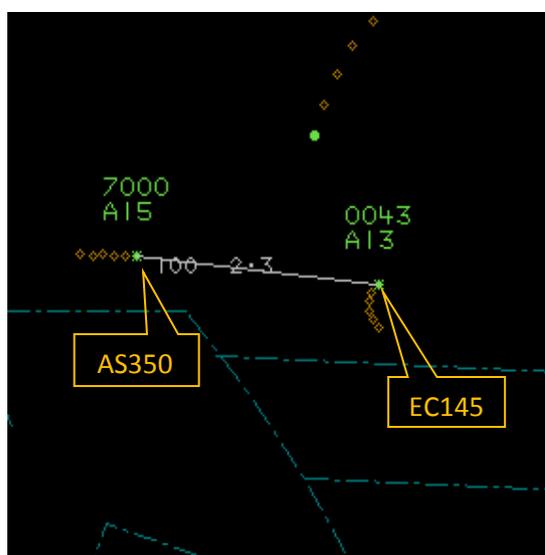
Figure 1 – 1338:16

At 1338:16 the AS350 contacted the Heathrow Special VFR controller and was told to standby (the controller was still engaged in the handover of the operational position). The AS350 was observed on the radar replay to be west of the EC145 by 4.5nm at this time (Figure 1).

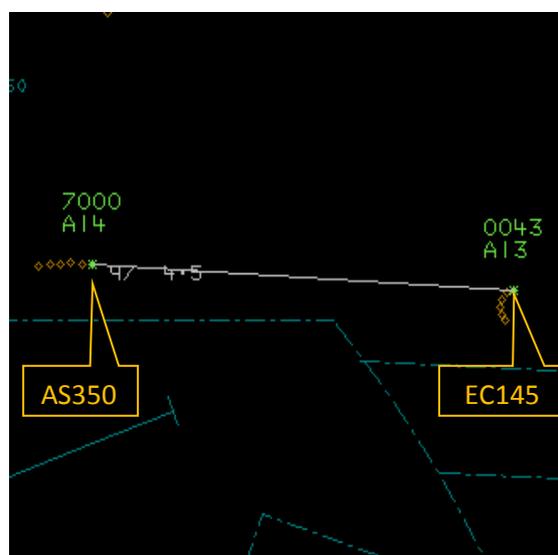
Figure 2 – 1339:30

At 1339:30 the handover was still in progress and the outgoing controller passed Traffic Information to the EC145 on unknown traffic, to the west, at a similar altitude (this subsequently turned out to be the AS350) (Figure 2).

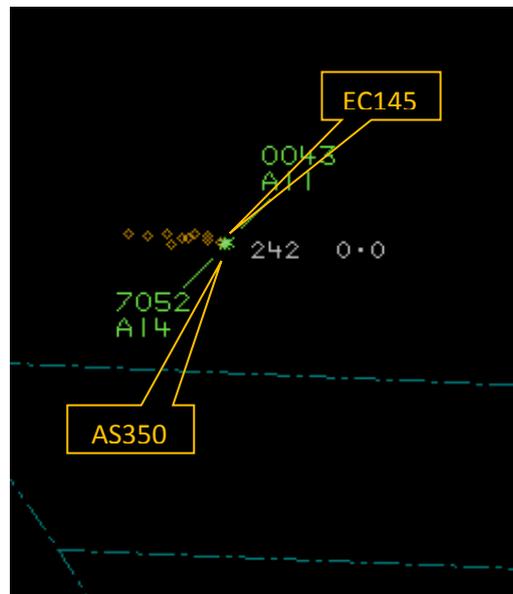
Figure 3 - 1340:58

CPA occurred at 1340:58 when the radar returns merged (Figure 3).

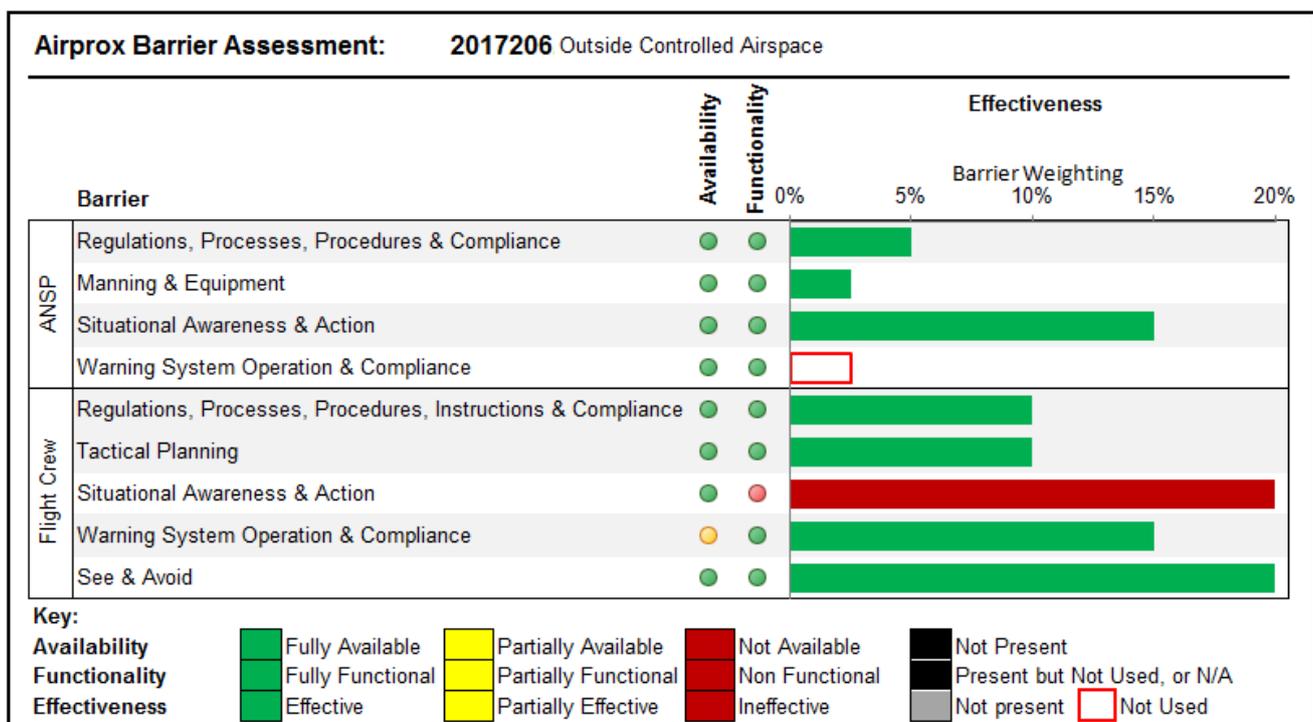
Safety Barrier Assessment²

In assessing the effectiveness of the safety barriers associated with this incident, the Board concluded that the key factors had been that:

Warning System Operation and Compliance were assessed as **not used** because, although Swanwick have the facility for STCA, the practical application outside controlled airspace at lower levels is not currently operationally viable.

Situational Awareness and Action were assessed as **ineffective** because although the AS350 pilot was visual with the EC145 and could have been expected to reasonably assume the pilot was flying a task, he did not alter his course to avoid the EC145.
