## AIRPROX REPORT No 2017278

Date: 14 Dec 2017 Time: 1340Z Position: 5409N 00103W Location: 10nm NE Linton

### PART A: SUMMARY OF INFORMATION REPORTED TO UKAB

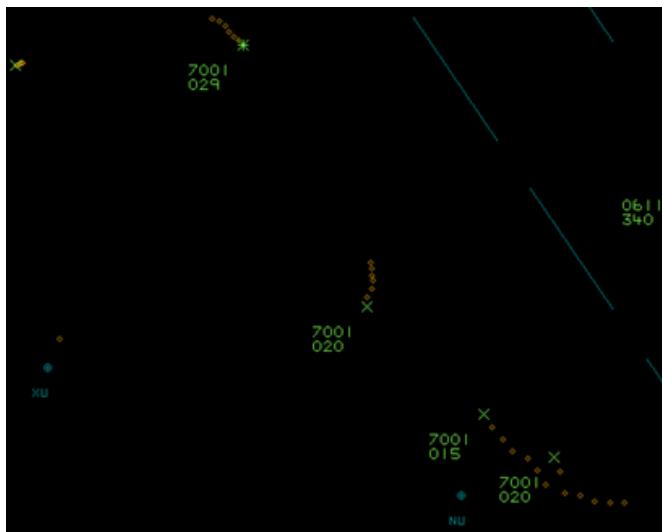
Figure 1: Geometry at 13:37:07

At 13:37:07 (Figure 1), the Linton Approach controller passed Traffic Information (TI) on the F15s to the first Tucano as "south east, 5nm, tracking north west, fast moving, two contacts, indicating slightly below", which indicates that they were visible on radar at that time. At 13:37:39 (Figure 2), the Airprox Tucano first called the Linton Approach Controller for recovery (seen with transponder code 4576), climbing to 8000ft QFE. The controller issued a squawk and requested that the pilot standby. He then returned his attention to the other Tucano aircraft.

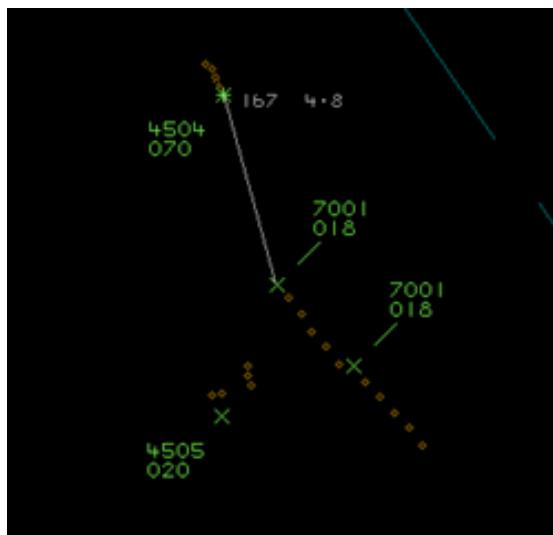
Figure 3: Geometry at 13:38:09

At 13:38:09 (Figure 3), the Linton Approach Controller identified the Tucano, agreed a Traffic Service and asked the pilot to pass his details. At 13:38:20 (Figure 4), while the Tucano pilot was passing his recovery details, the Mode C of each F15 disappeared on radar replay, which can indicate a rapid climb. The last indication displayed was that both were at 018.

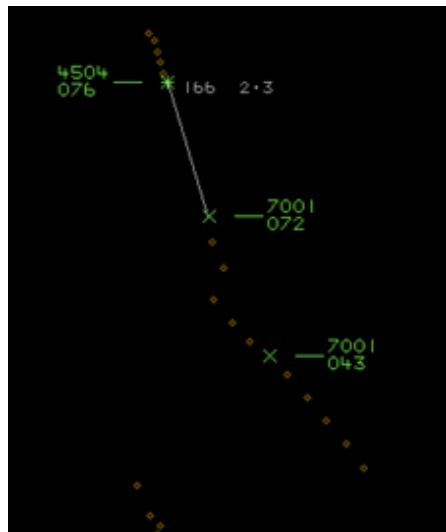
Figure 5: Geometry at 13:38:24

At 13:38:24 (Figure 5), the same time the Tucano pilot finished passing his details, the F15s' Mode C reappeared on radar replay indicating 072 (lead aircraft) and 043 (second aircraft). The controller acknowledged the pilot and turned his attention to the other recovering aircraft. No TI was passed at the time, and it is not known whether or not the F15s' Mode C was visible on the controller's radar screen. At 13:38:36 (Figure 6), the Linton Approach Controller was vectoring another aircraft for instrument recovery while the lead F15 passed above the Tucano with approximately 1400ft and 0.3nm separation.

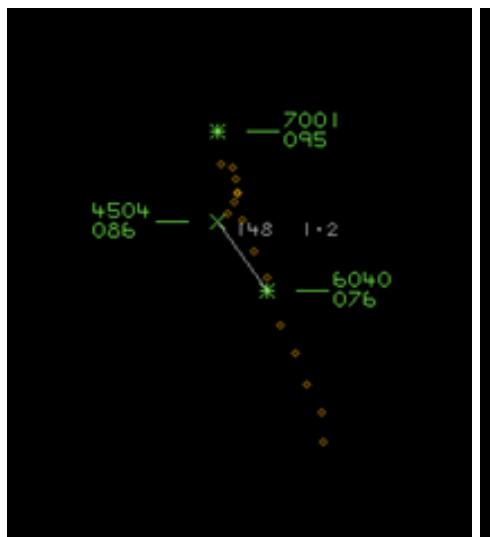
Figure 7: Geometry at 13:38:47

At 13:38:47 (Figure 7), as the controller asked the Tucano pilot to confirm his heading and height and he reported that he was coming right due to an aircraft passing 500ft above. Replays showed the Tucano between the F15s, 1000ft below the lead and 1000ft above the second aircraft. Figure 8, (13:38:56) shows the second F15 as it passed the Tucano with approximately 0.7nm and 400ft separation.

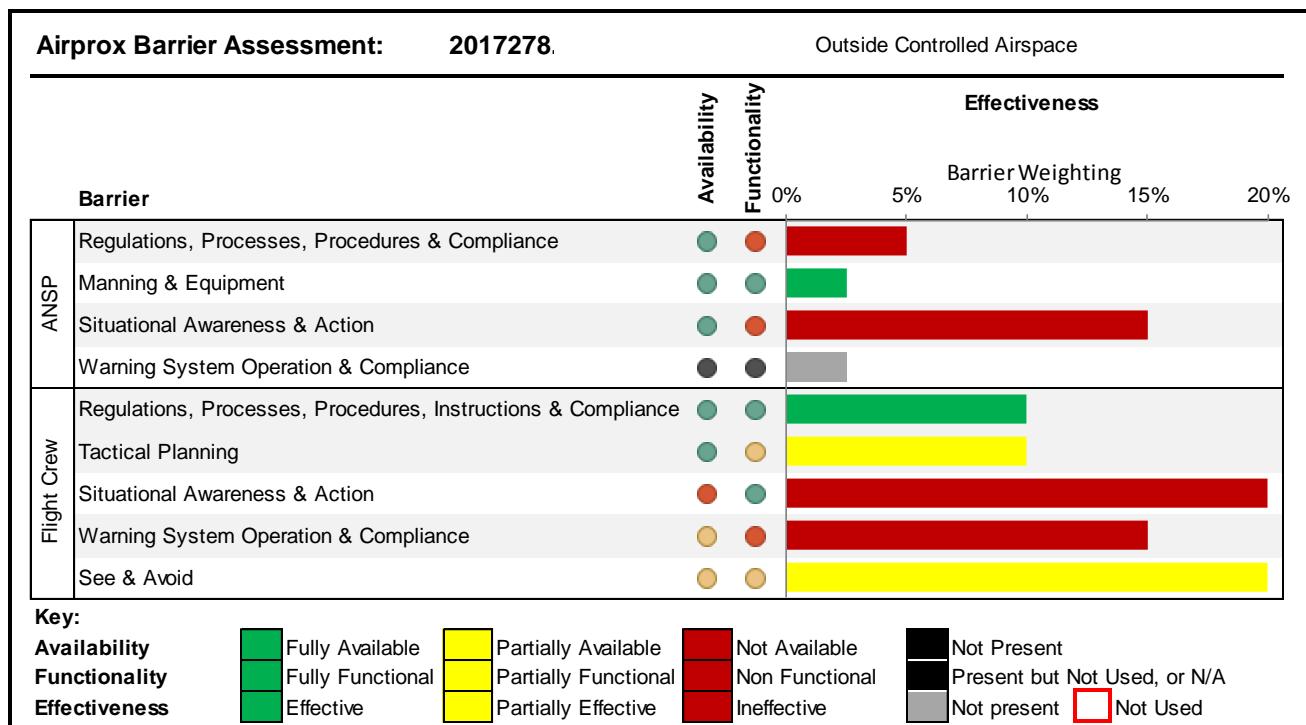
**Warning System Operation and Compliance** were assessed as **ineffective** because the Tucano pilot had not received any information from his TCAS on the F15s, probably due to their high rate of climb.

**See and Avoid** were assessed as **partially effective** because the Tucano pilot saw the first F15 late as it broke cloud and had only been able to take emergency avoiding action.
